DEKRA Boksburg
Bentel Ave - 1459
BOKSBURG - GT
011 826 4386

Vehicle Type	PASSENGER VEHICLE	Registered Owner	
Manufacturer	FIAT	Registration Number	CY282326
Model	PALIO 1.6	Register Number	DXJ161S
VIN	AFZ178F7101531110	Date Of First Licensing	
Engine Number	178D20110713477	Last COR	04/02/2026
Doors	4	License Expiry Date	
Color	WHITE	Power / Displacement	74KW/1581CCM
Year Model	2005	Paint Finish	C - COMMON
Km Reading	91,015 KM	Fuel	PETROL
Cab / Body Type	HATCHBACK	Transmission	MANUAL

VEHICLE INSPECTION

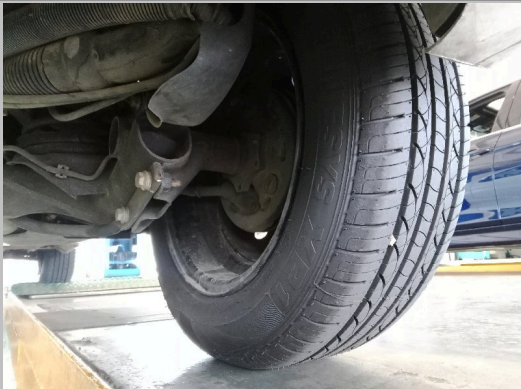
RR TYRE TREAD

Size	Load/Speed Index	Manufacture	Model	Type*	Production Date	Tread Depth (mm)
Front Left	175/65/14	82T	Hilo	Genyses	V	3825	5 mm
Front Right	175/65/14	86T	Hilo	Genyses	V	2025	5 mm
Rear Left	175/65/14	82T	Hilo	Genyses	V	3825	6 mm
Rear Right	175/65/14	82T	Hilo	Genyses	V	3825	0 mm
Spare	175/65/14	82T	Davanti	DX390	V	0000	2 mm
