DEKRA Boksburg  
Bentel Ave - 1459  
BOKSBURG - GT  
011 826 4386

Vehicle Type	PASSENGER VEHICLE	Registered Owner	CBK CBK MOTORS
Manufacturer	AUDI	Registration Number	KHK403NW
Model	A5	Register Number	DNW839K
VIN	WUAZZZ8T7BA902340	Date Of First Licensing	
Engine Number		Last COR	2026/03/19
Doors	2	License Expiry Date	
Color	SILVER	Power / Displacement	331kW/4163cc
Year Model	2011	Paint Finish	M - METALLIC
Km Reading	68,644 KM	Fuel	PETROL
Cab / Body Type	COUPE	Transmission	AUTOMATIC

**VEHICLE INSPECTION**

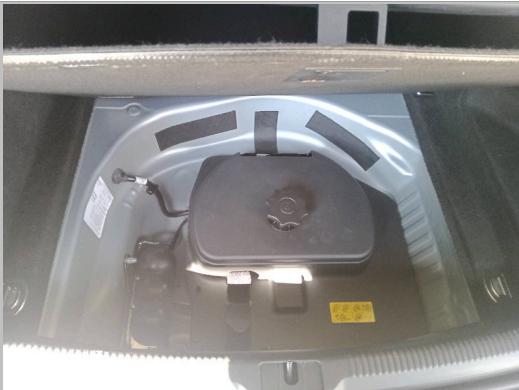
No Spare wheel

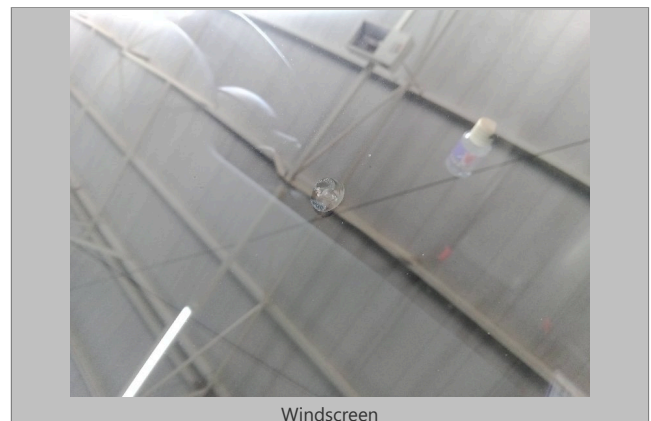
Windscreen Chipped

General Comments: ACCORDING TO AGE AND MILEAGE OF VEHICLE NORMAL WEAR AND TEAR ON INTERIOR, EXTERIOR, ELECTRICAL AND MECHANICAL PARTS. Interior: in accordance with the age and mileage of the vehicle minor wear and tear to be expected on the interior of the vehicle.  
Body • Exterior: In accordance to the age and mileage of the vehicle minor dents and scratches visible on some body panels. Windscreen chipped to be stopped.
