DEKRA Boksburg  
Bentel Ave - 1459  
BOKSBURG - GT  
011 826 4386

## Assignment

| Manufacturer | ISUZU | Registration Number | CR76DXGP |
| Model | KB300 LX D-CAB CLOTH DSL PU [2013-2014] | Register Number | FRY058K |

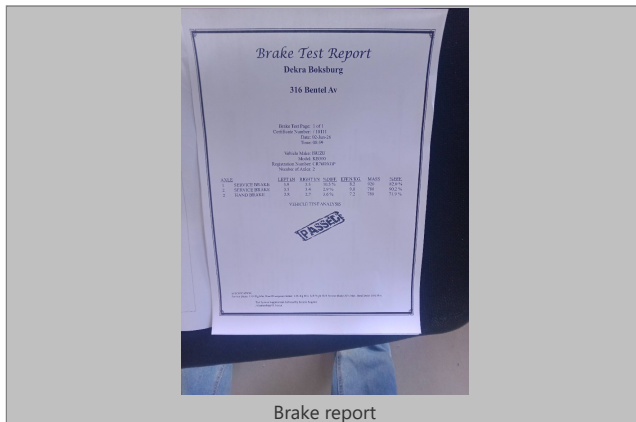
Brake report

| | Left | Right | | |
|---|---|---|---|---|
| Front | 3.9 | 3.5 | - | |
| Rear | 3.5 | 3.4 | - | |
| Emergency / Parking | 2.8 | 2.7 | - | |

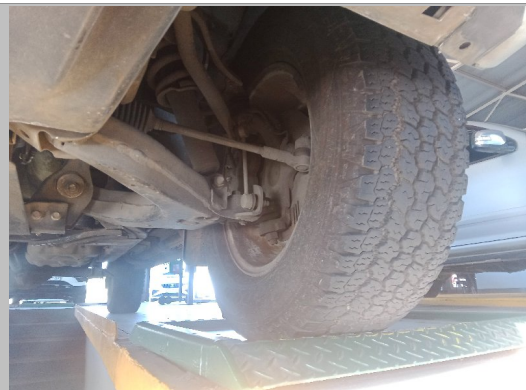
LF TYRE TREAD

| | Size | Load/Speed Index | Manufacture | Model | Type* | Production Date | Tread Depth (mm) |
|---|---|---|---|---|---|---|---|
| Front Left | 265/65R17 | 112T | Goodyear | Wrangler | V | 3321 | 6 mm |

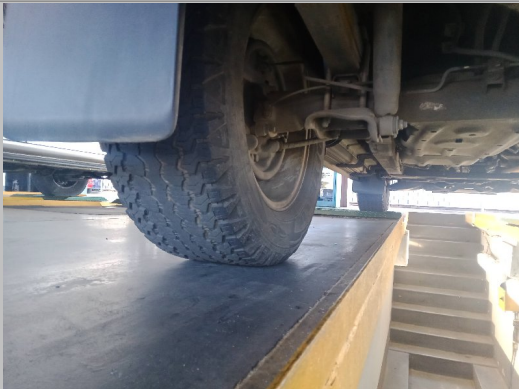
LR TYRE TREAD

| | Size | Load/Speed Index | Manufacture | Model | Type* | Production Date | Tread Depth (mm) |
|---|---|---|---|---|---|---|---|
| Rear Left | 255/65R17 | 110T | Goodyear | Wrangler | V | 2613 | 3 mm |

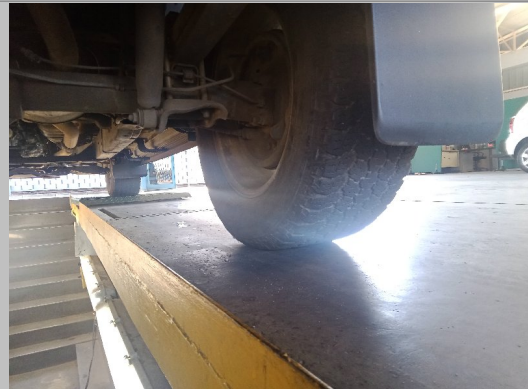
RR TYRE TREAD

| | Size | Load/Speed Index | Manufacture | Model | Type* | Production Date | Tread Depth (mm) |
|---|---|---|---|---|---|---|---|
| Rear Right | 255/65R17 | 110T | Goodyear | Wrangler | V | 4917 | 4 mm |

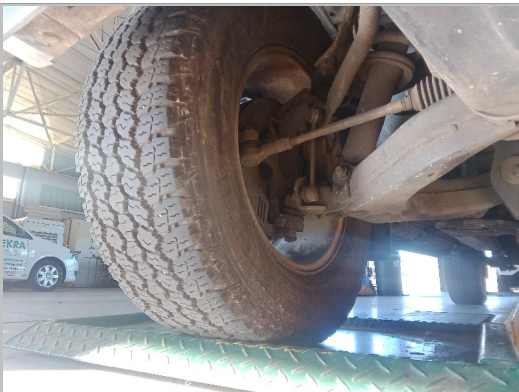
RF TYRE TREAD

| | Size | Load/Speed Index | Manufacture | Model | Type* | Production Date | Tread Depth (mm) |
|---|---|---|---|---|---|---|---|
| Front Right | 265/65R17 | 112T | Goodyear | Wrangler | V | 2821 | 6 mm |

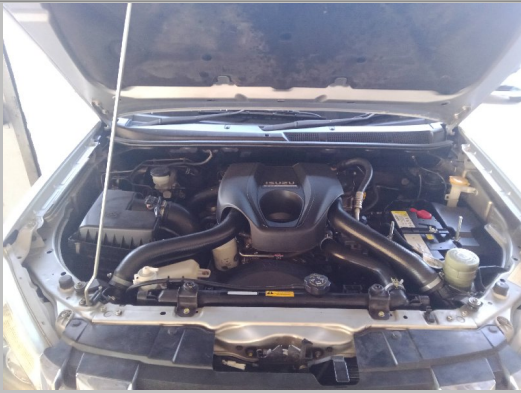
ENGINE 1

Engine number – not possible to verify engine number (not visible without dismantling)
