DEKRA Boksburg  
Bentel Ave - 1459  
BOKSBURG - GT  
011 826 4386

## Assignment

| Model | FIESTA 1.0 ECOBOOST TREND 5-DR POWERSHIFT [2013-2018] | Register Number | TTW018W |

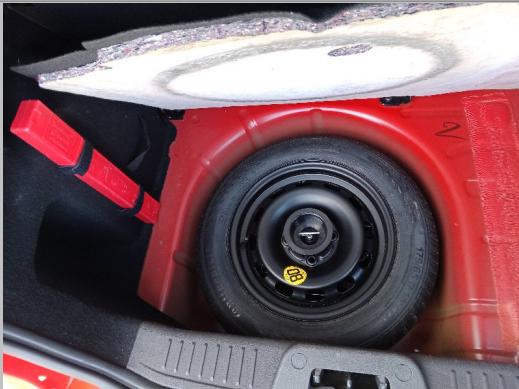
Sparewheel

| | Size | Load/Speed Index | Manufacture | Model | Type* | Production Date | Tread Depth (mm) |
|---|---|---|---|---|---|---|---|
| Spare | 175/65R14 | 82T | Continental | Contact 3 | V | 1214 | 7 mm |

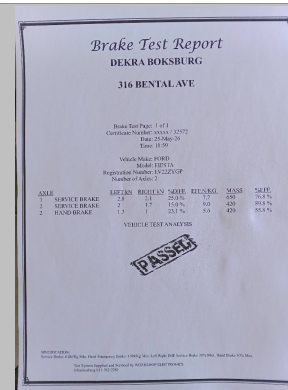
Brake test report

VEHICLE TEST ANALYSIS

**PASSED**

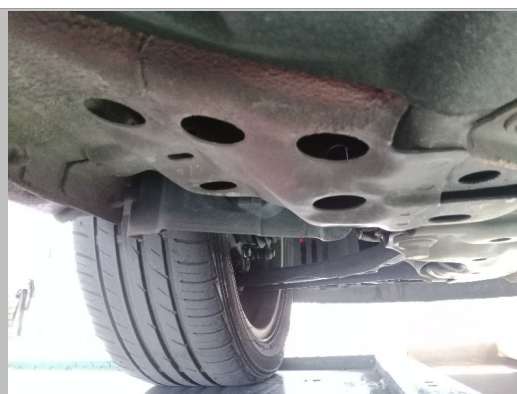
LF TYRE TREAD

| | Size | Load/Speed Index | Manufacture | Model | Type* | Production Date | Tread Depth (mm) |
|---|---|---|---|---|---|---|---|
| Front Left | 195/50R15 | 82V | Falken | Ziex | V | 1622 | 3 mm |

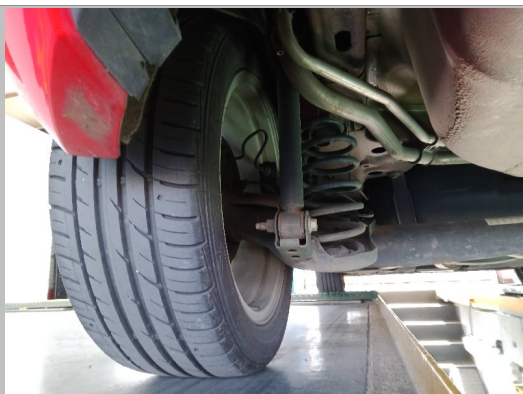
LR TYRE TREAD

| | Size | Load/Speed Index | Manufacture | Model | Type* | Production Date | Tread Depth (mm) |
|---|---|---|---|---|---|---|---|
| Rear Left | 195/50R15 | 82V | Falken | Ziex | V | 1022 | 5 mm |

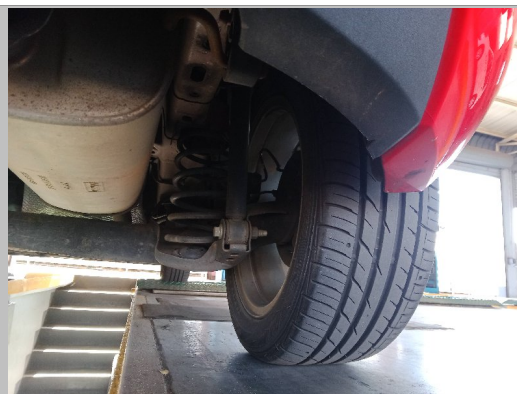
RR TYRE TREAD

| | Size | Load/Speed Index | Manufacture | Model | Type* | Production Date | Tread Depth (mm) |
|---|---|---|---|---|---|---|---|
| Rear Right | 195/50R15 | 82V | Falken | Ziex | V | 1622 | 5 mm |

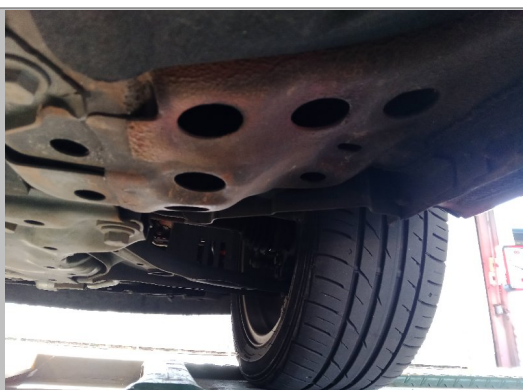
RF TYRE TREAD

| | Size | Load/Speed Index | Manufacture | Model | Type* | Production Date | Tread Depth (mm) |
|---|---|---|---|---|---|---|---|
| Front Right | 195/50R15 | 82V | Falken | Ziex | V | 1622 | 3 mm |
