Private Client

DEKRA Boksburg  
Bentel Ave - 1459  
BOKSBURG - GT  
011 826 4386

| Manufacturer | SUZUKI | Registration Number | DW87ZKGP |
| Model | SWIFT | Register Number | WCP035W |

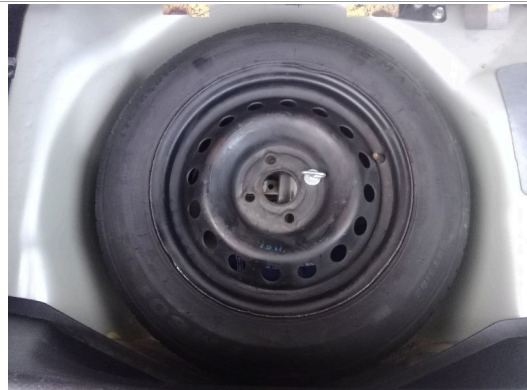
Sparewheel

| | Size | Load/Speed Index | Manufacture | Model | Type* | Production Date | Tread Depth (mm) |
|---|---|---|---|---|---|---|---|
| Spare | 175/65R14 | 82H | Firemax | FM601 | | 3425 | 3 mm |

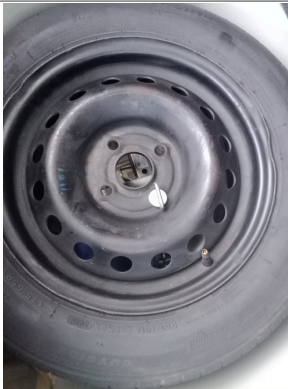
Mirror Adjusters Malfunction  
Rim Spare Wheel Dented
