Private Client

DEKRA Boksburg
Bentel Ave - 1459
BOKSBURG - GT
011 826 4386

Vehicle Type	PASSENGER VEHICLE	Registered Owner	CBK MOTORS
Manufacturer	TOYOTA	Registration Number	DP82FCGP
Model	ETIOS CROSS 1.5 5-DR [2014-2015]	Register Number	FYB524L
VIN	MBJM29BT402022118	Date Of First Licensing	
Engine Number	2NRD076562	Last COR	13/01/2026
Doors	5	License Expiry Date	30/09/2026
Color	GREY	Power / Displacement	66kw 1496ccm
Year Model	2015	Paint Finish	M - METALLIC
Km Reading	87,448 KM	Fuel	PETROL
Cab / Body Type	HATCHBACK	Transmission	MANUAL

VEHICLE INSPECTION

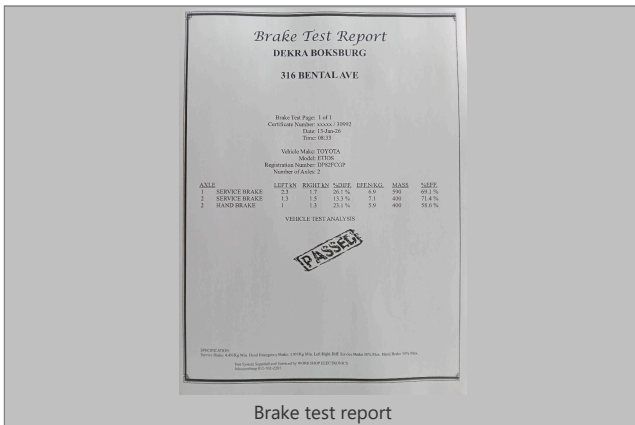
Brake test report

Left	Right		
	Braking Force [KN]	Braking Force [KN]	Axle Weight [KG]	Deceleration [m/s ²]
Front	2.3	1.7	-	
Rear	1.3	1.5	-	
Emergency / Parking	1	1.3	-

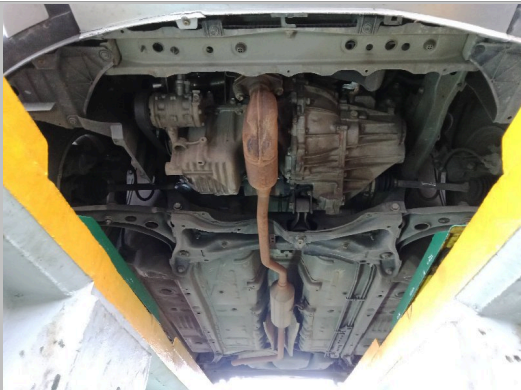
CHASSIS

Axle and Suspension: Rear axle trailing arm bushes slightly perished and appears to be soft.

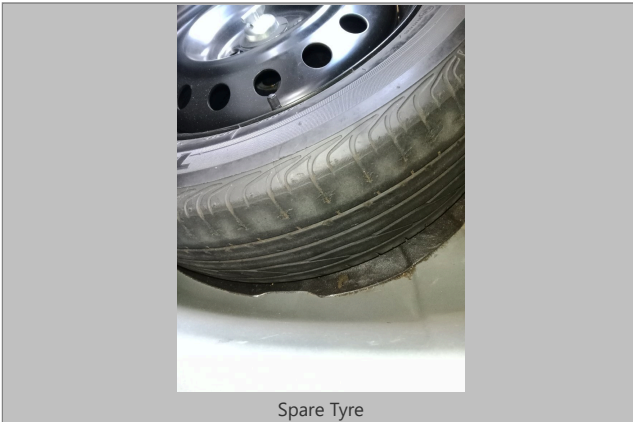
Spare Tyre Worn

Size	Load/Speed Index	Manufacture	Model	Type*	Production Date	Tread Depth (mm)
Front Left	185/60R15	88H	Dunlop	SP Sport	V	2918	3 mm
Front Right	185/60R15	88H	Dunlop	SP Sport	V	2918	3 mm
Rear Left	185/60R15	84H	Bridgestone	Turanza	V	3614	4 mm
Rear Right	185/60R15	84H	Bridgestone	Turanza	V	3514	4 mm
Spare	185/60R15	84H	Bridgestone	Turanza	V	3714	0 mm
