DEKRA Boksburg  
Bentel Ave - 1459  
BOKSBURG - GT  
011 826 4386

Vehicle Type	PASSENGER VEHICLE	Registered Owner	CBK MOTORS
Manufacturer	BMW	Registration Number	FK14DMGP
Model	420D GRAN COUPE DSL AT [2015-2017]	Register Number	XBT336W
VIN	WBA4E920X0G428683	Date Of First Licensing	
Engine Number		Last COR	26/01/2026
Doors	4	License Expiry Date	
Color	BLUE	Power / Displacement	140kw 1995ccm
Year Model	2016	Paint Finish	M - METALLIC
Km Reading	121,474 KM	Fuel	DIESEL
Cab / Body Type	COUPE	Transmission	AUTOMATIC

**VEHICLE INSPECTION**

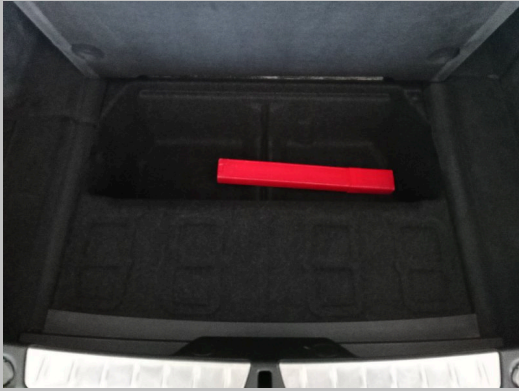
No sparewheel

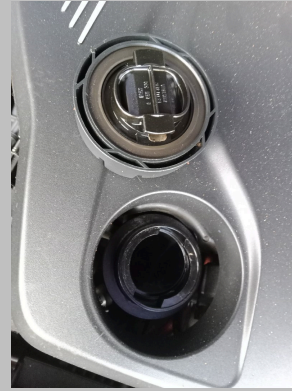
Oil cap no dipstick

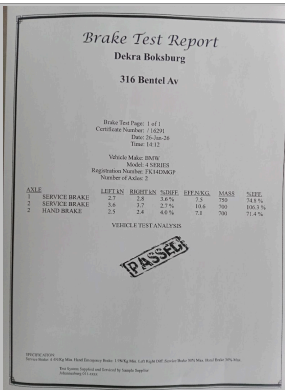
Brake test report

Left	Right		
	Braking Force [KN]	Braking Force [KN]	Axle Weight [KG]	Deceleration [m/s <sup>2</sup> ]
Front	2.7	2.8	-	
Rear	3.6	3.7	-	
Emergency / Parking	2.5	2.4	-
