DEKRA Boksburg
Bentel Ave - 1459
BOKSBURG - GT
011 826 4386

Vehicle Type	PASSENGER VEHICLE	Registered Owner	CBK MOTORS
Manufacturer	HYUNDAI	Registration Number	KK79TNGP
Model	I10	Register Number	XKT321W
VIN	MALAN51BLHM692020	Date Of First Licensing	
Engine Number	G4HGGM945768	Last COR	2023/08/10
Doors	4	License Expiry Date	
Color	WHITE	Power / Displacement	49kW/1086cc
Year Model	2017	Paint Finish	C - COMMON
Km Reading	82,797 KM	Fuel	PETROL
Cab / Body Type	HATCHBACK	Transmission	MANUAL

VEHICLE INSPECTION

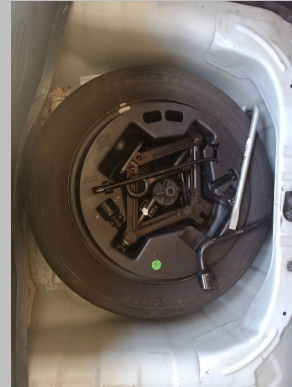
Spare wheel

Size	Load/Speed Index	Manufacture	Model	Type*	Production Date	Tread Depth (mm)
Front Left	165/60/14	75H	Velocity	Rota Eco	V	4123	4 mm
Front Right	165/60/15/4	75H	Velocity	Rota Eco	V	4123	4 mm
Rear Left	165/60/14	75H	Velocity	Rota Eco	V	4123	4 mm
Rear Right	165/60/14	75H	Velocity	Rota Eco	V	4123	4 mm
Spare	165/60/14	75T	Khumo	Solus	V	0000	1 mm
