Private Client

DEKRA Boksburg  
Bentel Ave - 1459  
BOKSBURG - GT  
011 826 4386

VEHICLE INSPECTION

VIN: ADNACAD23Z0002819

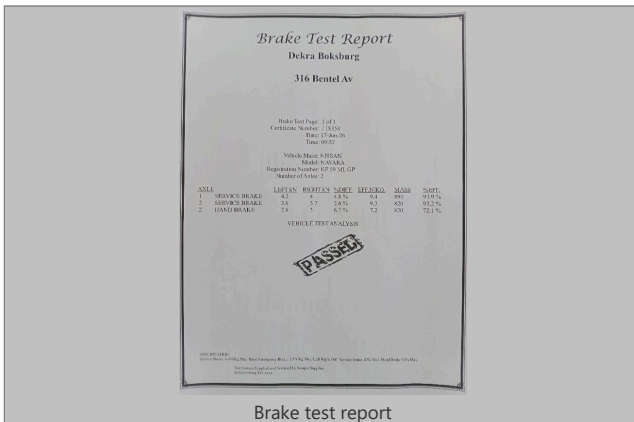
Brake test report

Left	Right		
	Braking Force [KN]	Braking Force [KN]	Axle Weight [KG]	Deceleration [m/s <sup>2</sup> ]
Front	4.2	4.0	-	
Rear	3.8	3.7	-	
Emergency / Parking	2.8	3	-

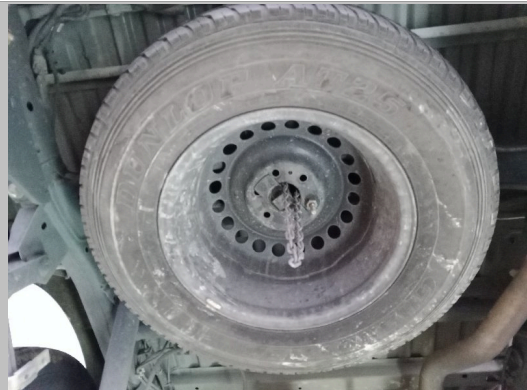
Sparewheel

Size	Load/Speed Index	Manufacture	Model	Type*	Production Date	Tread Depth (mm)
Front Left	205R16C	110/108S	Continental	Worldcontact	V	0623	7 mm
Front Right	205R16C	110/108S	Dunlop	Grandtrek	V	3021	6 mm
Rear Left	205R16C	110/108S	Royalblack	Royal A/T	V	2825	7 mm
Rear Right	205R16C	110/108S	Royalblack	Royal A/T	V	2825	7 mm
Spare	205R16C	110/108S	Dunlop	Grandtrek	V	0000	2 mm

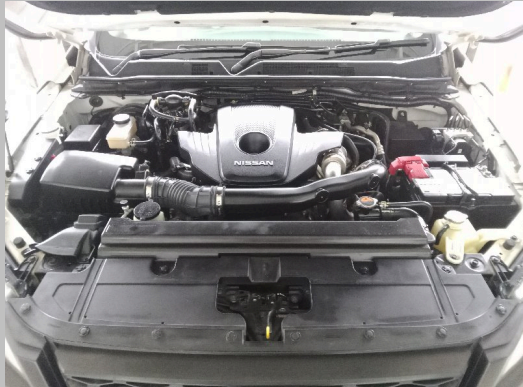
ENGINE 1

General Comments: ACCORDING TO THE AGE AND MILEAGE OF THE VEHICLE, NORMAL WEAR AND TEAR MARKS ARE VISIBLE ON THE INTERIOR, EXTERIOR, ELECTRICAL AND MECHANICAL PARTS. Engine Compartment: Engine mostly covered underneath, visible area wet, not dripping.  
Body • Exterior: Minor dents, scratches and stonechips on some body panels. Cosmetic enhancements done to some body panels.

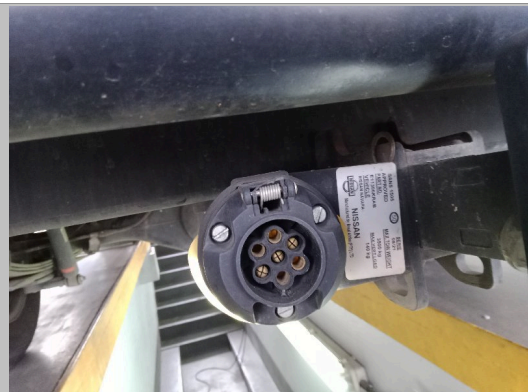
Trailer plug cover missing

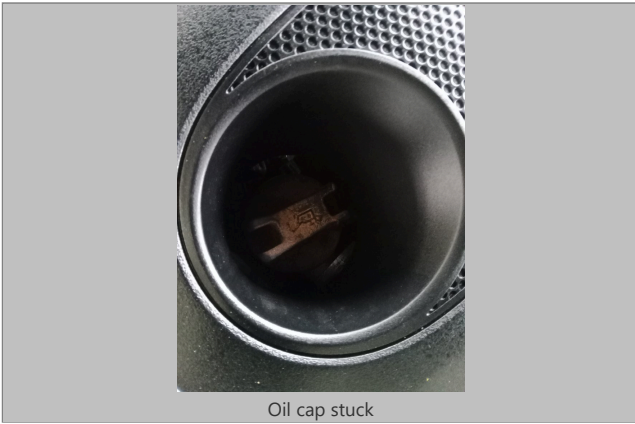
Oil cap stuck
