Private Client

DEKRA Boksburg
Bentel Ave - 1459
BOKSBURG - GT
011 826 4386

Vehicle Type	PASSENGER VEHICLE	Registered Owner	CBK MOTORS
Manufacturer	BMW	Registration Number	MB88TCGP
Model	318I STEPTRONIC [2015-2019]	Register Number	YHR674W
VIN	WBA8E36070NU81555	Date Of First Licensing	
Engine Number	F7201809	Last COR	30/03/2026
Doors	4	License Expiry Date	
Color	SILVER	Power / Displacement	100Kw. 1499Ccm
Year Model	2018	Paint Finish	M - METALLIC
Km Reading	65,160 KM	Fuel	PETROL
Cab / Body Type	SEDAN	Transmission	AUTOMATIC

VEHICLE INSPECTION

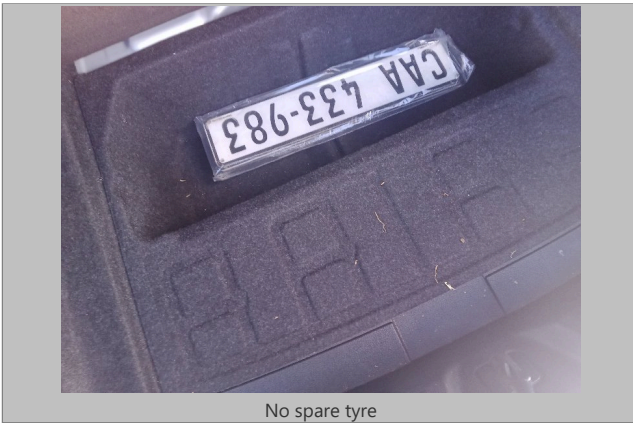
No spare tyre

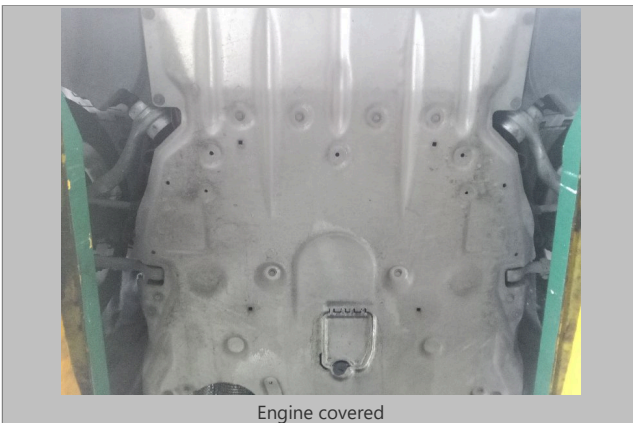
Engine number – not possible to verify engine number (not visible without dismantling)
Inspection conditions for the vehicle inspection were sufficient

Engine covered

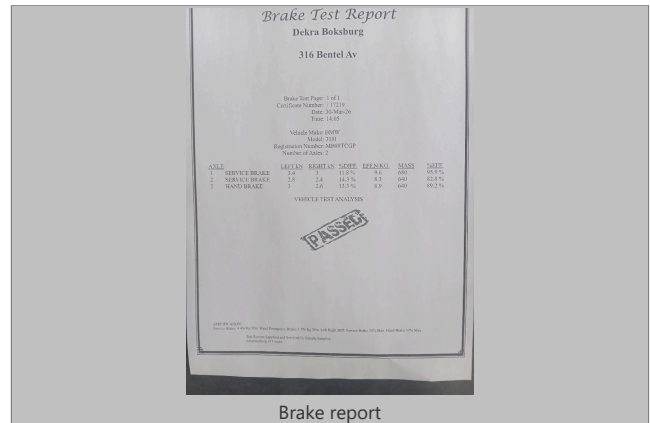
Brake report

Left	Right		
	Braking Force [KN]	Braking Force [KN]	Axle Weight [KG]	Deceleration [m/s ²]
Front	3.4	3.0	-	
Rear	2.8	2.4	-	
Emergency / Parking	3	2.6	-

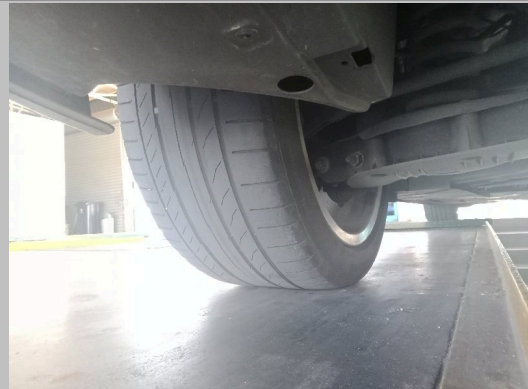
LR TYRE TREAD

Size	Load/Speed Index	Manufacture	Model	Type*	Production Date	Tread Depth (mm)
Front Left	225/45R18	91Y	Continental	Contact 5	V	4222	4 mm
Front Right	225/45R18	91Y	Continental	Contact 5	V	0623	4 mm
Rear Left	255/40R18	95Y	Continental	Contact 5	V	3517	2 mm
Rear Right	255/40R18	95Y	Continental	Contact 5	V	3517	2 mm
