Private Client

## Assignment

| Manufacturer | HYUNDAI | Registration Number | HF83HMGP |
| Model | CRETA GS | Register Number | YDZ012W |

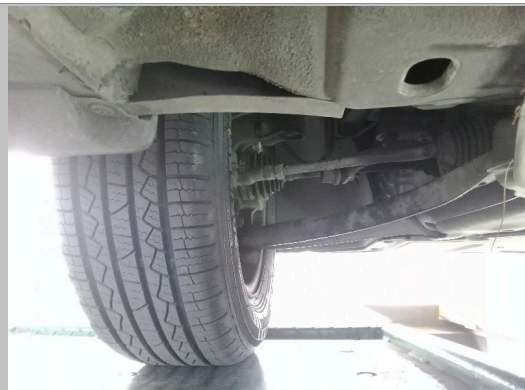
LF TYRE TREAD

| | Size | Load/Speed Index | Manufacture | Model | Type* | Production Date | Tread Depth (mm) |
|---|---|---|---|---|---|---|---|
| Front Left | 205/65R16 | 95H | Hilo | Sport XV1 | V | 0924 | 5 mm |

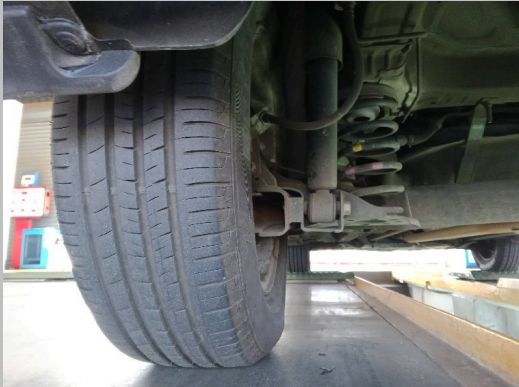
LR TYRE TREAD

| | Size | Load/Speed Index | Manufacture | Model | Type* | Production Date | Tread Depth (mm) |
|---|---|---|---|---|---|---|---|
| Rear Left | 205/65R16 | 95H | Royalblack | Royalmile | V | 3623 | 4 mm |

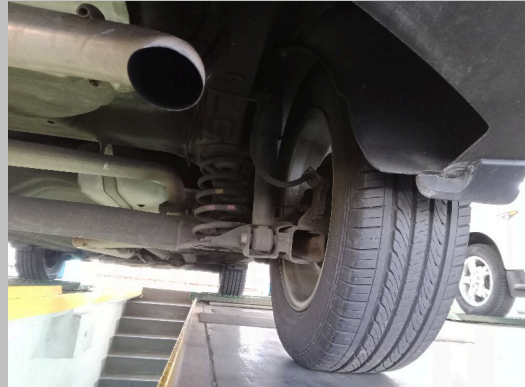
RR TYRE TREAD

| | Size | Load/Speed Index | Manufacture | Model | Type* | Production Date | Tread Depth (mm) |
|---|---|---|---|---|---|---|---|
| Rear Right | 205/65R16 | 95H | Goodyear | Assurance | V | 2017 | 5 mm |

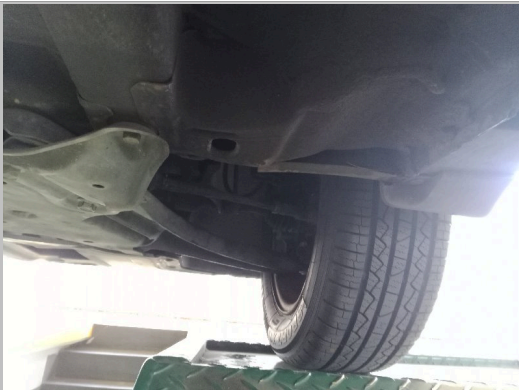
RF TYRE TREAD

| | Size | Load/Speed Index | Manufacture | Model | Type* | Production Date | Tread Depth (mm) |
|---|---|---|---|---|---|---|---|
| Front Right | 205/65R16 | 95H | Hilo | Sport XV1 | V | 1826 | 5 mm |

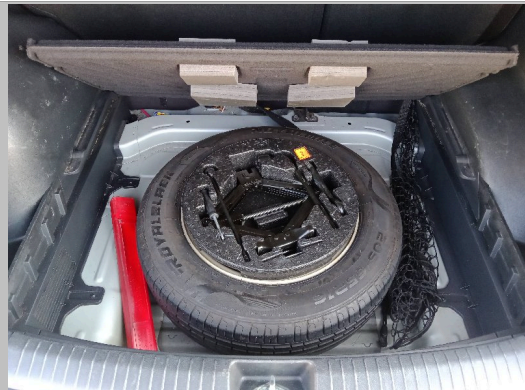
Sparewheel

| | Size | Load/Speed Index | Manufacture | Model | Type* | Production Date | Tread Depth (mm) |
|---|---|---|---|---|---|---|---|
| Spare | 205/65R16 | 95H | Royalblack | Royalmile | V | 0000 | 5 mm |

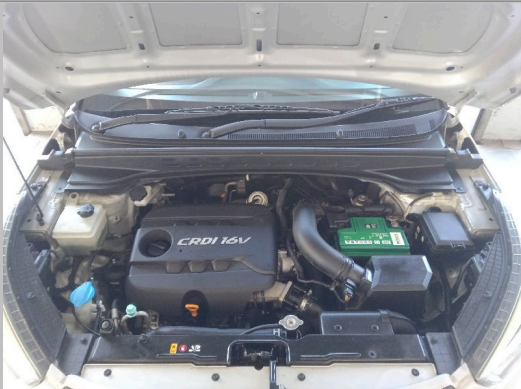
ENGINE 1

Engine number – not possible to verify engine number (not visible without dismantling)
