Private Client

DEKRA Boksburg
Bentel Ave - 1459
BOKSBURG - GT
011 826 4386

Vehicle Type	PASSENGER VEHICLE	Registered Owner	CBK MOTORS
Manufacturer	HYUNDAI	Registration Number	JZ90ZDGP
Model	H1 9 SEATER	Register Number	ZJL483W
VIN	KMHW81KMKU020366	Date Of First Licensing	
Engine Number	D4CBJ625978	Last COR	16/02/2026
Doors	5	License Expiry Date	31/05/2026
Color	SILVER	Power / Displacement	126Kw/2497Cc
Year Model	2018	Paint Finish	M - METALLIC
Km Reading	85,605 KM	Fuel	DIESEL
Cab / Body Type	OTHERS	Transmission	AUTOMATIC

VEHICLE INSPECTION

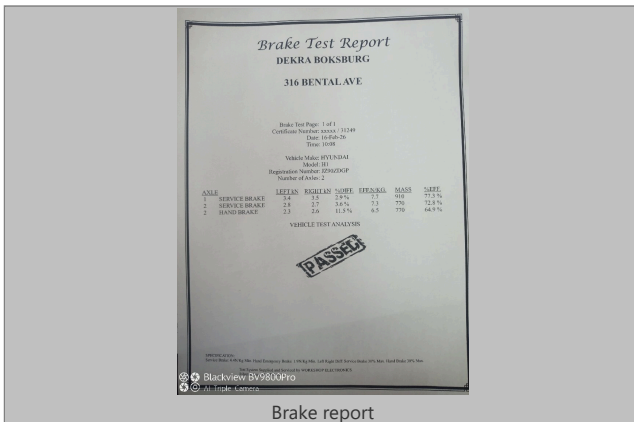
Brake report

Left	Right		
	Braking Force [KN]	Braking Force [KN]	Axle Weight [KG]	Deceleration [m/s ²]
Front	3.4	3.5	-	
Rear	2.8	2.7	-	
Emergency / Parking	2.3	2.6	-

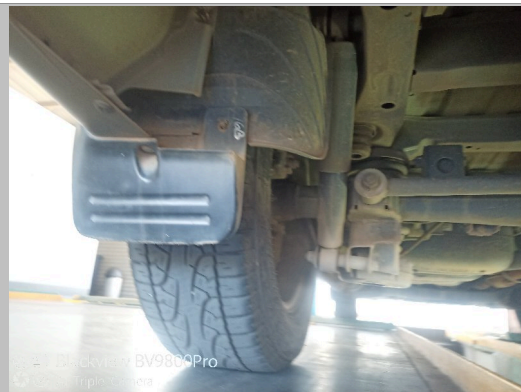
LR TYRE TREAD

Size	Load/Speed Index	Manufacture	Model	Type*	Production Date	Tread Depth (mm)
Front Left	225/65R17	106H	Pirelli	Scorpio	V	3321	3 mm
Front Right	225/65R17	106H	Pirelli	Scorpio	V	3221	3 mm
Rear Left	225/65R17	106H	Pirelli	Scorpio	V	3221	5 mm
Rear Right	225/65R17	106H	Pirelli	Scorpio	V	3421	5 mm
Spare	225/65R17	106H	Pirelli	Scorpio	V	0000	5 mm

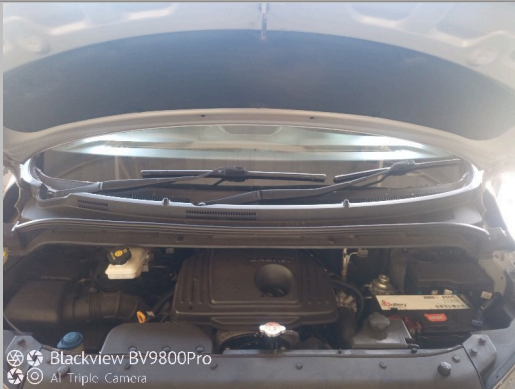
ENGINE 1

Vehicle Dirty
Engine number – not possible to verify engine number (not visible without dismantling)
Inspection conditions for the vehicle inspection were sufficient
