DEKRA Boksburg  
Bentel Ave - 1459  
BOKSBURG - GT  
011 826 4386

Client	Private Client	Inspection Location	BOKSBURG DEKRA
Requested Date	04/05/2026		316 Bentel Ave - 1459
Inspection Date	04/05/2026		Boksburg Dekra - GT

Vehicle Type	PASSENGER VEHICLE	Registered Owner	CBK CBK MOTORS
Manufacturer	MERCEDES BENZ	Registration Number	1611ZN
Model	CLA200	Register Number	YZB279W
VIN	WDD1173432N686564	Date Of First Licensing	
Engine Number		Last COR	04/05/2026
Doors	4	License Expiry Date	31/10/2026
Color	RED	Power / Displacement	115KW/1595CCM
Year Model	2018	Paint Finish	M - METALLIC
Km Reading	114,203 KM	Fuel	PETROL
Cab / Body Type	SEDAN	Transmission	AUTOMATIC

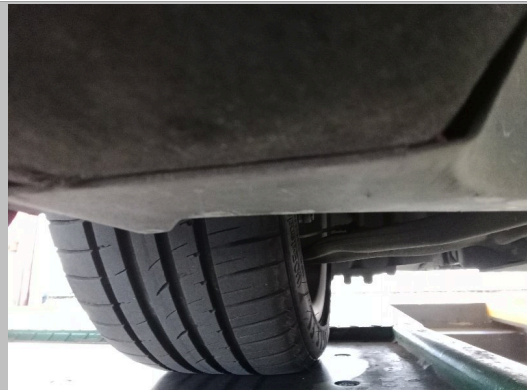
LF TYRE TREAD

Size	Load/Speed Index	Manufacture	Model	Type*	Production Date	Tread Depth (mm)
Front Left	225/40R18	92W	Goodyear	Eagle	V	0925	5 mm
Front Right	225/40R18	92W	Goodyear	Eagle	V	0724	5 mm
Rear Left	225/40R18	92W	Continental	Contact 5	V	3525	6 mm
Rear Right	225/40R18	92W	Goodyear	Eagle	V	0925	6 mm
