Private Client

DEKRA Boksburg  
Bentel Ave - 1459  
BOKSBURG - GT  
011 826 4386

| Manufacturer | BMW | Registration Number | HZ56KFGP |
| Model | X3 M40D SAV (SPORT) AWD DSL 8-SP<br>STEPTRONIC [2019-2022] | Register Number | ZXP357W |

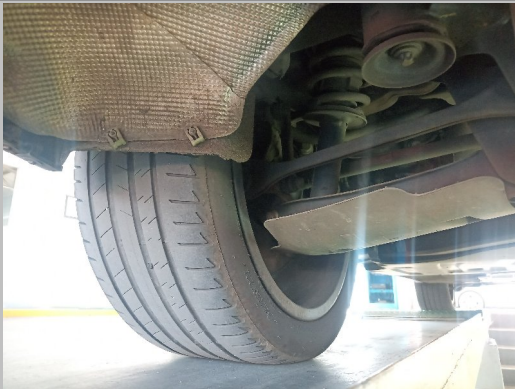
LR TYRE TREAD

| | Size | Load/Speed Index | Manufacture | Model | Type* | Production Date | Tread Depth (mm) |
|---|---|---|---|---|---|---|---|
| Rear Left | 275/40R20 | 106W | BRIDGESTONE | ALENZA | V | 1524 | 5 mm |

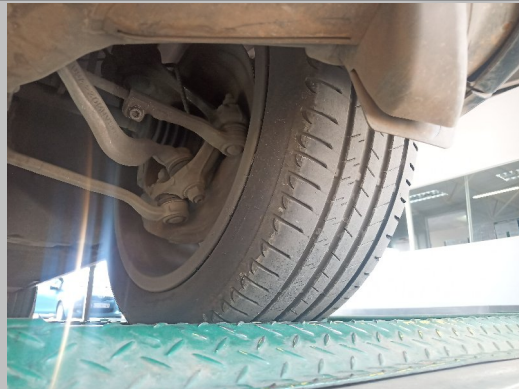
LF TYRE TREAD

| | Size | Load/Speed Index | Manufacture | Model | Type* | Production Date | Tread Depth (mm) |
|---|---|---|---|---|---|---|---|
| Front Left | 245/45R20 | 103W | BRIDGESTONE | ALENZA | V | 1825 | 5 mm |

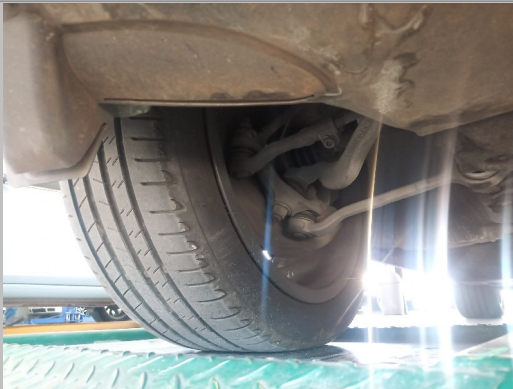
RF TYRE TREAD

| | Size | Load/Speed Index | Manufacture | Model | Type* | Production Date | Tread Depth (mm) |
|---|---|---|---|---|---|---|---|
| Front Right | 245/45R20 | 103W | BRIDGESTONE | ALENZA | V | 1625 | 5 mm |

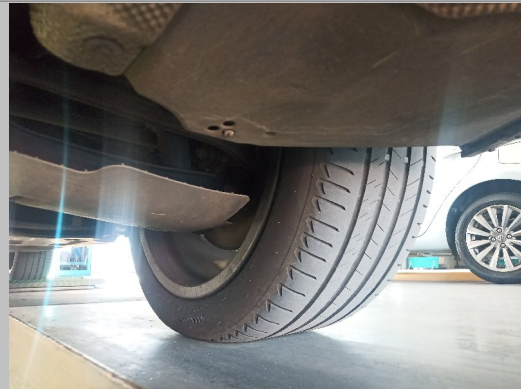
RR TYRE TREAD

| | Size | Load/Speed Index | Manufacture | Model | Type* | Production Date | Tread Depth (mm) |
|---|---|---|---|---|---|---|---|
| Rear Right | 275/40R20 | 106W | BRIDGESTONE | ALENZA | V | 1424 | 5 mm |

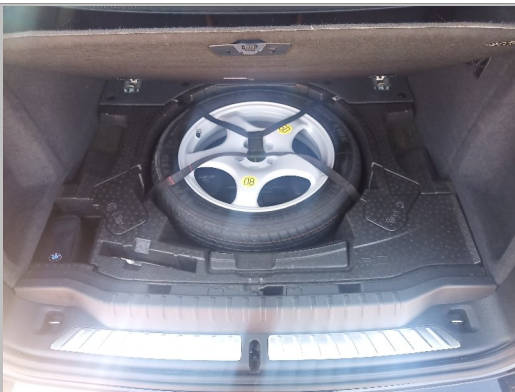
SPAREWHEEL

| | Size | Load/Speed Index | Manufacture | Model | Type* | Production Date | Tread Depth (mm) |
|---|---|---|---|---|---|---|---|
| Spare | T135/80R18 | 104M | MAXXIS | SPARE TIRE | V | 3817 | 5 mm |
