DEKRA Boksburg  
Bentel Ave - 1459  
BOKSBURG - GT  
011 826 4386

## Assignment

## Vehicle Data

## VEHICLE INSPECTION

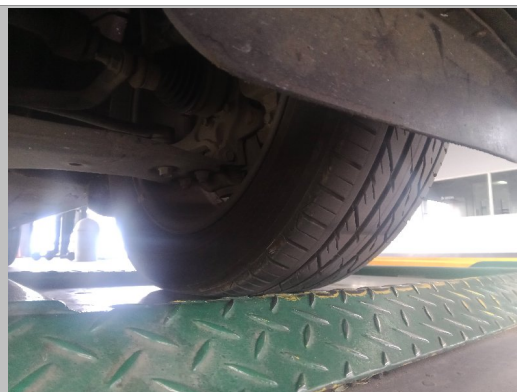
LF TYRE TREAD

| | Size | Load/Speed Index | Manufacture | Model | Type* | Production Date | Tread Depth (mm) |
|---|---|---|---|---|---|---|---|
| Front Left | 235/60R18 | 107V | Landsail | LS588 | V | 4423 | 5 mm |

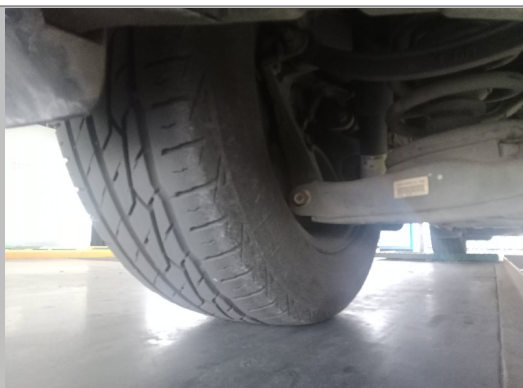
LR TYRE TREAD

| | Size | Load/Speed Index | Manufacture | Model | Type* | Production Date | Tread Depth (mm) |
|---|---|---|---|---|---|---|---|
| Rear Left | 235/60R18 | 107W | General | Grabber | V | 4722 | 4 mm |

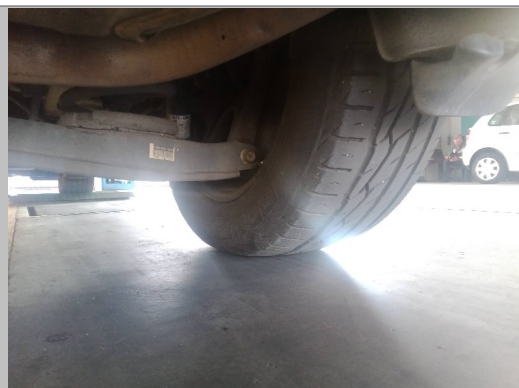
RR TYRE TREAD

| | Size | Load/Speed Index | Manufacture | Model | Type* | Production Date | Tread Depth (mm) |
|---|---|---|---|---|---|---|---|
| Rear Right | 235/60R18 | 107W | General | Grabber | V | 4722 | 4 mm |

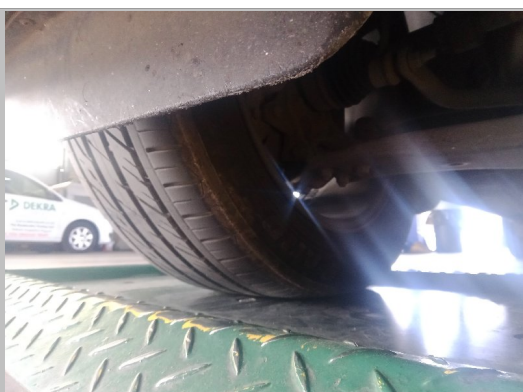
RF TYRE TREAD

| | Size | Load/Speed Index | Manufacture | Model | Type* | Production Date | Tread Depth (mm) |
|---|---|---|---|---|---|---|---|
| Front Right | 235/60R18 | 107V | Landsail | LS588 | V | 4323 | 5 mm |

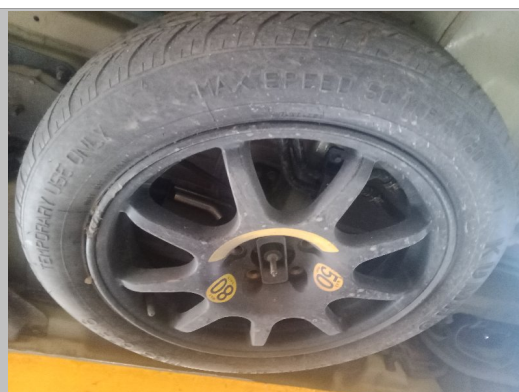
Spare tyre

| | Size | Load/Speed Index | Manufacture | Model | Type* | Production Date | Tread Depth (mm) |
|---|---|---|---|---|---|---|---|
| Spare | T135/80R18 | 104M | Kumho | Temporary | V | 0000 | 3 mm |

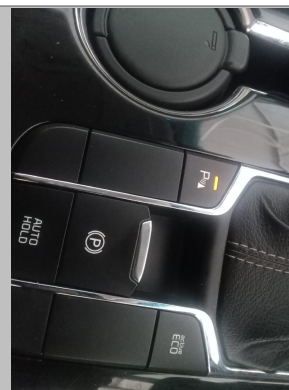
Parking Brake Performance

| | Left | Right | | |
|---|---|---|---|---|
| Emergency / Parking | 0.2 | 0 | - | |
