Private Client

DEKRA Boksburg
Bentel Ave - 1459
BOKSBURG - GT
011 826 4386

VEHICLE INSPECTION

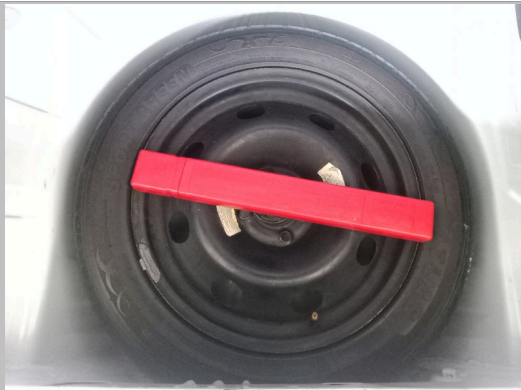
Sparewheel

Size	Load/Speed Index	Manufacture	Model	Type*	Production Date	Tread Depth (mm)
Front Left	205/55R16	91V	Dunlop	SP Sport	V	0224	3 mm
Front Right	205/55R16	91V	Dunlop	SP Sport	V	0824	3 mm
Rear Left	205/55R16	91H	Continental	Contact 5	V	0919	4 mm
Rear Right	205/55R16	91H	Continental	Contact 5	V	0919	4 mm
Spare	205/55R16	91W	Atlas	Sport Green	V	0117	1 mm

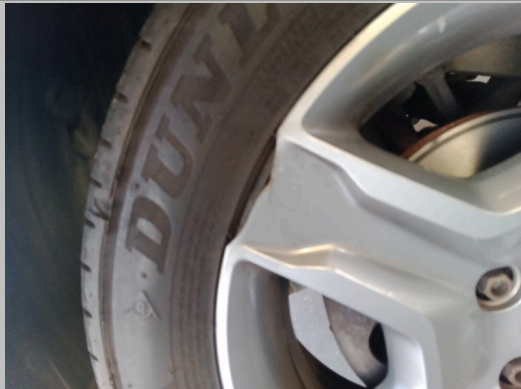
General Comments: ACCORDING TO AGE AND MILEAGE OF VEHICLE NORMAL WEAR AND TEAR ON INTERIOR, EXTERIOR, ELECTRICAL AND MECHANICAL PARTS. Engine Compartment: Engine and gearbox partly covered underneath.
Electrical Components and Instruments: Washer jets not spraying at time of inspection.
Body • Exterior: Minor dents, scratches, and stonechips on some body panels. Cosmetic spraywork done to some body panels.
Tyres and Rims: Hubcaps damaged

Hubcaps damaged
