Private Client

## Assignment

## Vehicle Data

| Manufacturer | VOLKSWAGEN | Registration Number | CF67LXZN |

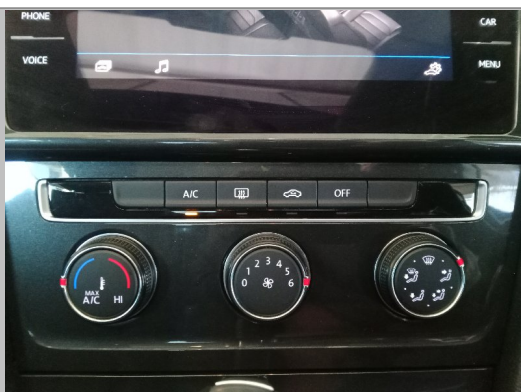
Aircon working

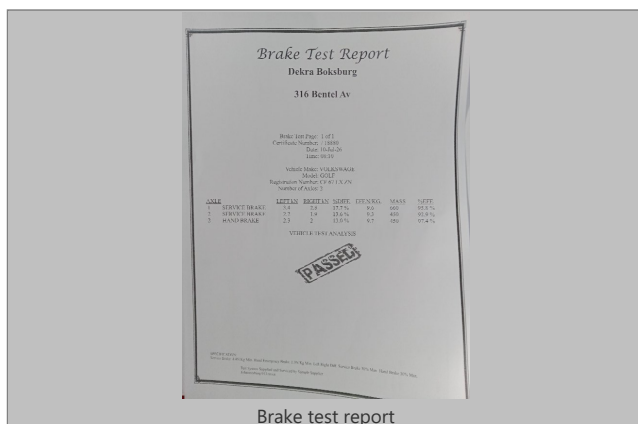
Brake test report

| | Left | Right | | |
|---|---|---|---|---|
| Front | 3.4 | 2.8 | - | |
| Rear | 2.2 | 1.9 | - | |
| Emergency / Parking | 2.3 | 2 | - | |

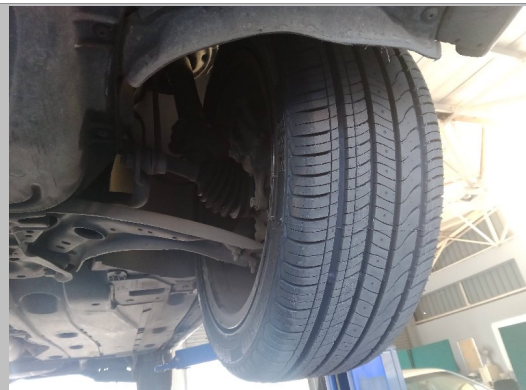
LF TYRE TREAD

| | Size | Load/Speed Index | Manufacture | Model | Type* | Production Date | Tread Depth (mm) |
|---|---|---|---|---|---|---|---|
| Front Left | 225/45ZR17 | 94W | Hilo | Vantage | V | 0526 | 5 mm |

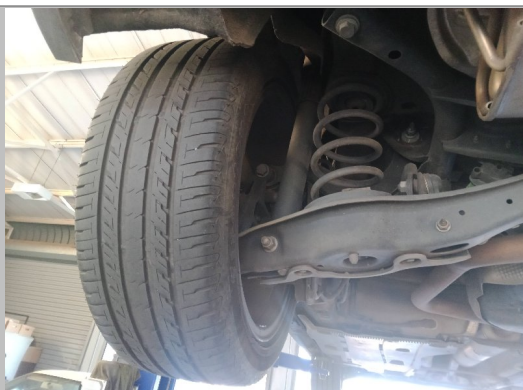
LR TYRE TREAD

| | Size | Load/Speed Index | Manufacture | Model | Type* | Production Date | Tread Depth (mm) |
|---|---|---|---|---|---|---|---|
| Rear Left | 225/45R17 | 91W | Firestone | Touring | V | 2722 | 3 mm |

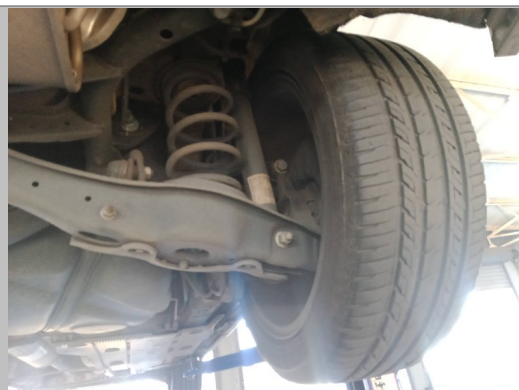
RR TYRE TREAD

| | Size | Load/Speed Index | Manufacture | Model | Type* | Production Date | Tread Depth (mm) |
|---|---|---|---|---|---|---|---|
| Rear Right | 225/45R17 | 91W | Firestone | Touring | V | 2322 | 3 mm |

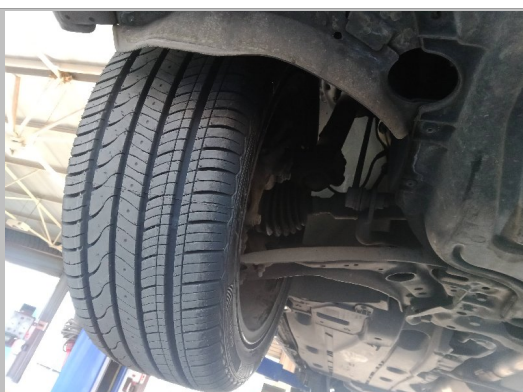
RF TYRE TREAD

| | Size | Load/Speed Index | Manufacture | Model | Type* | Production Date | Tread Depth (mm) |
|---|---|---|---|---|---|---|---|
| Front Right | 225/45R17 | 91W | Firestone | Touring | V | 2422 | 5 mm |
