Private Client

DEKRA Boksburg
Bentel Ave - 1459
BOKSBURG - GT
011 826 4386

Vehicle Type	PASSENGER VEHICLE	Registered Owner	CBK MOTORS CBK MOTORS
Manufacturer	MERCEDES BENZ	Registration Number	MM84LFGP
Model	A35 AMG	Register Number	BST117X
VIN	W1K1770512J209240	Date Of First Licensing	
Engine Number		Last COR	17/09/2025
Doors	5	License Expiry Date	31/03/2027
Color	WHITE	Power / Displacement	225kW/1991cc
Year Model	2020	Paint Finish	C - COMMON
Km Reading	78,954 KM	Fuel	PETROL
Cab / Body Type	HATCHBACK	Transmission	AUTOMATIC

VEHICLE INSPECTION

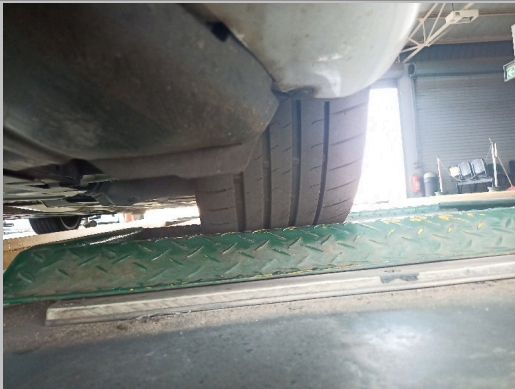
LF TYRE TREAD

Size	Load/Speed Index	Manufacture	Model	Type*	Production Date	Tread Depth (mm)
Front Left	235/35ZR19	91Y	BRIDGESTONE	POTENZA	V	3323	3 mm
Front Right	235/35ZR19	91Y	PIRELLI	P ZERO	V	4319	4 mm
Rear Left	235/35ZR19	91Y	BRIDGESTONE	POTENZA	V	4223	4 mm
Rear Right	235/35ZR19	91Y	BRIDGESTONE	POTENZA	V	2222	2 mm

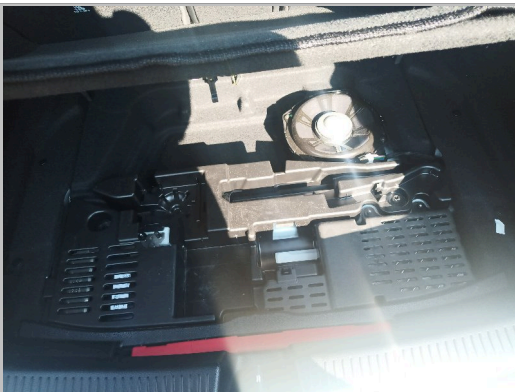
NO SPAREWHEEL

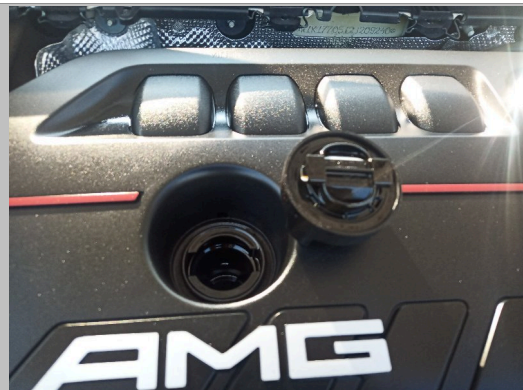
OIL CAP NO DIPSTICK
