Private Client

DEKRA Boksburg  
Bentel Ave - 1459  
BOKSBURG - GT  
011 826 4386

## Assignment

## Vehicle Data

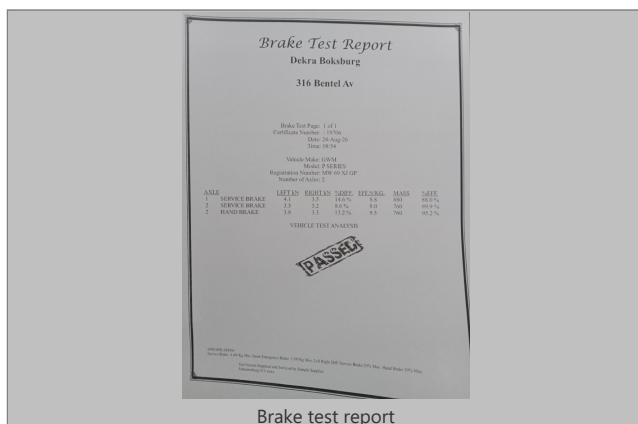
Brake test report

| | Left | Right | | |
|---|---|---|---|---|
| Front | 4.1 | 3.5 | - | |
| Rear | 3.5 | 3.2 | - | |
| Emergency / Parking | 3.8 | 3.3 | - | |

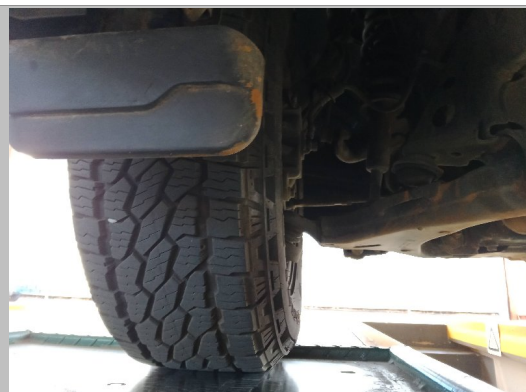
LF TYRE TREAD

| | Size | Load/Speed Index | Manufacture | Model | Type* | Production Date | Tread Depth (mm) |
|---|---|---|---|---|---|---|---|
| Front Left | 265/65R17 | 112T | Bridgestone | Dueler | V | 3625 | 7 mm |

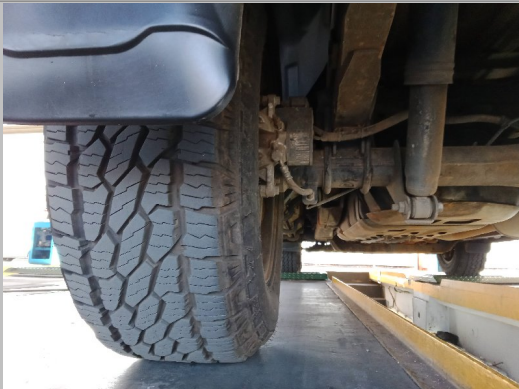
LR TYRE TREAD

| | Size | Load/Speed Index | Manufacture | Model | Type* | Production Date | Tread Depth (mm) |
|---|---|---|---|---|---|---|---|
| Rear Left | 265/65R17 | 112T | Bridgestone | Dueler | | 3625 | 7 mm |

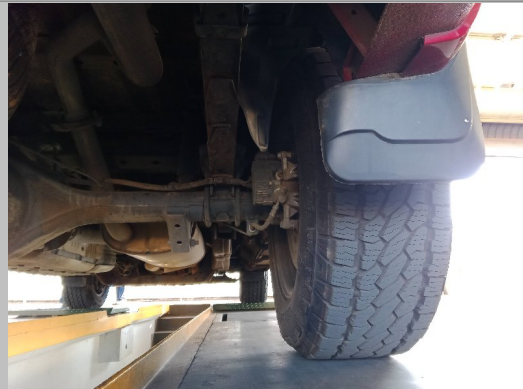
RR TYRE TREAD

| | Size | Load/Speed Index | Manufacture | Model | Type* | Production Date | Tread Depth (mm) |
|---|---|---|---|---|---|---|---|
| Rear Right | 265/65R17 | 112T | Bridgestone | Dueler | V | 3625 | 7 mm |

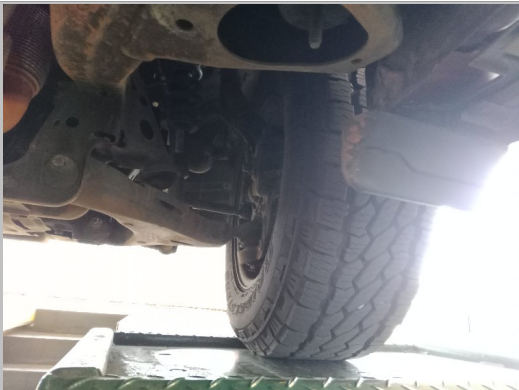
RF TYRE TREAD

| | Size | Load/Speed Index | Manufacture | Model | Type* | Production Date | Tread Depth (mm) |
|---|---|---|---|---|---|---|---|
| Front Right | 265/65R17 | 112T | Bridgestone | Dueler | V | 3625 | 7 mm |

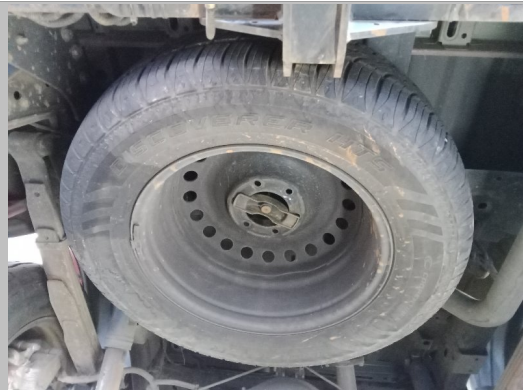
Sparewheel

| | Size | Load/Speed Index | Manufacture | Model | Type* | Production Date | Tread Depth (mm) |
|---|---|---|---|---|---|---|---|
| Spare | 265/60R18 | 110H | Cooper | Discoverer | V | 0000 | 5 mm |
