Private Client

DEKRA Boksburg
Bentel Ave - 1459
BOKSBURG - GT
011 826 4386

Vehicle Type	PASSENGER VEHICLE	Registered Owner	CBK MOTORS CBK MOTORS
Manufacturer	SUZUKI	Registration Number	CFM851388
Model	VITARA BREZZA 1.5 GL AT [2021-2024]	Register Number	DKS952X
VIN	MA3NYFJ1S00889568	Date Of First Licensing	
Engine Number	K15BN4220051	Last COR	19/06/2026
Doors	5	License Expiry Date	31/07/2026
Color	SILVER	Power / Displacement	77Kw/1462Cc
Year Model	2022	Paint Finish	M - METALLIC
Km Reading	87,349 KM	Fuel	PETROL
Cab / Body Type	HATCHBACK	Transmission	AUTOMATIC

VEHICLE INSPECTION

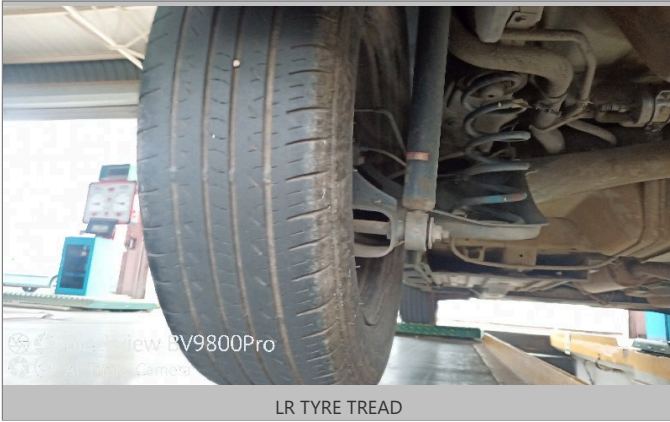
LR TYRE TREAD

Size	Load/Speed Index	Manufacture	Model	Type*	Production Date	Tread Depth (mm)
Front Left	205/60R16	92H	Autogrip	P308	V	3725	6 mm
Front Right	205/60R16	92H	Autogrip	P308	V	8725	6 mm
Rear Left	205/60R16	92H	Hilo	Genesys	V	3223	3 mm
Rear Right	205/60R16	92H	Hilo	Genesys	V	2923	3 mm
Spare	205/60R16	92H	Ceat	Securadrive	V	0000	3 mm
