DEKRA Boksburg  
Bentel Ave - 1459  
BOKSBURG - GT  
011 826 4386

## Assignment

| Manufacturer | MERCEDES-BENZ | Registration Number | LJ20BZGP |
| Model | C 200 | Register Number | FLP003X |

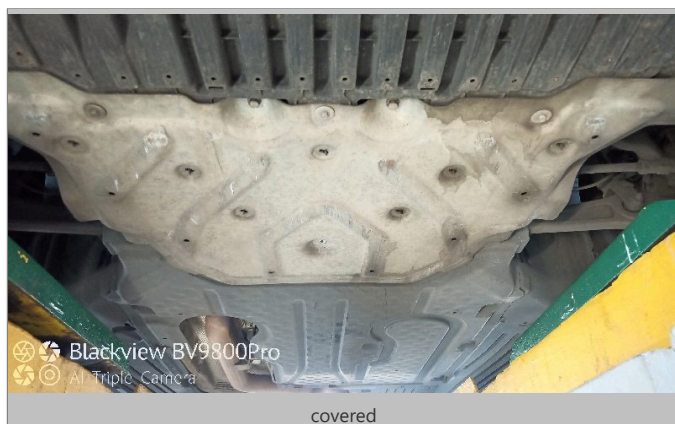
Undercarriage: Undercarriage and engine mostly covered.

covered

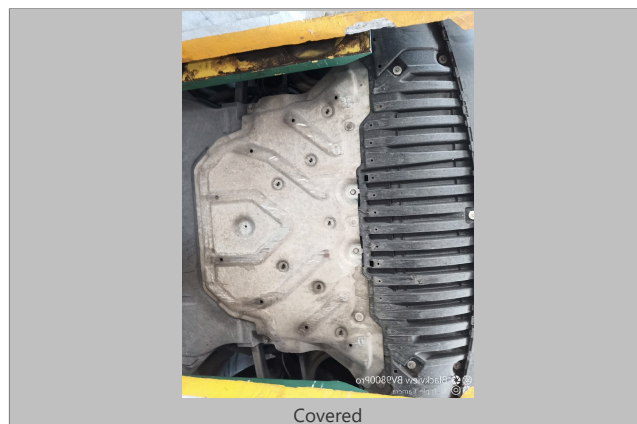
Covered

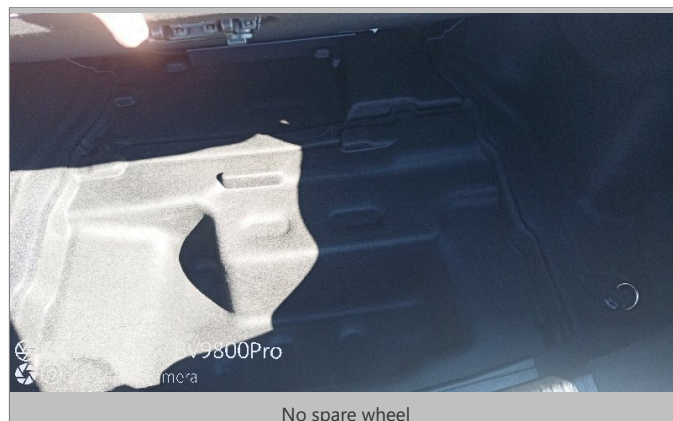
Tyres and Rims: No spare wheel

No spare wheel

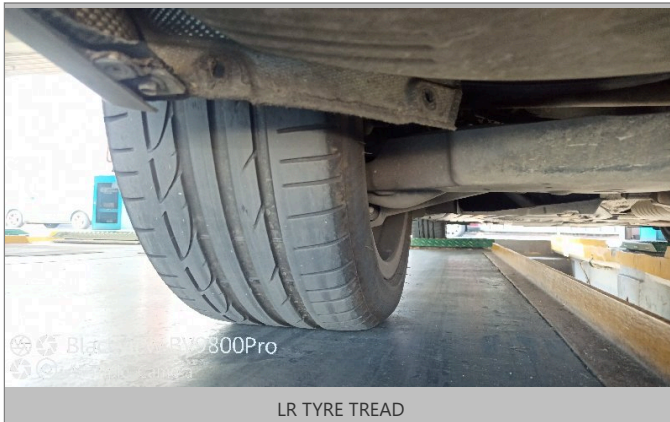
LR TYRE TREAD

| | Size | Load/Speed Index | Manufacture | Model | Type* | Production Date | Tread Depth (mm) |
|---|---|---|---|---|---|---|---|
| Rear Left | 245/40R18 | 97Y | Bridgestone | Potenza | V | 3924 | 4 mm |

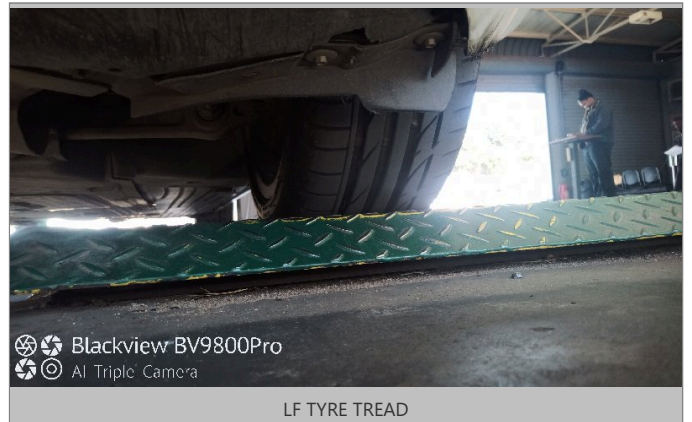
LF TYRE TREAD

| | Size | Load/Speed Index | Manufacture | Model | Type* | Production Date | Tread Depth (mm) |
|---|---|---|---|---|---|---|---|
| Front Left | 225/45R18 | 95Y | Bridgestone | Potenza | V | 0125 | 5 mm |

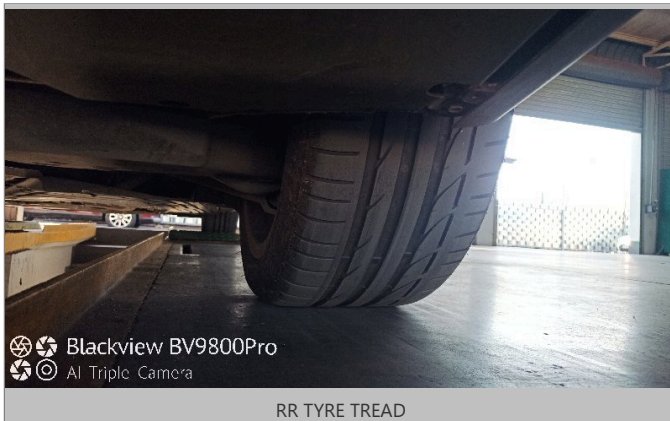
RR TYRE TREAD

| | Size | Load/Speed Index | Manufacture | Model | Type* | Production Date | Tread Depth (mm) |
|---|---|---|---|---|---|---|---|
| Rear Right | 245/40R18 | 97Y | Bridgestone | Potenza | V | 3924 | 4 mm |

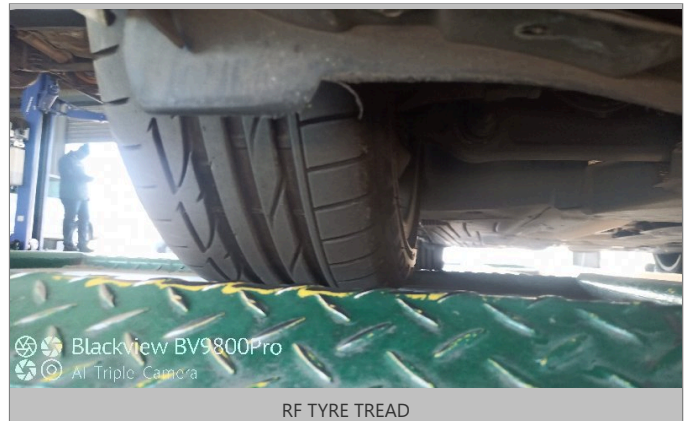
RF TYRE TREAD

| | Size | Load/Speed Index | Manufacture | Model | Type* | Production Date | Tread Depth (mm) |
|---|---|---|---|---|---|---|---|
| Front Right | 225/45R28 | 95Y | Bridgestone | Potenza | V | 0225 | 5 mm |

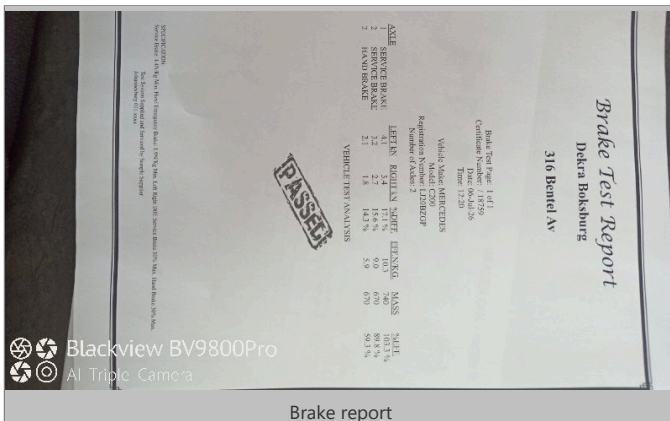
Brake report

| | Left | Right | | |
|---|---|---|---|---|
| Front | 4.1 | 3.4 | - | |
| Rear | 3.2 | 2.7 | - | |
| Emergency / Parking | 2.1 | 1.8 | - | |
