DEKRA Boksburg  
Bentel Ave - 1459  
BOKSBURG - GT  
011 826 4386

## Assignment

| Model | HILUX 2.4 GD S A/C DSL PU [2019-2021] | Register Number | HMC619L |

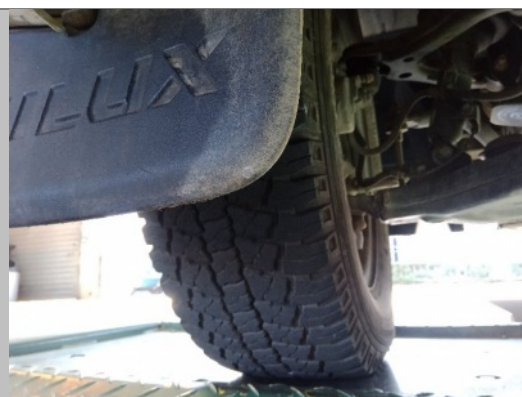
LF TYRE TREAD

| | Size | Load/Speed Index | Manufacture | Model | Type* | Production Date | Tread Depth (mm) |
|---|---|---|---|---|---|---|---|
| Front Left | 205/70R15C | 106/104S | Continental | Worldcontact | V | 2721 | 4 mm |

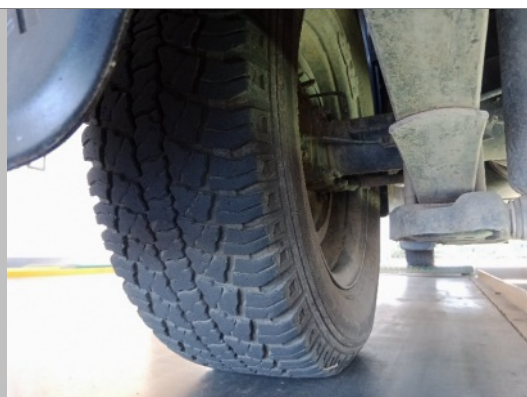
LR TYRE TREAD

| | Size | Load/Speed Index | Manufacture | Model | Type* | Production Date | Tread Depth (mm) |
|---|---|---|---|---|---|---|---|
| Rear Left | 205/70R15C | 106/104S | Continental | Worldcontact | V | 2521 | 4 mm |

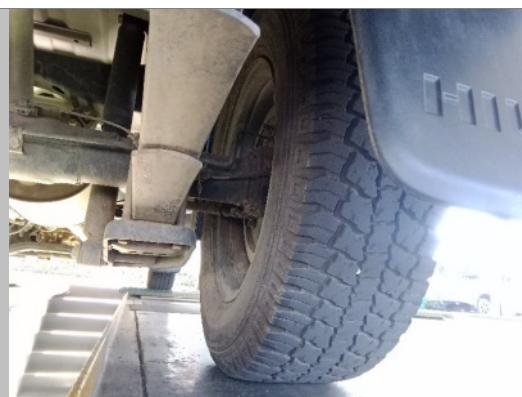
RR TYRE TREAD

| | Size | Load/Speed Index | Manufacture | Model | Type* | Production Date | Tread Depth (mm) |
|---|---|---|---|---|---|---|---|
| Rear Right | 205/70R16C | 106/104S | Continental | Worldcontact | V | 2721 | 3 mm |

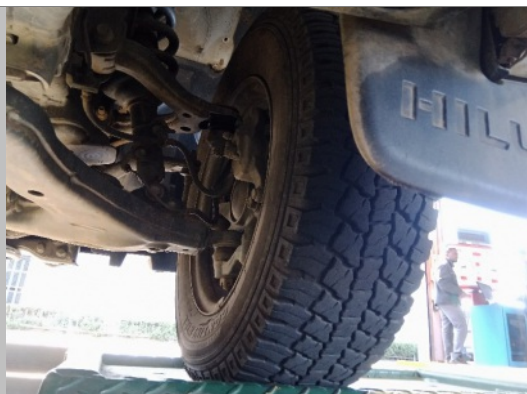
RF TYRE TREAD

| | Size | Load/Speed Index | Manufacture | Model | Type* | Production Date | Tread Depth (mm) |
|---|---|---|---|---|---|---|---|
| Front Right | 205/70R16 C | 106/104S | Continental | Worldcontact | V | 0421 | 4 mm |

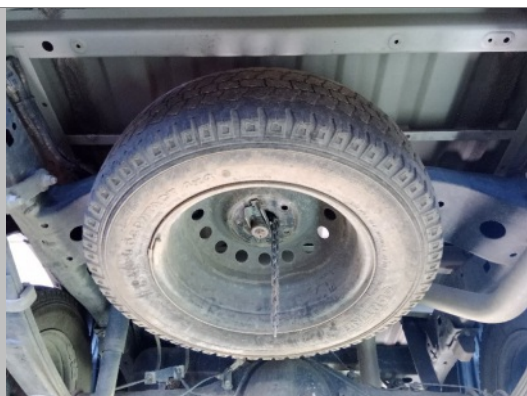
Sparewheel

| | Size | Load/Speed Index | Manufacture | Model | Type* | Production Date | Tread Depth (mm) |
|---|---|---|---|---|---|---|---|
| Spare | 205/70R15C | 106/104S | Continental | Worldcontact | V | 0000 | 1 mm |
