Private Client

DEKRA Boksburg  
Bentel Ave - 1459  
BOKSBURG - GT  
011 826 4386

## Assignment

| Model | DISCOVERY SPORT 2.2 SD4 HSE DSL 4X4 AT [2015-2018] | Register Number | WMB341W |

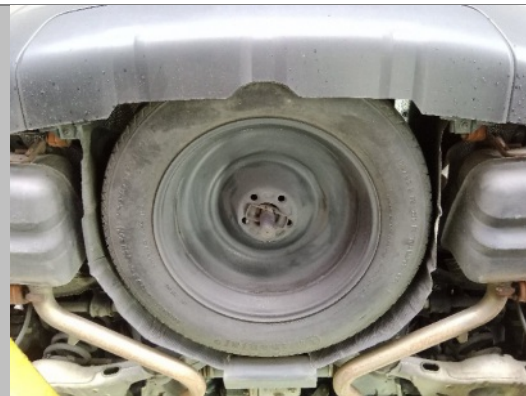
Sparewheel

| | Size | Load/Speed Index | Manufacture | Model | Type* | Production Date | Tread Depth (mm) |
|---|---|---|---|---|---|---|---|
| Spare | T155/85R18 | 115M | Continental | CST17 | V | 0000 | 3 mm |

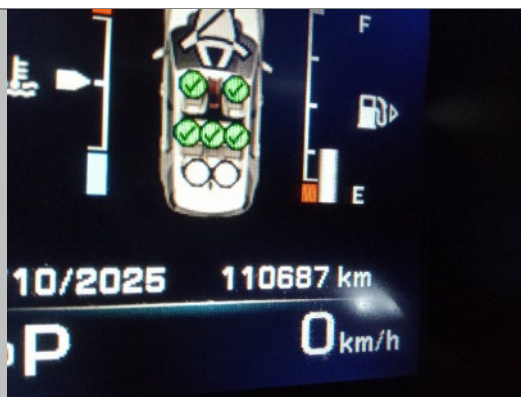
ODOMETER

| Km Reading | 110,687 KM | Fuel | DIESEL |

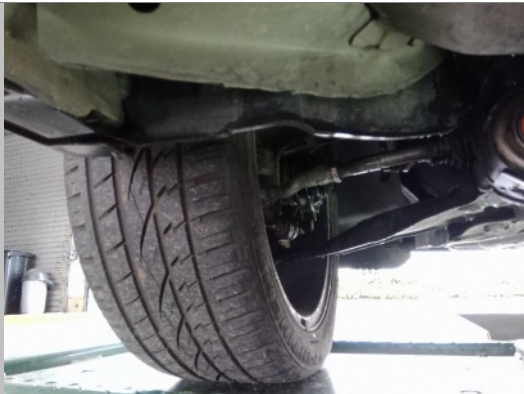
LF TYRE TREAD

| | Size | Load/Speed Index | Manufacture | Model | Type* | Production Date | Tread Depth (mm) |
|---|---|---|---|---|---|---|---|
| Front Left | 245/45R20 | 103W | Continental | Crosscontact | V | 2423 | 2 mm |

Tyres and Rims: Left front tyre slight sidewall damage.

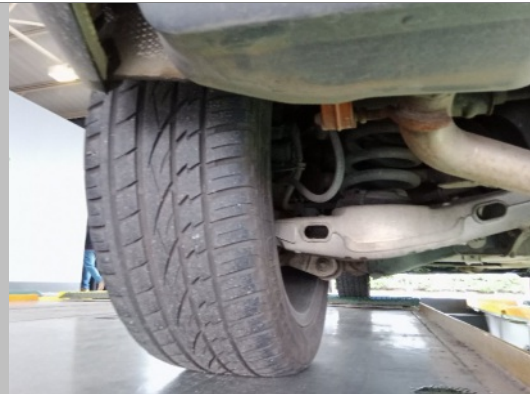
LR TYRE TREAD

| | Size | Load/Speed Index | Manufacture | Model | Type* | Production Date | Tread Depth (mm) |
|---|---|---|---|---|---|---|---|
| Rear Left | 245/45R20 | 103W | Continental | Crosscontact | V | 1322 | 5 mm |

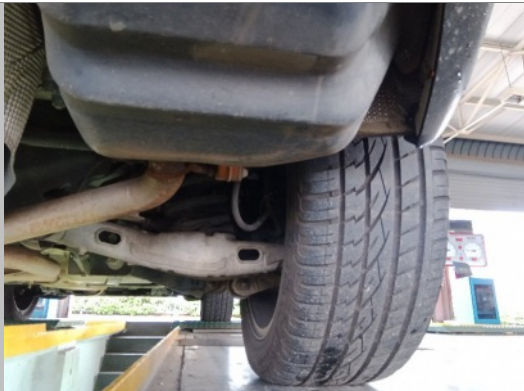
RR TYRE TREAD

| | Size | Load/Speed Index | Manufacture | Model | Type* | Production Date | Tread Depth (mm) |
|---|---|---|---|---|---|---|---|
| Rear Right | 245/45R20 | 103W | Continental | Crosscontact | V | 0223 | 5 mm |

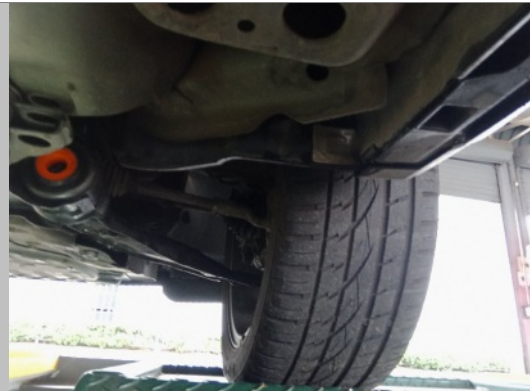
RF TYRE TREAD

| | Size | Load/Speed Index | Manufacture | Model | Type* | Production Date | Tread Depth (mm) |
|---|---|---|---|---|---|---|---|
| Front Right | 245/45R20 | 103W | Continental | Crosscontact | V | 0923 | 3 mm |
