Private Client

DEKRA Boksburg  
Bentel Ave - 1459  
BOKSBURG - GT  
011 826 4386

## Assignment

| Model | TIGUAN ALLSPACE 1.4 TSI 110KW<br>COMFORTLINE DSG [2019-2021] | Register Number | HTG511K |

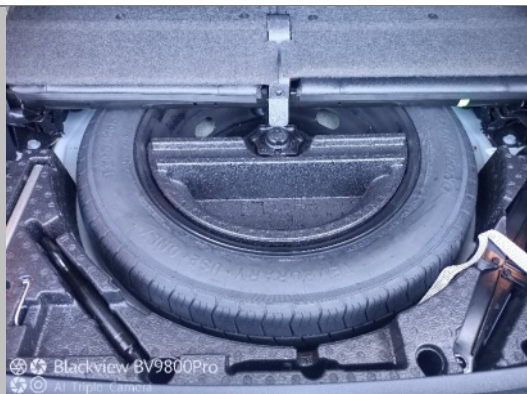
Spare tyre

| | Size | Load/Speed Index | Manufacture | Model | Type* | Production Date | Tread Depth (mm) |
|---|---|---|---|---|---|---|---|
| Spare | T 145/85R19 | 108M | Ling Long | Temporary | V | 0000 | 4 mm |

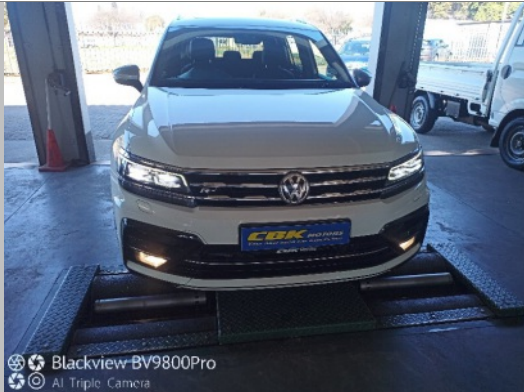
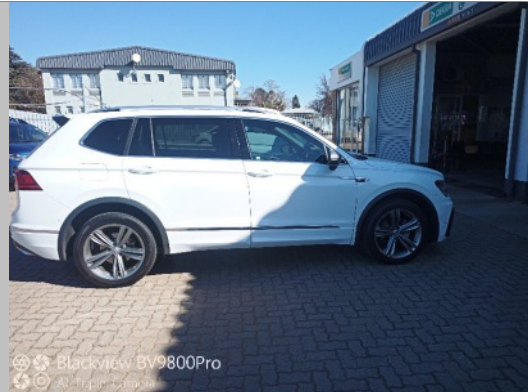
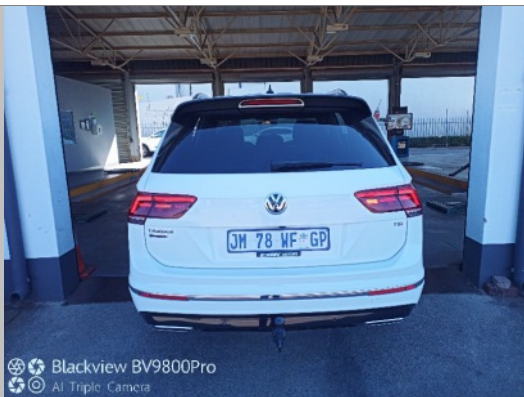
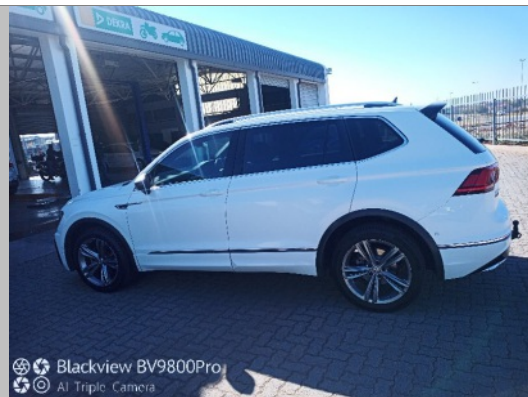
General Comments: Body • Exterior: Minor dents scratches and stone chips

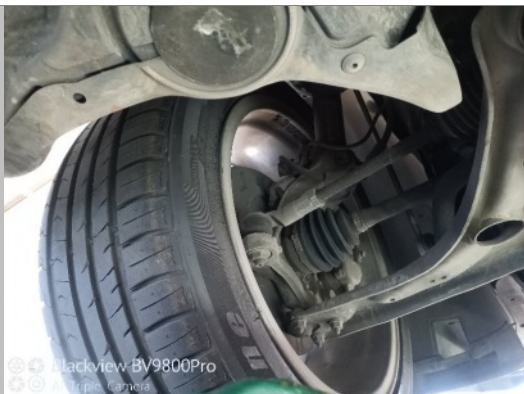
LF TYRE TREAD

| | Size | Load/Speed Index | Manufacture | Model | Type* | Production Date | Tread Depth (mm) |
|---|---|---|---|---|---|---|---|
| Front Left | 255/45R19 | 104Y | Sunwide | Rs-one | V | 4624 | 5 mm |

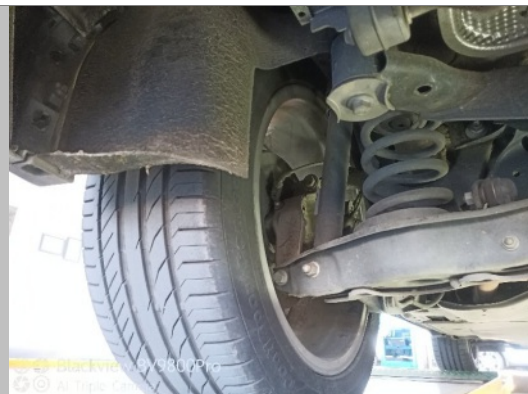
LR TYRE TREAD

| | Size | Load/Speed Index | Manufacture | Model | Type* | Production Date | Tread Depth (mm) |
|---|---|---|---|---|---|---|---|
| Rear Left | 255/45R19 | 100W | Continental | Contact 5 | V | 0324 | 6 mm |

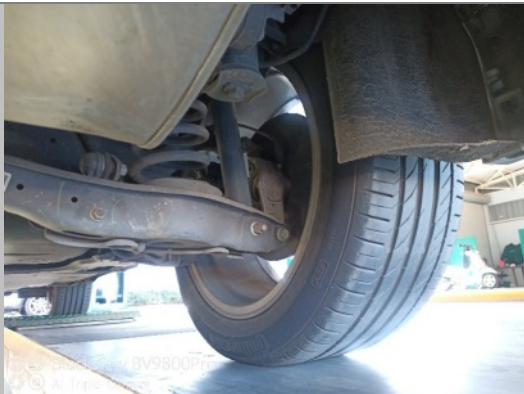
RR TYRE TREAD

| | Size | Load/Speed Index | Manufacture | Model | Type* | Production Date | Tread Depth (mm) |
|---|---|---|---|---|---|---|---|
| Rear Right | 255/45R19 | 100E | Continental | Contact 5 | V | 0324 | 6 mm |

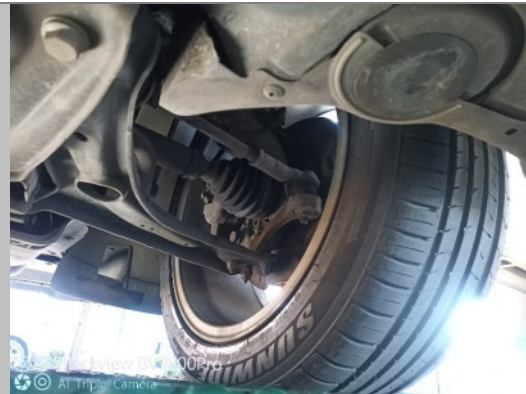
RF TYRE TREAD

| | Size | Load/Speed Index | Manufacture | Model | Type* | Production Date | Tread Depth (mm) |
|---|---|---|---|---|---|---|---|
| Front Right | 2545R19 | 104Y | Sunwide | Rs-one | V | 4624 | 5 mm |
