Private Client

DEKRA Boksburg  
Bentel Ave - 1459  
BOKSBURG - GT  
011 826 4386

## Assignment

| Model | FIESTA 1.6 ST 3-DR [2013-2018] | Register Number | XYW534W |

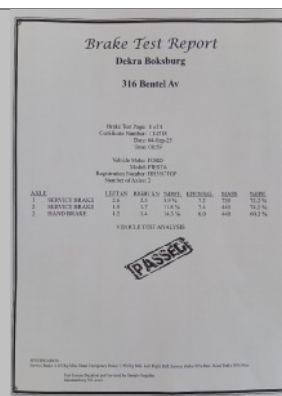
Brake test report

| AXLE | LEFT | RIGHT | MAX | MIN | DIFF |
| 1. SERVICE BRAKE | 2.8 | 3.1 | 3.1% | 2.8% | 0.3% |
| 2. SERVICE BRAKE | 1.8 | 1.7 | 1.8% | 1.7% | 0.1% |
| 3. PARKING BRAKE | 1.2 | 1.1 | 1.2% | 1.1% | 0.1% |

VEHICLE TEST ANALYSIS

**PASSED**

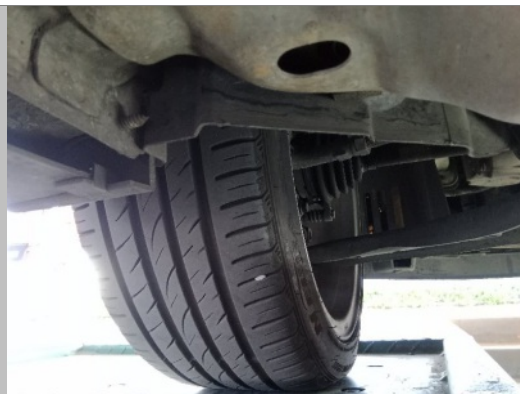
LF TYRE TREAD

| | Size | Load/Speed Index | Manufacture | Model | Type* | Production Date | Tread Depth (mm) |
|---|---|---|---|---|---|---|---|
| Front Left | 205/40ZR17 | 84W | Nexen | Nfera | V | 4424 | 4 mm |

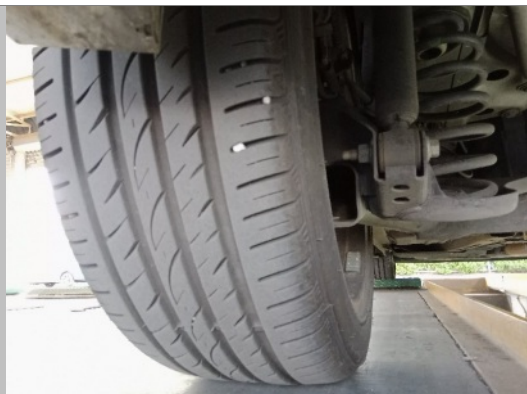
LR TYRE TREAD

| | Size | Load/Speed Index | Manufacture | Model | Type* | Production Date | Tread Depth (mm) |
|---|---|---|---|---|---|---|---|
| Rear Left | 205/40ZR17 | 84W | Nexen | Nfera | V | 4424 | 4 mm |

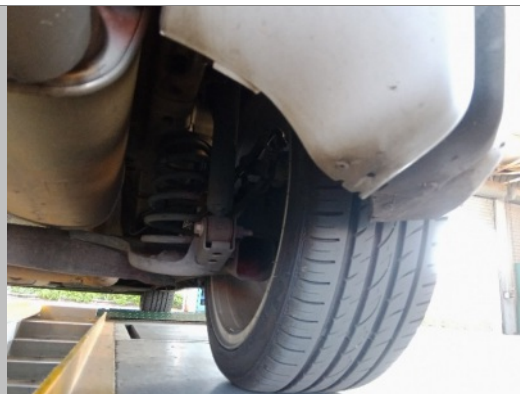
RR TYRE TREAD

| | Size | Load/Speed Index | Manufacture | Model | Type* | Production Date | Tread Depth (mm) |
|---|---|---|---|---|---|---|---|
| Rear Right | 205/40ZR17 | 84W | Nexen | Nfera | V | 4024 | 4 mm |

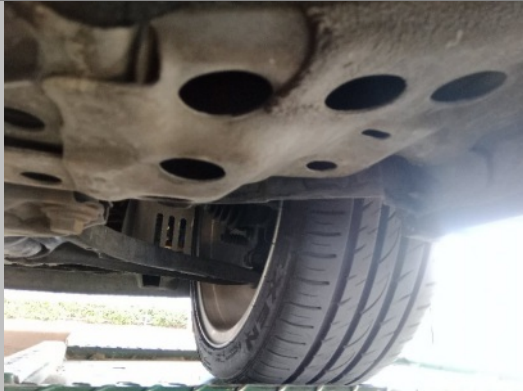
RF TYRE TREAD

| | Size | Load/Speed Index | Manufacture | Model | Type* | Production Date | Tread Depth (mm) |
|---|---|---|---|---|---|---|---|
| Front Right | 205/40ZR17 | 84W | Nexen | Nfera | V | 4424 | 4 mm |
