Private Client

DEKRA Boksburg  
Bentel Ave - 1459  
BOKSBURG - GT  
011 826 4386

| Manufacturer | VOLKSWAGEN | Registration Number | CNP884L |
| Model | TIGUAN 2.0 TDI TREND&FUN BLUEMOTION DSL [2011-2015] | Register Number | FFN515K |

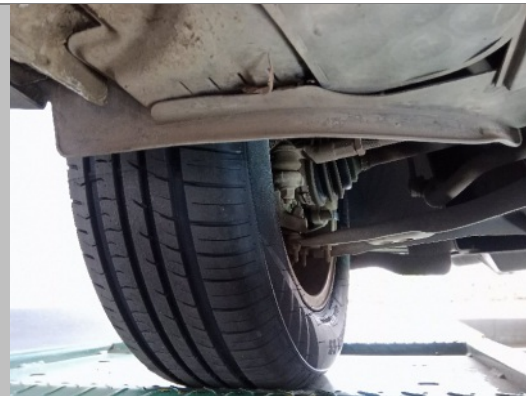
LF TYRE TREAD

| | Size | Load/Speed Index | Manufacture | Model | Type* | Production Date | Tread Depth (mm) |
|---|---|---|---|---|---|---|---|
| Front Left | 215/65R16 | 98H | Fromway | Ecogreen | V | 1925 | 5 mm |

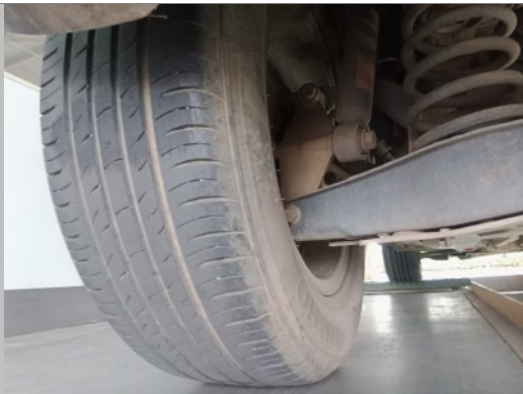
LR TYRE TREAD

| | Size | Load/Speed Index | Manufacture | Model | Type* | Production Date | Tread Depth (mm) |
|---|---|---|---|---|---|---|---|
| Rear Left | 215/65R16 | 98V | Kumho | Ecowing | V | 3119 | 3 mm |

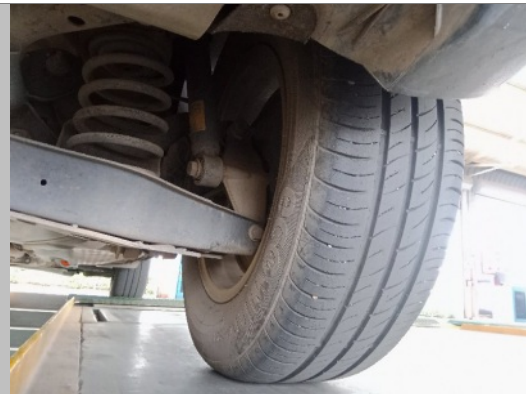
RR TYRE TREAD

| | Size | Load/Speed Index | Manufacture | Model | Type* | Production Date | Tread Depth (mm) |
|---|---|---|---|---|---|---|---|
| Rear Right | 215/65R16 | 98H | Kumho | Ecowing | V | 1718 | 4 mm |

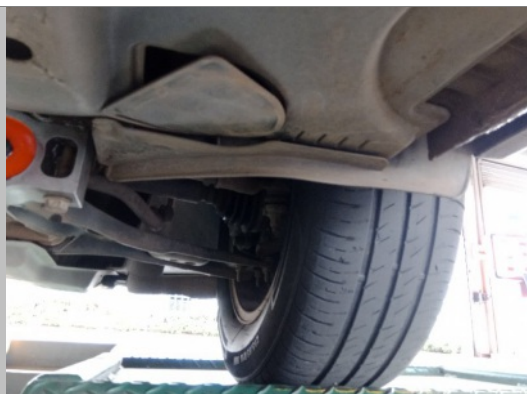
RF TYRE TREAD

| | Size | Load/Speed Index | Manufacture | Model | Type* | Production Date | Tread Depth (mm) |
|---|---|---|---|---|---|---|---|
| Front Right | 215/65R16 | 98H | Kumho | Ecowing | V | 1718 | 2 mm |

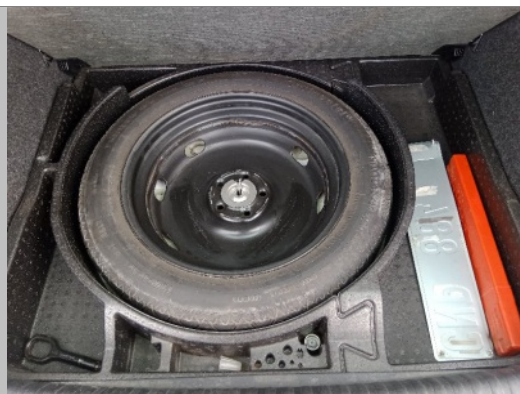
Sparewheel

| | Size | Load/Speed Index | Manufacture | Model | Type* | Production Date | Tread Depth (mm) |
|---|---|---|---|---|---|---|---|
| Spare | T 145/80R18 | 99M | Continental | CST17 | V | 0000 | 2 mm |
