Private Client

DEKRA Boksburg
Bentel Ave - 1459
BOKSBURG - GT
011 826 4386

VEHICLE INSPECTION

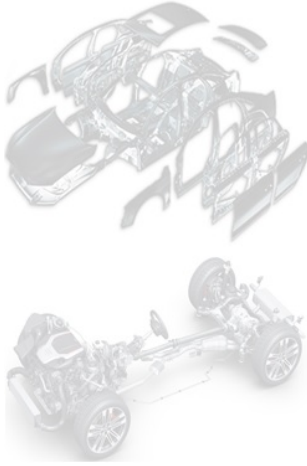
Damage

General Comments: ACCORDING TO AGE AND MILEAGE OF VEHICLE NORMAL WEAR AND TEAR ON INTERIOR, EXTERIOR, ELECTRICAL AND MECHANICAL PARTS. Body • Exterior: Minor dents stone chips and or scratches on various body panels. Cosmetical spray work on various body panels.

Repair Way

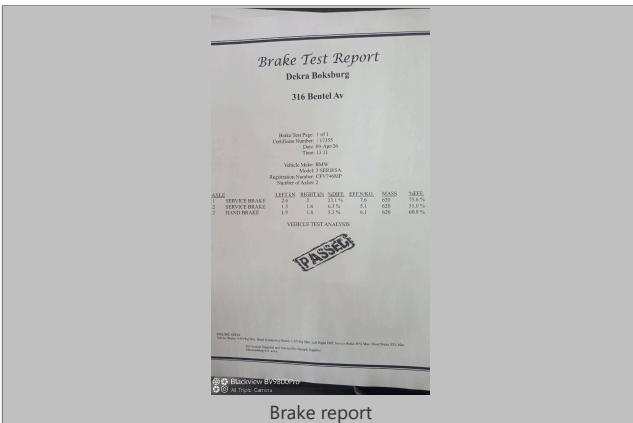
Brake report

Left	Right		
	Braking Force [KN]	Braking Force [KN]	Axle Weight [KG]	Deceleration [m/s ²]
Front	2.1	2.0	-	
Rear	1.9	1.8	-	
Emergency / Parking	2.3	1.7	-

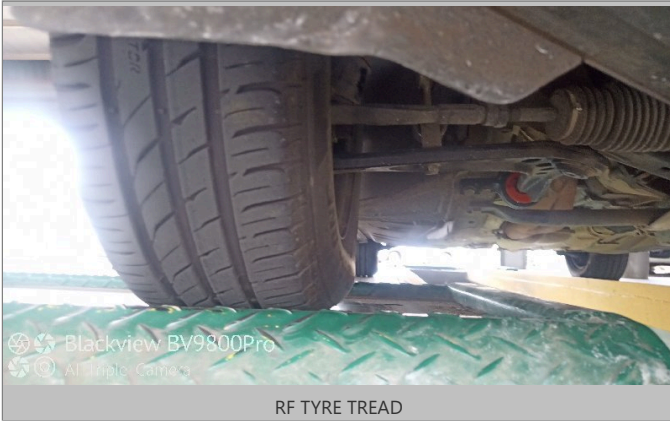
RF TYRE TREAD

Size	Load/Speed Index	Manufacture	Model	Type*	Production Date	Tread Depth (mm)
Front Left	195/65R15	91T	General	Altimax	V	3722	4 mm
Front Right	195/65R15	91T	General	Altimax	V	3722	4 mm
Rear Left	195/65R15	91T	General	Altimax	V	3722	4 mm
Rear Right	195/65R15	91T	General	Altimax	V	3722	4 mm
Spare	195/65R15	91T	Road stone	Eurovis	V	0820	4 mm

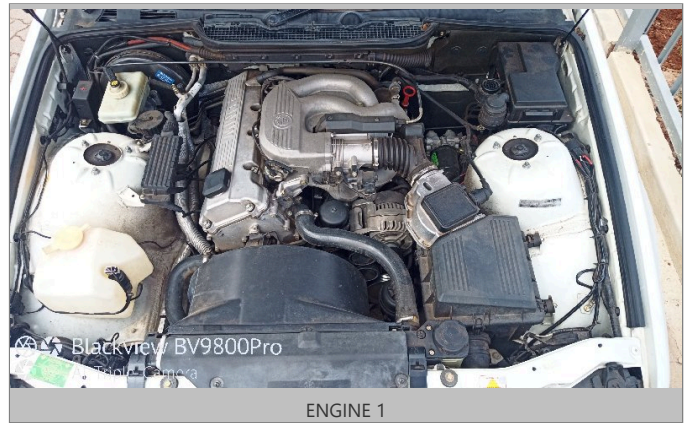
ENGINE 1

Engine number – not possible to verify engine number (not visible without dismantling)
Inspection conditions for the vehicle inspection were sufficient
