Private Client

DEKRA Boksburg  
Bentel Ave - 1459  
BOKSBURG - GT  
011 826 4386

| Model | E200 K ELEGANCE AT [2004-2006] | Register Number | GYT715S |

## VEHICLE INSPECTION

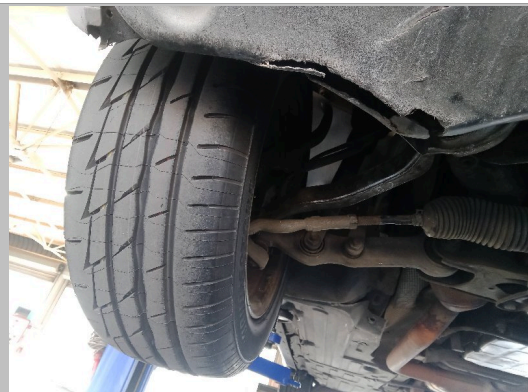
LF TYRE TREAD

| | Size | Load/Speed Index | Manufacture | Model | Type* | Production Date | Tread Depth (mm) |
|---|---|---|---|---|---|---|---|
| Front Left | 225/55R16 | 95W | Bridgestone | Potenza | V | 1617 | 5 mm |

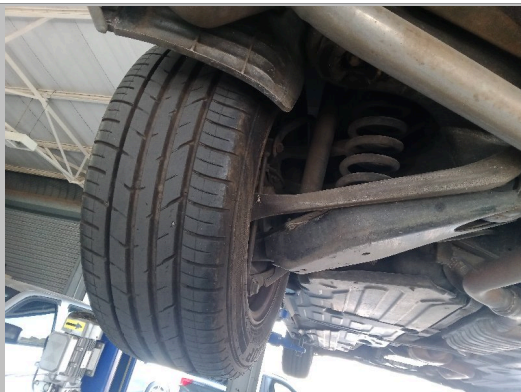
LR TYRE TREAD

| | Size | Load/Speed Index | Manufacture | Model | Type* | Production Date | Tread Depth (mm) |
|---|---|---|---|---|---|---|---|
| Rear Left | 225/55R16 | 99W | Dunlop | SP Sport | V | 3819 | 5 mm |

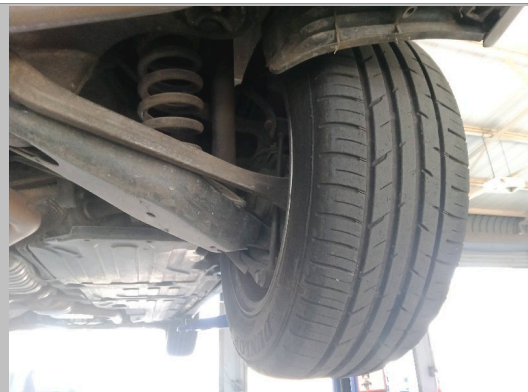
RR TYRE TREAD

| | Size | Load/Speed Index | Manufacture | Model | Type* | Production Date | Tread Depth (mm) |
|---|---|---|---|---|---|---|---|
| Rear Right | 225/55R16 | 99W | Dunlop | SP Sport | V | 0320 | 4 mm |

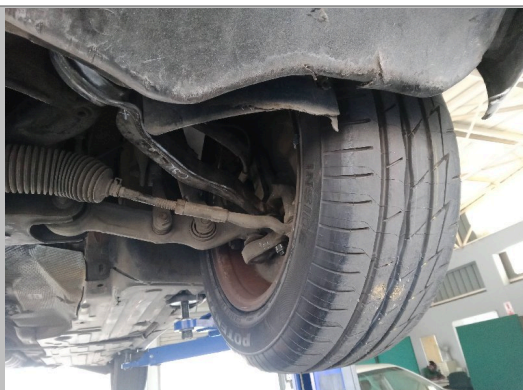
RF TYRE TREAD

| | Size | Load/Speed Index | Manufacture | Model | Type* | Production Date | Tread Depth (mm) |
|---|---|---|---|---|---|---|---|
| Front Right | 225/55R16 | 95W | Bridgestone | Potenza | V | 1617 | 5 mm |

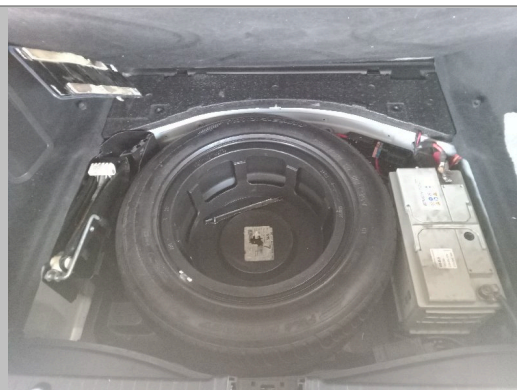
Sparewheel

| | Size | Load/Speed Index | Manufacture | Model | Type* | Production Date | Tread Depth (mm) |
|---|---|---|---|---|---|---|---|
| Spare | 225/55R16 | 95V | Michelin | Primacy | V | 0000 | 5 mm |

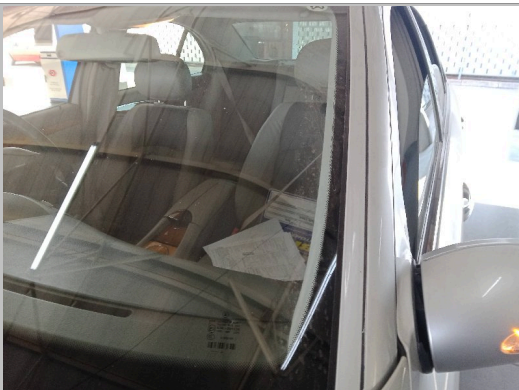
LICENSE DISC MISSING

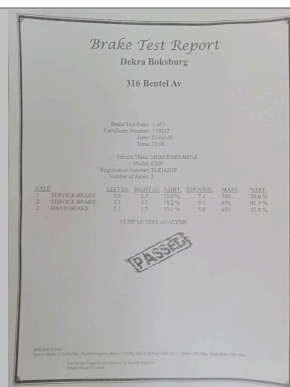
BRAKE TEST REPORT

| | Left | Right | | |
|---|---|---|---|---|
| Front | 2.9 | 2.5 | - | |
| Rear | 3.3 | 2.7 | - | |
| Emergency / Parking | 2.1 | 1.7 | - | |
