## Assignment

| Manufacturer | MERCEDES-BENZ | Registration Number | MB93VHGP |
| Model | SLK 350 ROADSTER 7-SP AT [2004-2008] | Register Number | HPH489S |

## VEHICLE INSPECTION

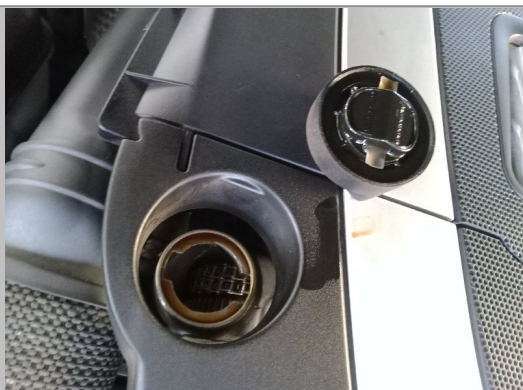
Oil cap. No sparewheel

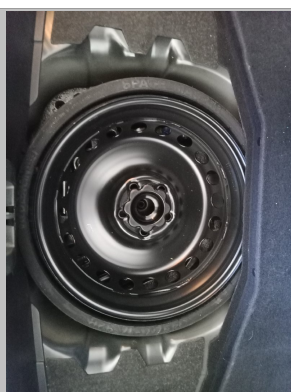
Sparewheel

| | Size | Load/Speed Index | Manufacture | Model | Type* | Production Date | Tread Depth (mm) |
|---|---|---|---|---|---|---|---|
| Spare | 145/70R17 | 92P | Vredestein | Spacemaster | V | 0008 | 3 mm |

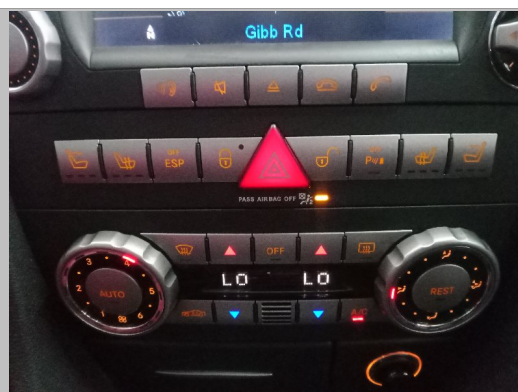
General Comments: ACCORDING TO THE AGE AND MILEAGE OF THE VEHICLE, NORMAL WEAR AND TEAR MARKS ON INTERIOR, EXTERIOR, ELECTRICAL AND MECHANICAL PARTS. Electrical Components and Instruments: Aircon blower working. Not cooling at time of inspection.  
Brakes: Front brake discs slightly dished and ridged.  
Undercarriage: Engine, transmission and undercarriage mostly covered underneath.

AC Blower working

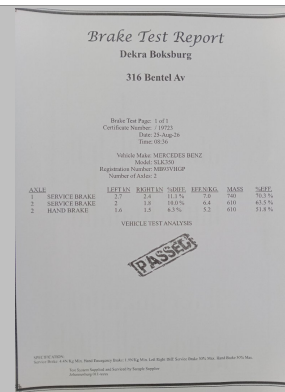
Brake test report

| | Left | Right | | |
|---|---|---|---|---|
| Front | 2.7 | 2.4 | - | |
| Rear | 2.0 | 1.8 | - | |
| Emergency / Parking | 1.6 | 1.5 | - | |

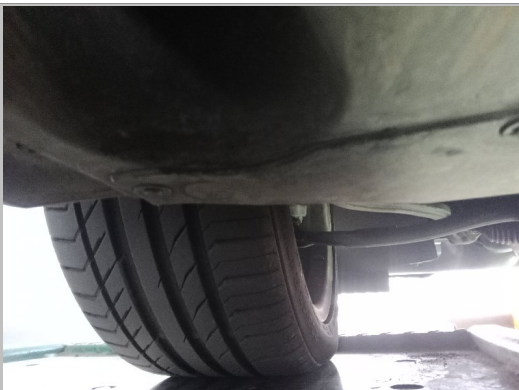
LF TYRE TREAD

| | Size | Load/Speed Index | Manufacture | Model | Type* | Production Date | Tread Depth (mm) |
|---|---|---|---|---|---|---|---|
| Front Left | 225/45R17 | 91W | Continental | Contact 5 | V | 0523 | 5 mm |

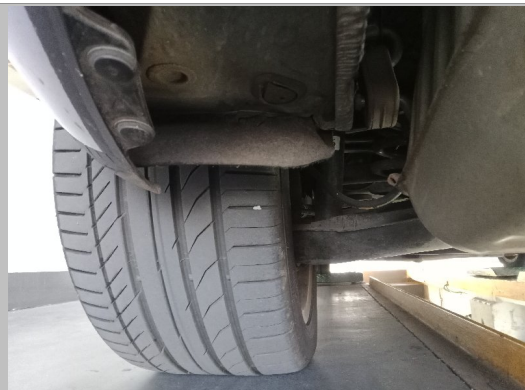
LR TYRE TREAD

| | Size | Load/Speed Index | Manufacture | Model | Type* | Production Date | Tread Depth (mm) |
|---|---|---|---|---|---|---|---|
| Rear Left | 245/40R17 | 91Y | Continental | Contact 5 | V | 1323 | 5 mm |

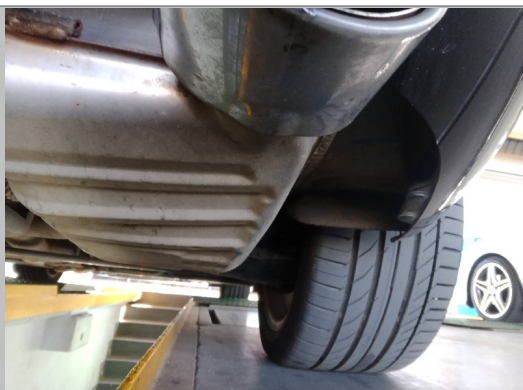
RR TYRE TREAD

| | Size | Load/Speed Index | Manufacture | Model | Type* | Production Date | Tread Depth (mm) |
|---|---|---|---|---|---|---|---|
| Rear Right | 245/40R17 | 91Y | Continental | Contact 5 | V | 1323 | 5 mm |

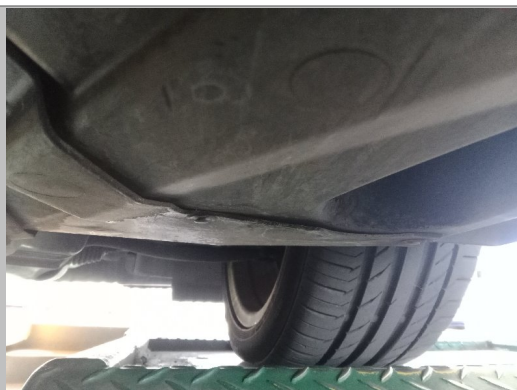
RF TYRE TREAD

| | Size | Load/Speed Index | Manufacture | Model | Type* | Production Date | Tread Depth (mm) |
|---|---|---|---|---|---|---|---|
| Front Right | 225/45R17 | 91W | Continental | Contact 5 | V | 0523 | 5 mm |
