## Assignment

## Vehicle Data

| Manufacturer | ISUZU | Registration Number | KZ91CYGP |
| Model | KB300 DTEQ D-CAB LX DSL PU AT [2007-2010] | Register Number | CRL721K |

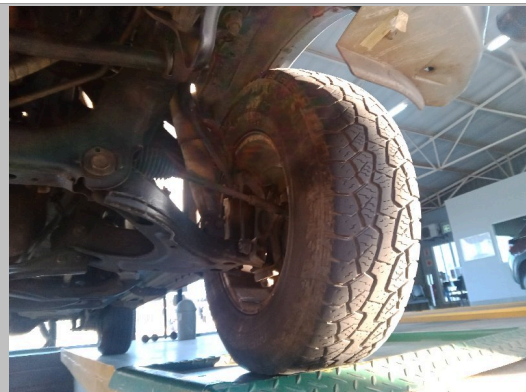
LF TYRE TREAD

| | Size | Load/Speed Index | Manufacture | Model | Type* | Production Date | Tread Depth (mm) |
|---|---|---|---|---|---|---|---|
| Front Left | 245/70R16 | 107T | Hankook | Dynapro | V | 4319 | 4 mm |

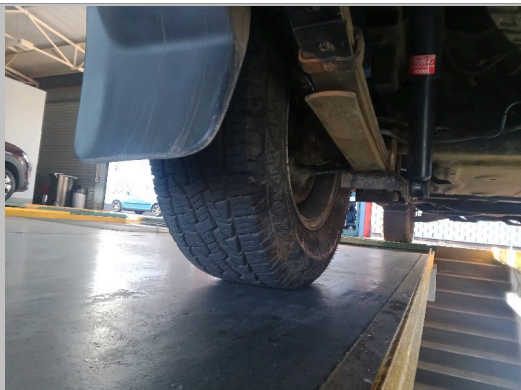
LR TYRE TREAD

| | Size | Load/Speed Index | Manufacture | Model | Type* | Production Date | Tread Depth (mm) |
|---|---|---|---|---|---|---|---|
| Rear Left | 245/70R16 | 111S | Nexen | Roadian | V | 2522 | 10 mm |

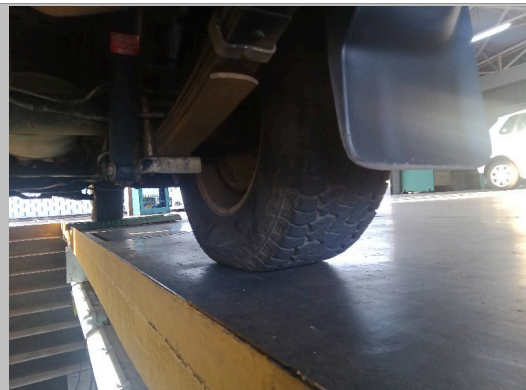
RR TYRE TREAD

| | Size | Load/Speed Index | Manufacture | Model | Type* | Production Date | Tread Depth (mm) |
|---|---|---|---|---|---|---|---|
| Rear Right | 245/70R16 | 107T | Hankook | Dynapro | V | 4219 | 7 mm |

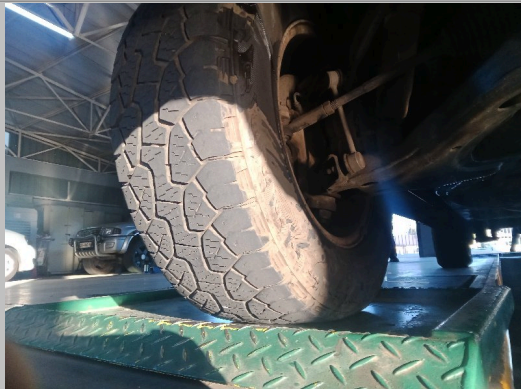
RF TYRE TREAD

| | Size | Load/Speed Index | Manufacture | Model | Type* | Production Date | Tread Depth (mm) |
|---|---|---|---|---|---|---|---|
| Front Right | 245/70R16 | 107T | Hankook | Dynapro | V | 4319 | 3 mm |

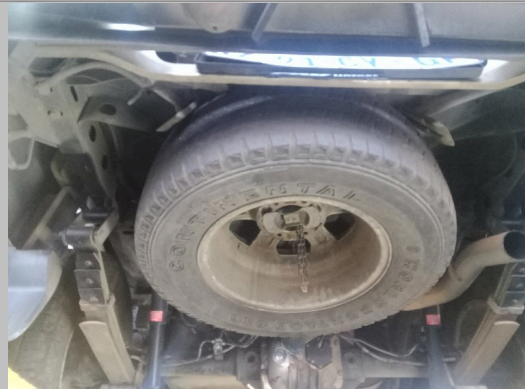
Spare tyre

| | Size | Load/Speed Index | Manufacture | Model | Type* | Production Date | Tread Depth (mm) |
|---|---|---|---|---|---|---|---|
| Spare | 245/60R16C | 111/100T | Continental | Worldcontact | V | 00000 | 1 mm |

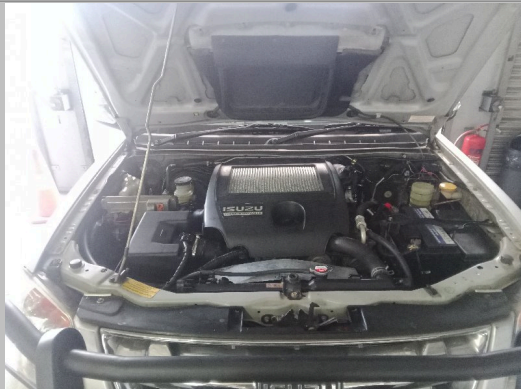
ENGINE 1

General Comments: ACCORDING TO THE AGE AND MILEAGE OF THE VEHICLE, NORMAL WEAR AND TEAR MARKS ARE VISIBLE ON THE INTERIOR, EXTERIOR, ELECTRICAL AND MECHANICAL PARTS. Engine Compartment: Engine wet, not dripping.

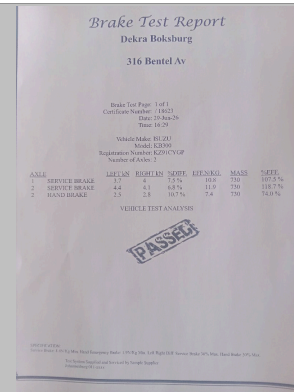
BRAKE TEST REPORT

| | Left | Right | | |
|---|---|---|---|---|
| Front | 3.7 | 4.0 | - | |
| Rear | 4.4 | 4.1 | - | |
| Emergency / Parking | 2.5 | 2.8 | - | |
