## CONDITION REPORT

Report No:  
2017223899  
DATE  
21/04/2026

Vehicle Type	PASSENGER VEHICLE	Registered Owner	CBK MOTORS
Manufacturer	BMW	Registration Number	BZ81ZBGP
Model	320D DSL AT [2012-2016]	Register Number	RNJ519W
VIN	WBA3D36080NP69565	Date Of First Licensing	
Engine Number	76688193	Last COR	
Doors	4	License Expiry Date	30/06/2026
Color	WHITE	Power / Displacement	135KW/1995CCM
Year Model	2013	Paint Finish	C - COMMON
Km Reading	285,621 KM	Fuel	DIESEL
Cab / Body Type	SEDAN	Transmission	AUTOMATIC

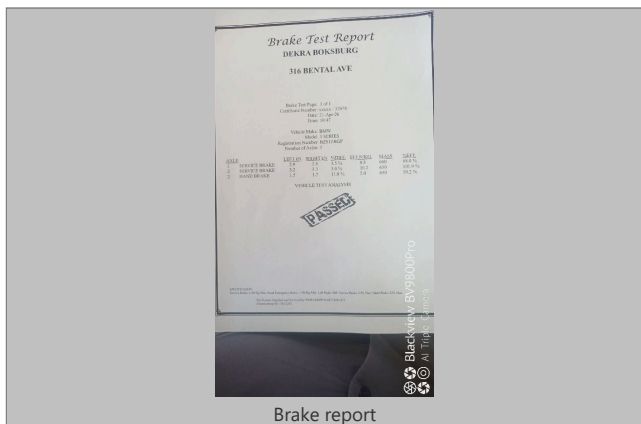
Brake report

Left	Right		
	Braking Force [KN]	Braking Force [KN]	Axle Weight [KG]	Deceleration [m/s <sup>2</sup> ]
Front	2.9	2.8	-	
Rear	3.2	3.3	-	
Emergency / Parking	1.5	1.7	-

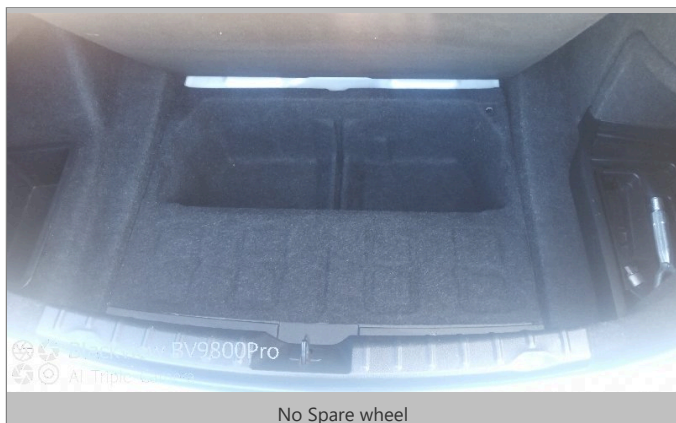
No Spare wheel

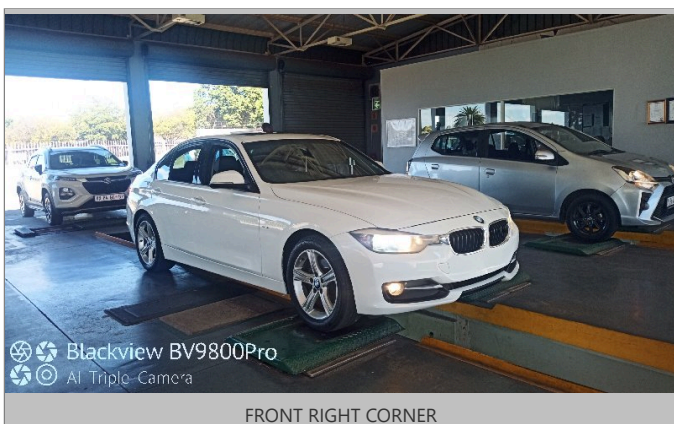
FRONT RIGHT CORNER

Body • Exterior: Minor dents, stone chips, and or scratches on various body panels. Bonnet shocks worn. Cosmetic spray work on various body panels.

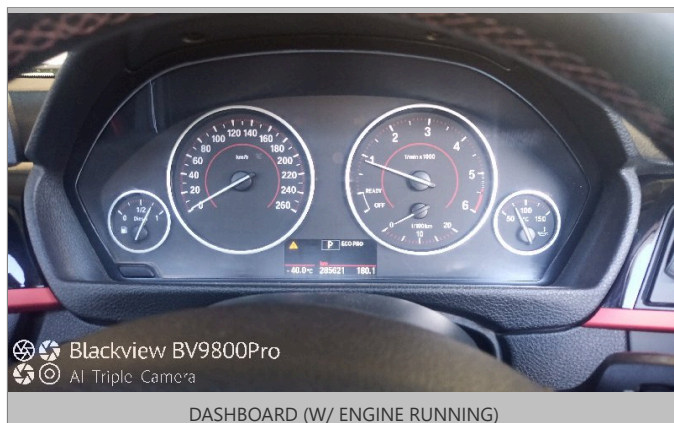
DASHBOARD (W/ ENGINE RUNNING)

General Comments: ACCORDING TO THE AGE AND MILEAGE OF THE VEHICLE, NORMAL WEAR AND TEAR MARKINGS ARE VISIBLE ON THE EXTERIOR, INTERIOR, ELECTRICAL, AND MECHANICAL PARTS. Lights: Reset fault display on cluster light failures.

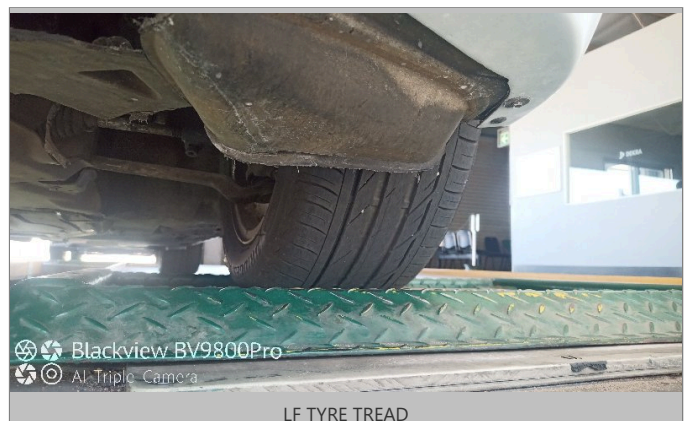
LF TYRE TREAD

Size	Load/Speed Index	Manufacture	Model	Type*	Production Date	Tread Depth (mm)
Front Left	225/50R17	94W	Bridgestone	Turanza	V	4723	4 mm
Front Right	225/50R17	94W	Bridgestone	Turanza	V	4723	4 mm
Rear Left	225/50R17	94W	Bridgestone	Turanza	V	1418	1 mm
Rear Right	225/50R17	94W	Bridgestone	Turanza	V	0418	1 mm
