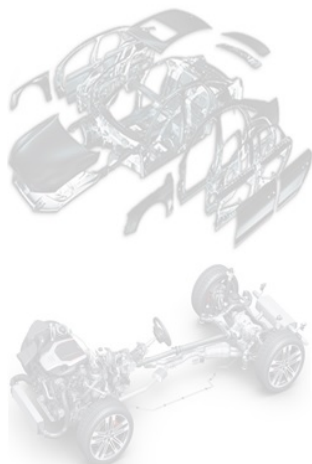
Belly plates Damaged

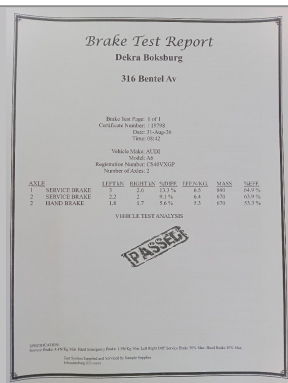
Brake test report

| | Left | Right | | |
| | Braking Force [KN] | Braking Force [KN] | Axle Weight [KG] | Deceleration [m/s <sup>2</sup> ] |
| Front | 3.0 | 2.6 | - | |
| Rear | 2.2 | 2.0 | - | |
| Emergency / Parking | 1.8 | 1.7 | - | |

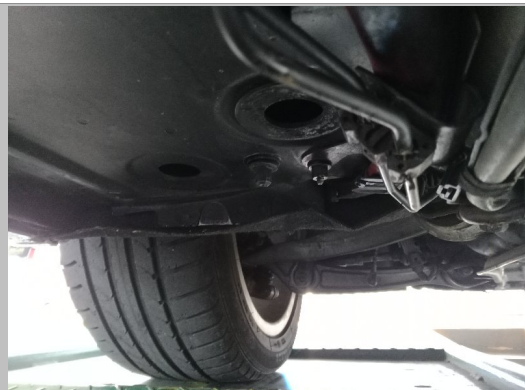
LF TYRE TREAD

| | Size | Load/Speed Index | Manufacture | Model | Type* | Production Date | Tread Depth (mm) |
|---|---|---|---|---|---|---|---|
| Front Left | 245/45R18 | 100Y | Goodyear | Efficient | V | 4522 | 3 mm |

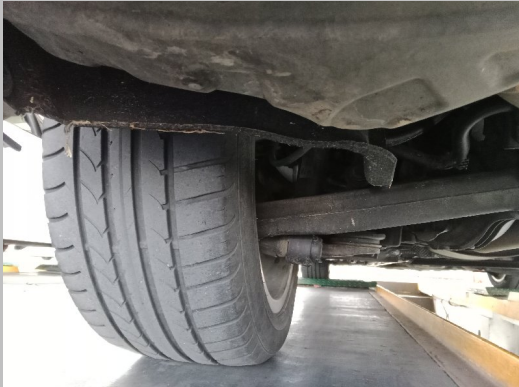
LR TYRE TREAD

| | Size | Load/Speed Index | Manufacture | Model | Type* | Production Date | Tread Depth (mm) |
|---|---|---|---|---|---|---|---|
| Rear Left | 245/45R18 | 100Y | Goodyear | Efficient | V | 4921 | 3 mm |

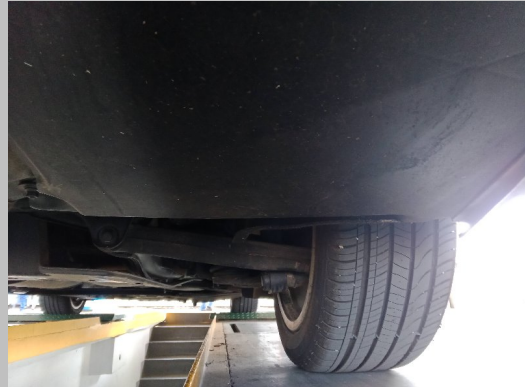
RR TYRE TREAD

| | Size | Load/Speed Index | Manufacture | Model | Type* | Production Date | Tread Depth (mm) |
|---|---|---|---|---|---|---|---|
| Rear Right | 245/45ZR18 | 100W | Anchee | AC 818 | V | 4025 | 5 mm |

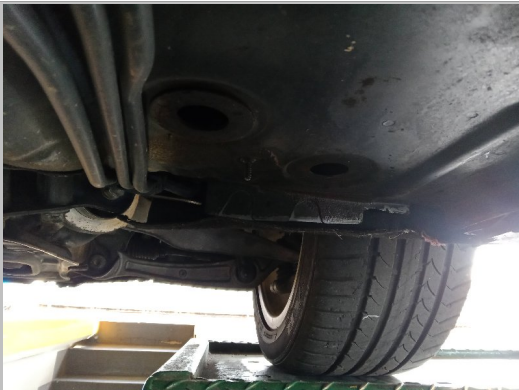
RF TYRE TREAD

| | Size | Load/Speed Index | Manufacture | Model | Type* | Production Date | Tread Depth (mm) |
|---|---|---|---|---|---|---|---|
| Front Right | 245/45R18 | 100Y | Goodyear | Efficient | V | 4422 | 4 mm |

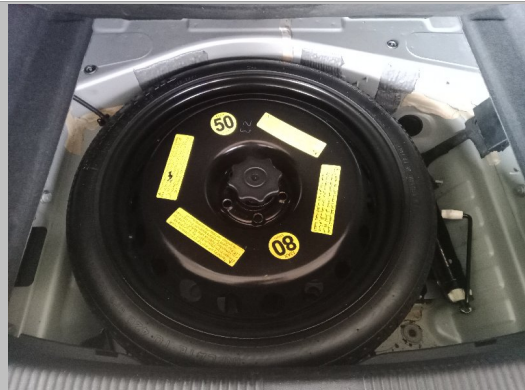
Sparewheel

| | Size | Load/Speed Index | Manufacture | Model | Type* | Production Date | Tread Depth (mm) |
|---|---|---|---|---|---|---|---|
| Spare | T145/60R20 | 105M | Pirelli | Spare tyre | V | 1913 | 3 mm |

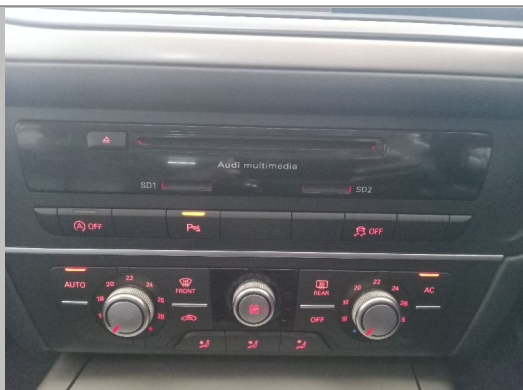
Aircon working

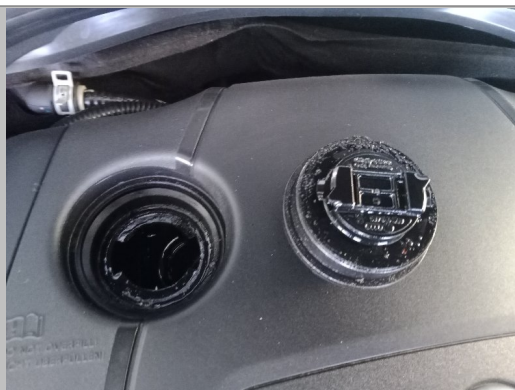
Oil cap no dipstick
