## CONDITION REPORT

Report No:  
2017296758  
DATE  
10/09/2026

| Manufacturer | BMW | Registration Number | LP28KFGP |
| Model | M5 8-SP AT [2013-2017] | Register Number | SYJ374W |

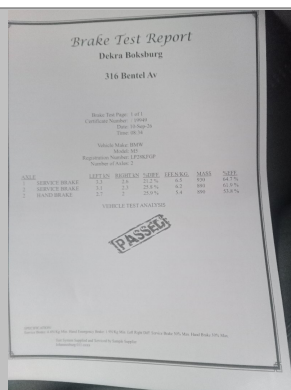
Brake report

Brake Test Results

| | Left | Right | | |
| | Braking Force [KN] | Braking Force [KN] | Axle Weight [KG] | Deceleration [m/s <sup>2</sup> ] |
| Front | 3.3 | 2.6 | - | |
| Rear | 3.1 | 2.3 | - | |
| Emergency / Parking | 2.7 | 2 | - | |

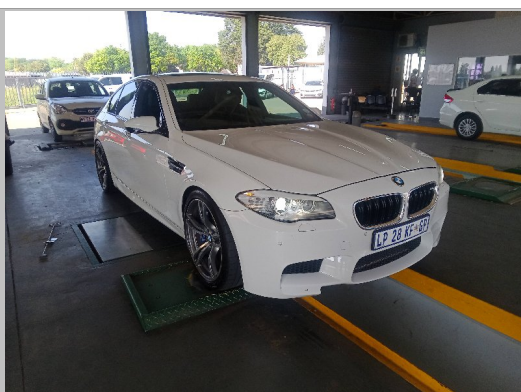
FRONT RIGHT CORNER

General Comments: ACCORDING TO THE AGE AND MILEAGE OF THE VEHICLE, NORMAL WEAR AND TEAR MARKS ARE VISIBLE ON THE INTERIOR, EXTERIOR, ELECTRICAL AND MECHANICAL PARTS. Body • Exterior: Minor dents scratches and stone chips. Cosmetic spray work various panels  
Tyres and Rims: Rear tyres scuffed and right front tyre on 1mm to be replaced soon  
Undercarriage: Undercarriage mostly covered

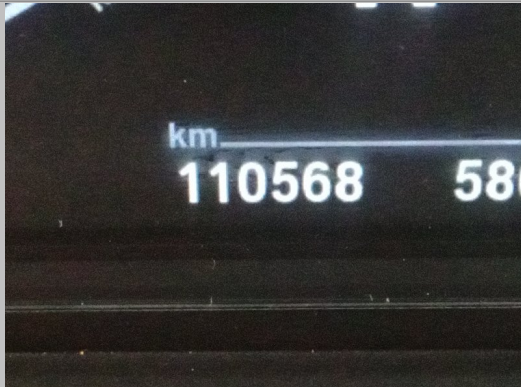
ODOMETER

| Km Reading | 110,568 KM | Fuel | PETROL |

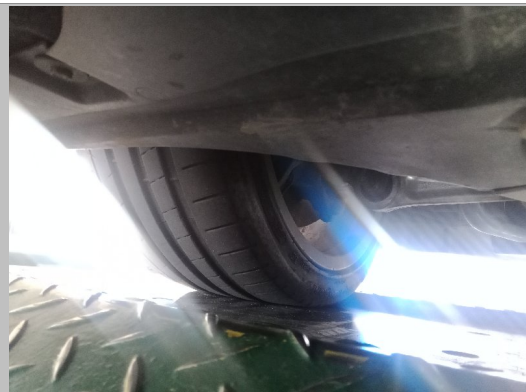
LF TYRE TREAD

| | Size | Load/Speed Index | Manufacture | Model | Type* | Production Date | Tread Depth (mm) |
|---|---|---|---|---|---|---|---|
| Front Left | 265/35ZR20 | 99Y | Michelin | Pilot | V | 0823 | 3 mm |

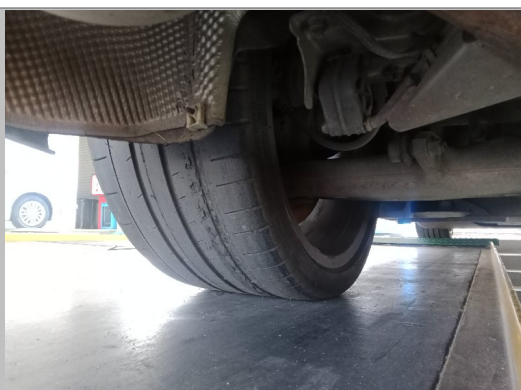
LR TYRE TREAD

| | Size | Load/Speed Index | Manufacture | Model | Type* | Production Date | Tread Depth (mm) |
|---|---|---|---|---|---|---|---|
| Rear Left | 295/30ZR20 | 101Y | Michelin | Pilot | V | 5020 | 0 mm |

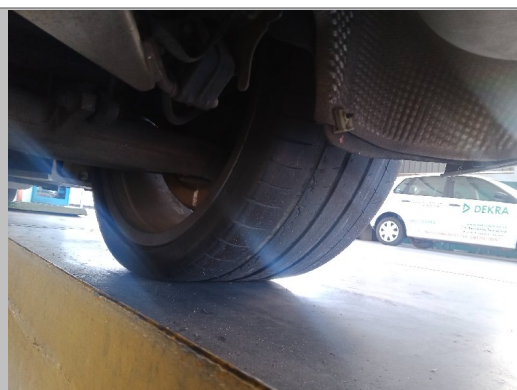
RR TYRE TREAD

| | Size | Load/Speed Index | Manufacture | Model | Type* | Production Date | Tread Depth (mm) |
|---|---|---|---|---|---|---|---|
| Rear Right | 295/30ZR20 | 101Y | Michelin | Pilot | V | 5020 | 0 mm |

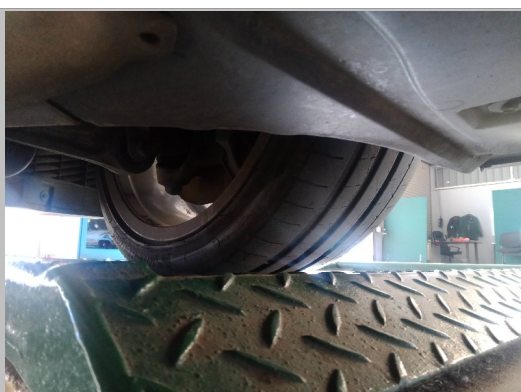
RF TYRE TREAD

| | Size | Load/Speed Index | Manufacture | Model | Type* | Production Date | Tread Depth (mm) |
|---|---|---|---|---|---|---|---|
| Front Right | 265/35ZR20 | 99Y | Michelin | Pilot | V | 3420 | 1 mm |

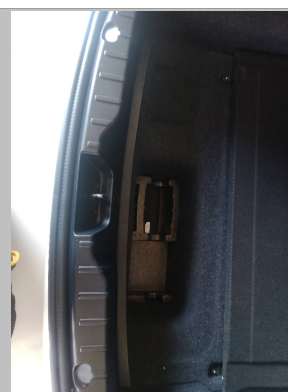
No spare tyre

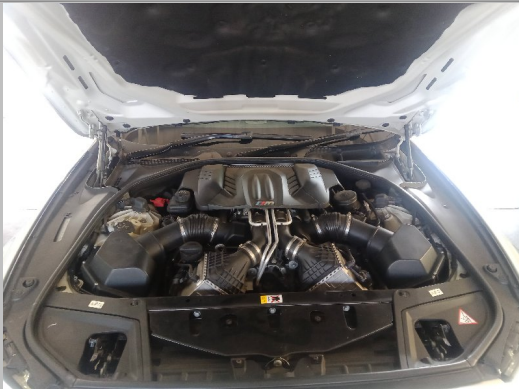
ENGINE 1

Engine number – not possible to verify engine number (not visible without dismantling)  
Inspection conditions for the vehicle inspection were sufficient
