DEKRA Boksburg  
Bentel Ave - 1459  
BOKSBURG - GT  
011 826 4386

Vehicle Type	PASSENGER VEHICLE	Registered Owner	CBK MOTORS
Manufacturer	HYUNDAI	Registration Number	MH28PSGP
Model	I10 1.1 MOTION 5-DR [2011-2018]	Register Number	SMG343W
VIN	MALAN51BLDM387247	Date Of First Licensing	
Engine Number	G4HGDM647104	Last COR	26/03/2026
Doors	5	License Expiry Date	30/06/2026
Color	WHITE	Power / Displacement	49Kw/1086Cc
Year Model	2013	Paint Finish	C - COMMON
Km Reading	126,438 KM	Fuel	PETROL
Cab / Body Type	HATCHBACK	Transmission	MANUAL

**VEHICLE INSPECTION**

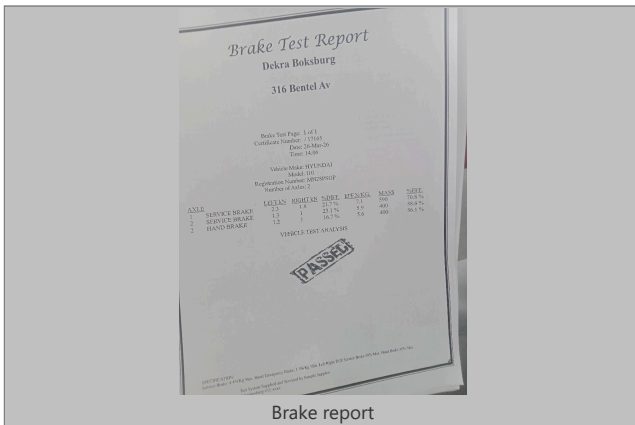
Brake report

Left	Right		
	Braking Force [KN]	Braking Force [KN]	Axle Weight [KG]	Deceleration [m/s <sup>2</sup> ]
Front	2.3	1.8	-	
Rear	1.3	1.0	-	
Emergency / Parking	1.2	1	-

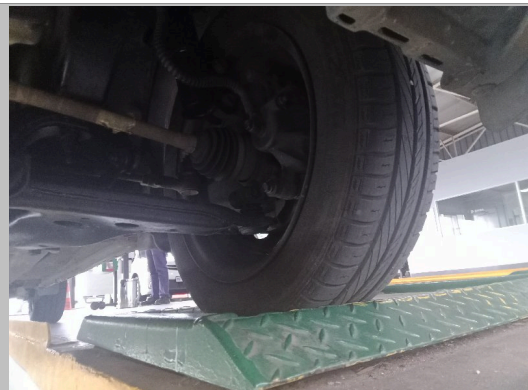
LF TYRE TREAD

Size	Load/Speed Index	Manufacture	Model	Type*	Production Date	Tread Depth (mm)
Front Left	165/60R14	75H	Goodyear	Dura Grip	V	2222	3 mm
Front Right	165/60R14	75H	Goodyear	Dura Grip	V	2222	3 mm
Rear Left	165/60R14	75H	Goodyear	Dura Grip	V	2222	6 mm
Rear Right	165/60R14	75H	Goodyear	Dura Grip	V	2917	3 mm
Spare	165/60R14	75H	Goodyear	Dura Grip	V	0000	6 mm
