## Assignment

## Vehicle Data

| Model | JIMNY 1.3 4X4 [2012-2014] | Register Number | SBB462W |

## VEHICLE INSPECTION

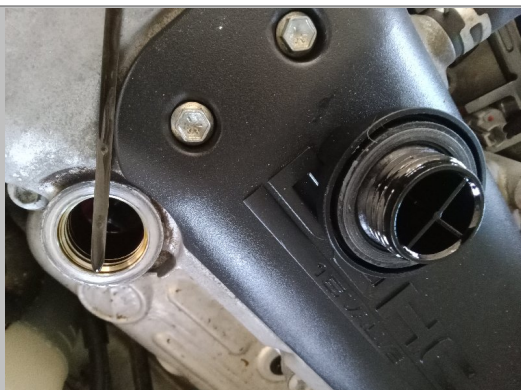
Oil cap and dipstick

General Comments: ACCORDING TO THE AGE AND MILEAGE OF THE VEHICLE NORMAL WEAR AND TEAR MARKS ON INTERIOR, EXTERIOR, ELECTRICAL AND MECHANICAL PARTS. Engine Compartment: Dipstick handle repaired.

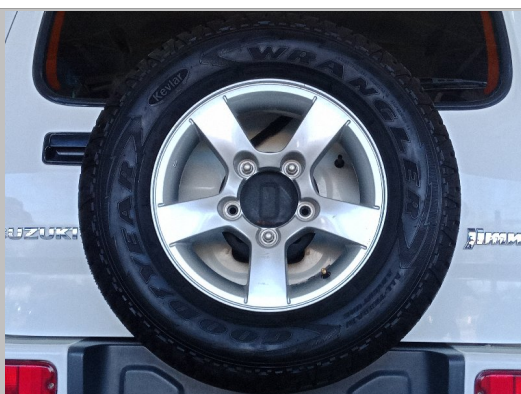
Sparewheel

| | Size | Load/Speed Index | Manufacture | Model | Type* | Production Date | Tread Depth (mm) |
|---|---|---|---|---|---|---|---|
| Spare | 205/75R15 | 102T | Goodyear | Wrangler | V | 1719 | 5 mm |

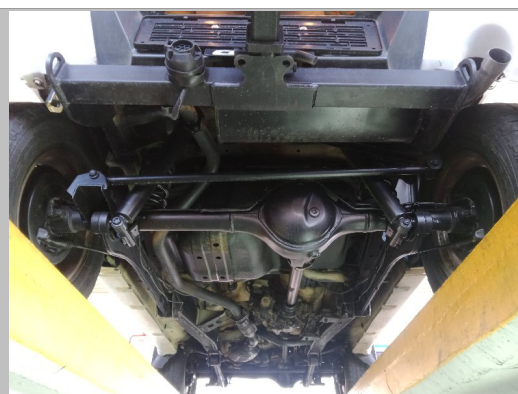
Chassis 2

Undercarriage: Chassis sprayed with chassis black.

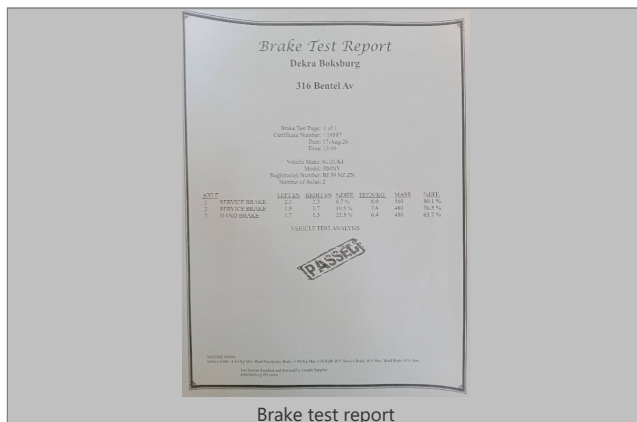
Brake test report

| | Left | Right | | |
| | Braking Force [KN] | Braking Force [KN] | Axle Weight [KG] | Deceleration [m/s <sup>2</sup> ] |
| Front | 2.1 | 2.3 | - | |
| Rear | 1.9 | 1.7 | - | |
| Emergency / Parking | 1.7 | 1.3 | - | |

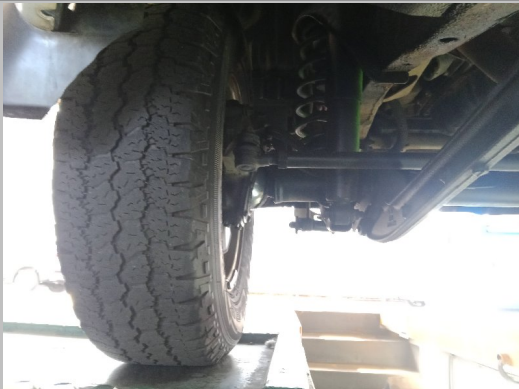
LF TYRE TREAD

| | Size | Load/Speed Index | Manufacture | Model | Type* | Production Date | Tread Depth (mm) |
|---|---|---|---|---|---|---|---|
| Front Left | 205/75R15 | 102T | Goodyear | Wrangler | V | 1719 | 4 mm |

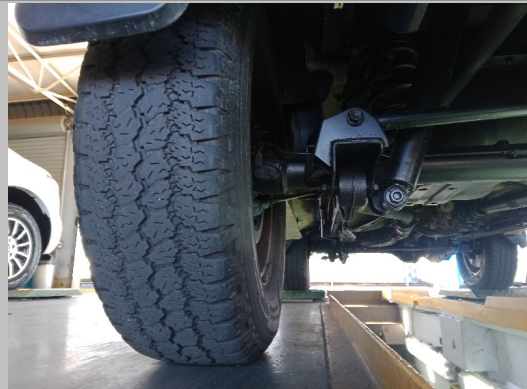
LR TYRE TREAD

| | Size | Load/Speed Index | Manufacture | Model | Type* | Production Date | Tread Depth (mm) |
|---|---|---|---|---|---|---|---|
| Rear Left | 205/75R15 | 102T | Goodyear | Wrangler | V | 1719 | 2 mm |

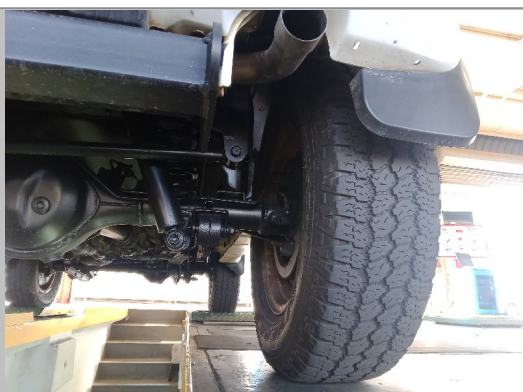
RR TYRE TREAD

| | Size | Load/Speed Index | Manufacture | Model | Type* | Production Date | Tread Depth (mm) |
|---|---|---|---|---|---|---|---|
| Rear Right | 205/75R15 | 102T | Goodyear | Wrangler | V | 2618 | 3 mm |

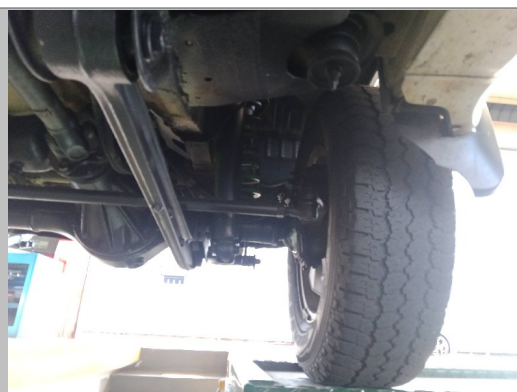
RF TYRE TREAD

| | Size | Load/Speed Index | Manufacture | Model | Type* | Production Date | Tread Depth (mm) |
|---|---|---|---|---|---|---|---|
| Front Right | 205/75R15 | 102T | Goodyear | Wrangler | V | 1719 | 4 mm |
