## Assignment

| Manufacturer | MERCEDES-BENZ | Registration Number | CS52FBZN |
| Model | CLA 200 [2013-2016] | Register Number | TLZ570W |

## VEHICLE INSPECTION

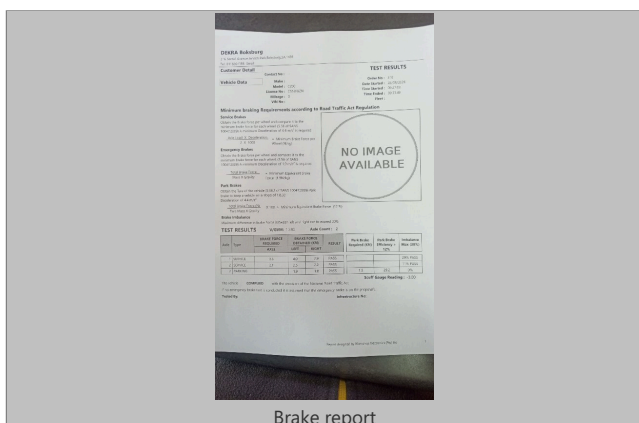
Brake report

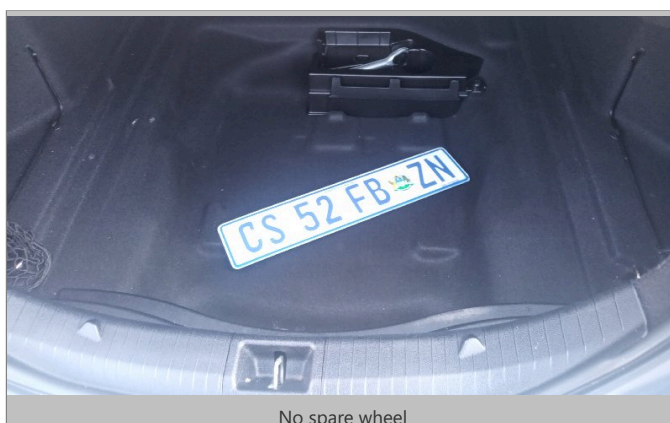
No spare wheel

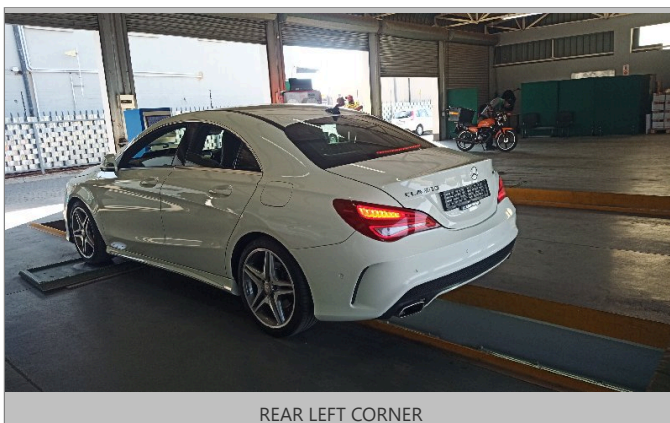
REAR LEFT CORNER

General Comments: ACCORDING TO AGE AND MILEAGE OF VEHICLE NORMAL WEAR AND TEAR ON INTERIOR, EXTERIOR, ELECTRICAL AND MECHANICAL PARTS. Body • Exterior: Minor dents stone chips and or Scratches on various body panels.  
Tyres and Rims: Left rear rim scratched

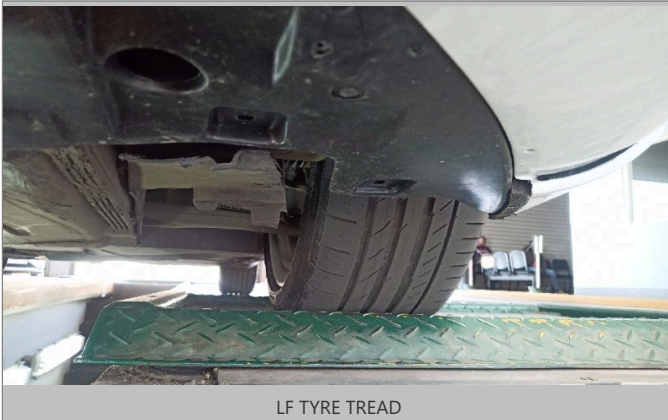
LF TYRE TREAD

| | Size | Load/Speed Index | Manufacture | Model | Type* | Production Date | Tread Depth (mm) |
|---|---|---|---|---|---|---|---|
| Front Left | 225/40R18 | 92W | Continental | Conti sport | V | 2222 | 3 mm |

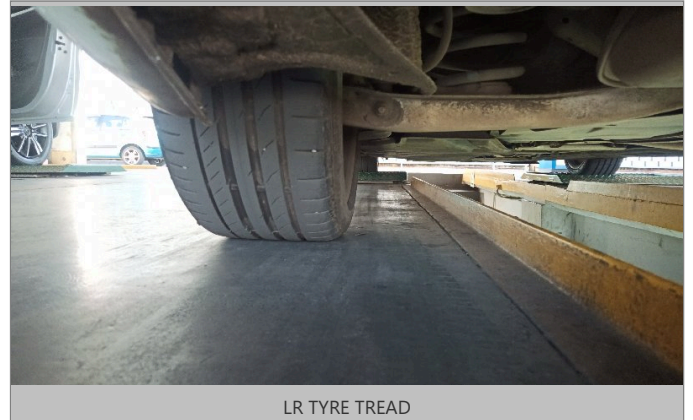
LR TYRE TREAD

| | Size | Load/Speed Index | Manufacture | Model | Type* | Production Date | Tread Depth (mm) |
|---|---|---|---|---|---|---|---|
| Rear Left | 225/40R18 | 92W | Continental | Conti sport | V | 0422 | 3 mm |

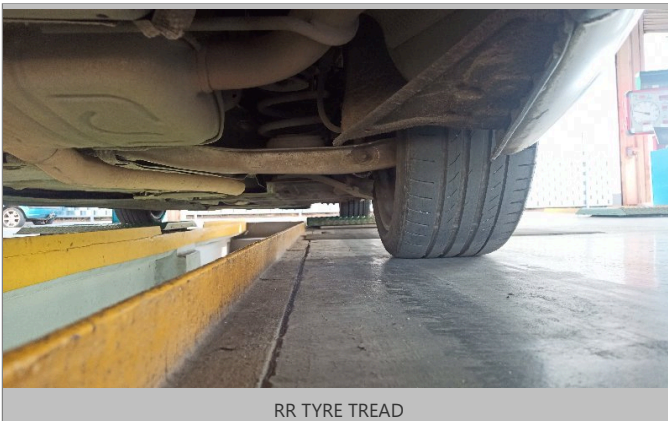
RR TYRE TREAD

| | Size | Load/Speed Index | Manufacture | Model | Type* | Production Date | Tread Depth (mm) |
|---|---|---|---|---|---|---|---|
| Rear Right | 225/40R18 | 92W | Continental | Conti sport | V | 2322 | 2 mm |

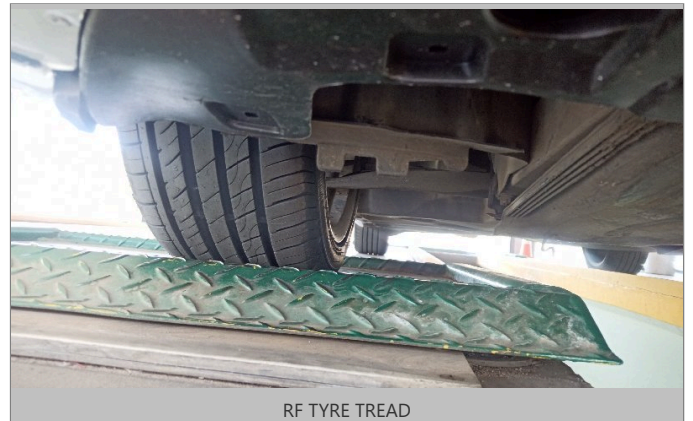
RF TYRE TREAD

| | Size | Load/Speed Index | Manufacture | Model | Type* | Production Date | Tread Depth (mm) |
|---|---|---|---|---|---|---|---|
| Front Right | 225/40ZR18 | 92W | llink | L-ZEAL56 | V | 1426 | 5 mm |
