DEKRA Boksburg
Bentel Ave - 1459
BOKSBURG - GT
011 826 4386

Client	Private Client	Inspection Location	BOKSBURG DEKRA
Requested Date	16/04/2026		316 BENTELL AVE BOKSBURG - 1459
Inspection Date	16/04/2026		BOKSBURG - GT

Vehicle Type	PASSENGER VEHICLE	Registered Owner	CBK MOTORS
Manufacturer	AUDI	Registration Number	KJD910EC
Model	TT COUPE 2.0T FSI 169KW S TRONIC [2015-2018]	Register Number	GKW997K
VIN	TRUZZZFV2F1018397	Date Of First Licensing	
Engine Number	CHH095692	Last COR	2026/04/16
Doors	2	License Expiry Date	
Color	WHITE	Power / Displacement	169Kw/1984Cc
Year Model	2016	Paint Finish	C - COMMON
Km Reading	47,222 KM	Fuel	PETROL
Cab / Body Type	COUPE	Transmission	MANUAL

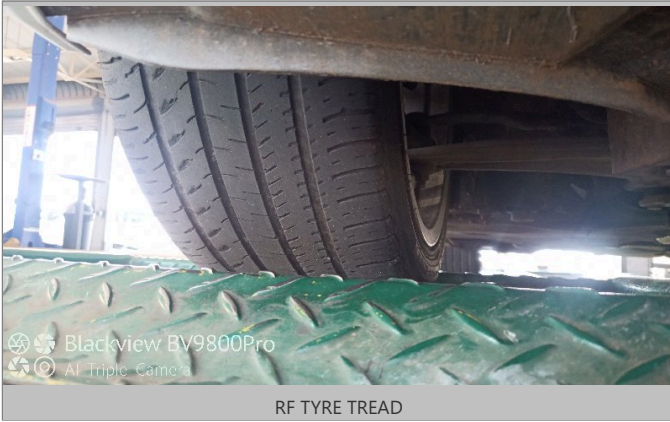
RF TYRE TREAD

Size	Load/Speed Index	Manufacture	Model	Type*	Production Date	Tread Depth (mm)
Front Left	245/40ZR18	97W	Annaite	An606	V	4024	1 mm
Front Right	245/40ZR18	97W	Annaite	AN606	V	4028	1 mm
Rear Left	245/40R18	97Y	Bridgestone	Potenza	V	4121	1 mm
Rear Right	245/40R18	97Y	Bridgestone	Potenza	V	3921	1 mm
Spare	T125/70R19	100F	Hankook	Temp	V	0000	4 mm

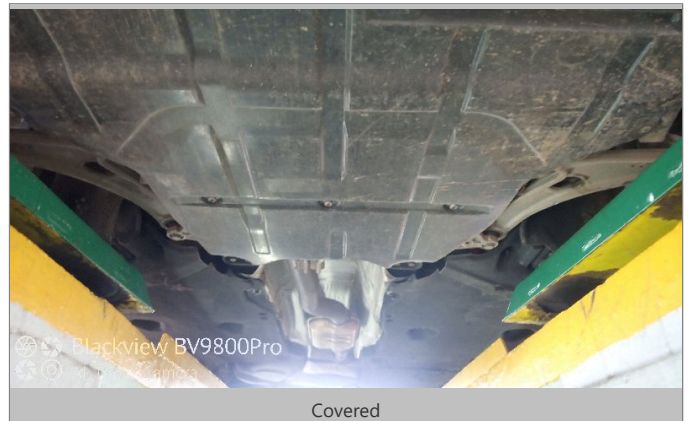
Covered

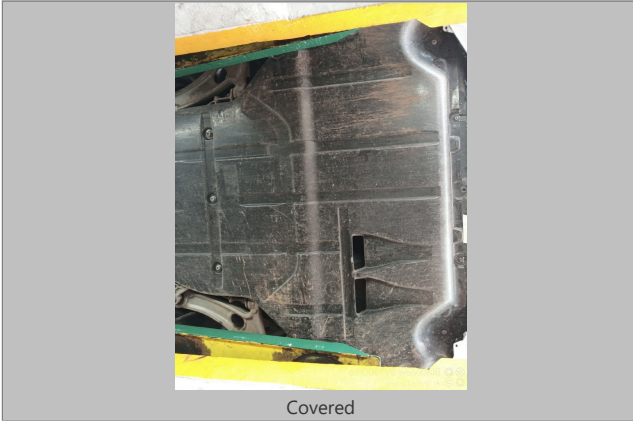
Covered

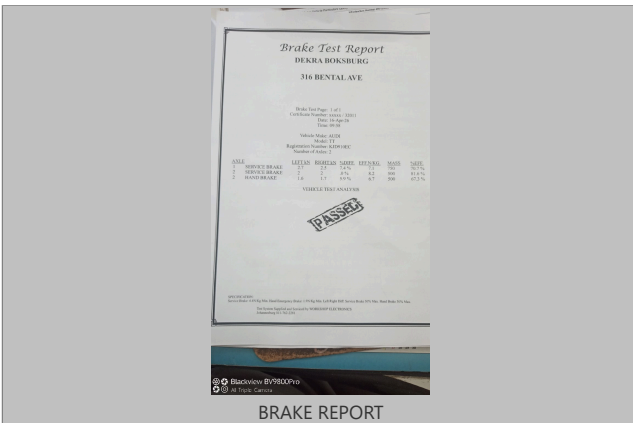
BRAKE REPORT

Left	Right		
	Braking Force [KN]	Braking Force [KN]	Axle Weight [KG]	Deceleration [m/s ²]
Front	2.7	2.5	-	
Rear	2.0	2.0	-	
Emergency / Parking	1.6	1.7	-
