## Assignment

## Vehicle Data

| Manufacturer | FORD | Registration Number | FN08HFGP |
| Model | FIESTA | Register Number | XGX695W |

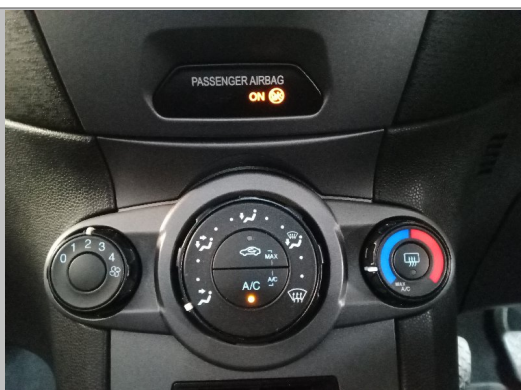
Air-conditioning working

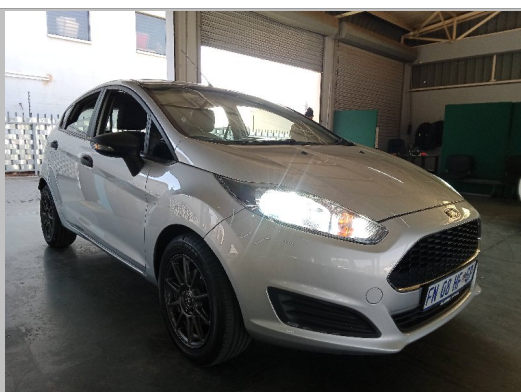
FRONT RIGHT CORNER

General Comments: ACCORDING TO THE AGE AND MILEAGE OF THE VEHICLE, NORMAL WEAR AND TEAR MARKS ARE VISIBLE ON THE INTERIOR, EXTERIOR, ELECTRICAL AND MECHANICAL PARTS. Body • Exterior: Minor dents, scratches, and stone chips on some body panels. Cosmetic enhancements were done to some body panels.
