Private Client

## Assignment

## Vehicle Data

## VEHICLE INSPECTION

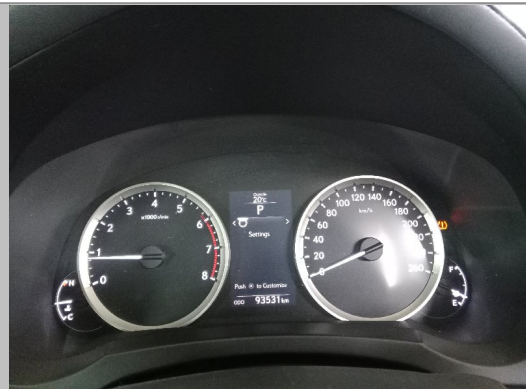
DASHBOARD (W/ ENGINE RUNNING)

General Comments: ACCORDING TO THE AGE AND MILEAGE OF THE VEHICLE NORMAL WEAR AND TEAR MARKS ON INTERIOR, EXTERIOR, ELECTRICAL AND MECHANICAL PARTS. Engine Compartment: Engine and transmission mostly covered underneath. Electrical Components and Instruments: Tyre pressure warning illuminated at time of inspection.

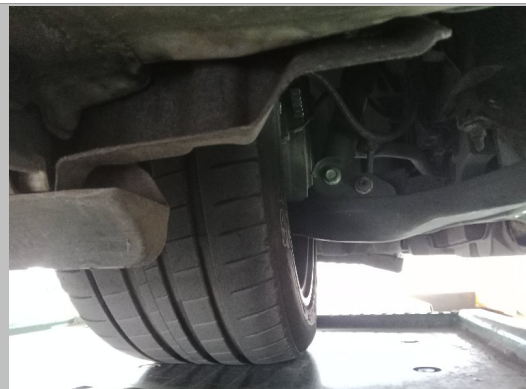
LF TYRE TREAD

| | Size | Load/Speed Index | Manufacture | Model | Type* | Production Date | Tread Depth (mm) |
|---|---|---|---|---|---|---|---|
| Front Left | 225/45R17 | 94Y | Dunlop | Sportmax | V | 2024 | 2 mm |

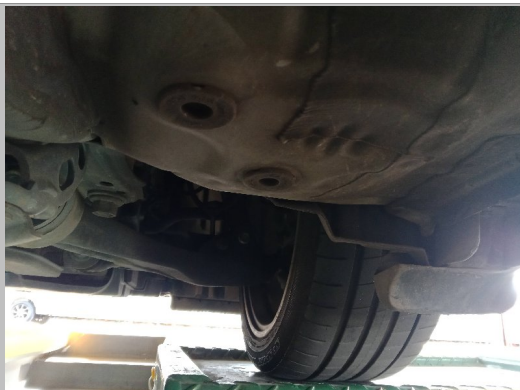
RF TYRE TREAD

| | Size | Load/Speed Index | Manufacture | Model | Type* | Production Date | Tread Depth (mm) |
|---|---|---|---|---|---|---|---|
| Front Right | 225/45R17 | 94Y | Dunlop | Sportmax | V | 2024 | 2 mm |

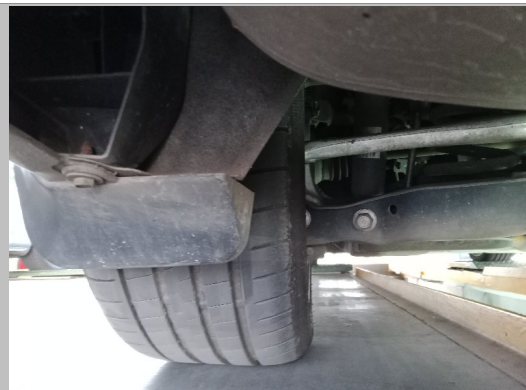
LR TYRE TREAD

| | Size | Load/Speed Index | Manufacture | Model | Type* | Production Date | Tread Depth (mm) |
|---|---|---|---|---|---|---|---|
| Rear Left | 225/45R17 | 94Y | Dunlop | Sportmax | V | 2024 | 3 mm |

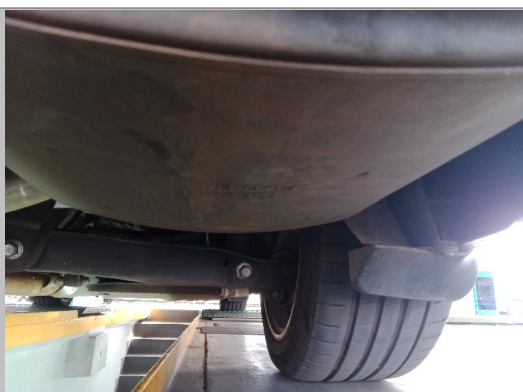
RR TYRE TREAD

| | Size | Load/Speed Index | Manufacture | Model | Type* | Production Date | Tread Depth (mm) |
|---|---|---|---|---|---|---|---|
| Rear Right | 225/45R17 | 94Y | Dunlop | Sportmax | V | 2024 | 2 mm |

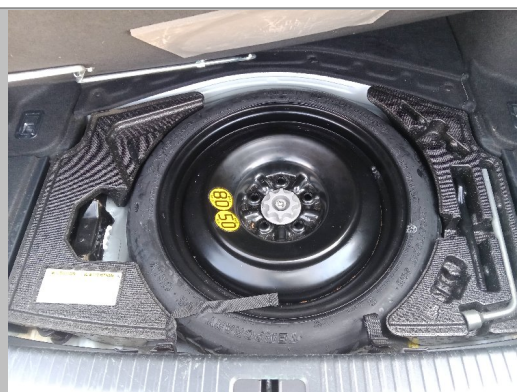
Sparewheel

| | Size | Load/Speed Index | Manufacture | Model | Type* | Production Date | Tread Depth (mm) |
|---|---|---|---|---|---|---|---|
| Spare | T125/70D17 | 98M | Yokohama | Temporary | V | 3315 | 4 mm |

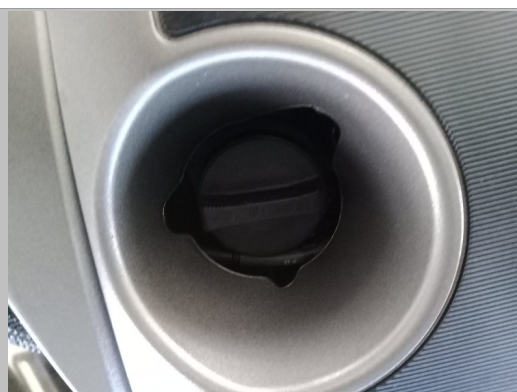
Oil cap stuck

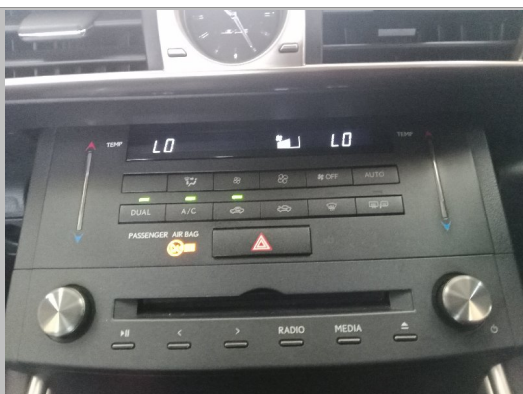
Airconditioning working

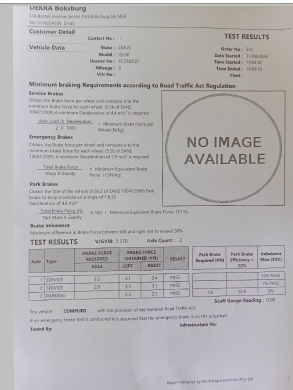
BRAKE TEST REPORT

| | Left | Right | | |
| | Braking Force [KN] | Braking Force [KN] | Axle Weight [KG] | Deceleration [m/s <sup>2</sup> ] |
| Front | 4.1 | 3.4 | - | |
| Rear | 3.3 | 3.1 | - | |
| Emergency / Parking | 2.3 | 2.1 | - | |

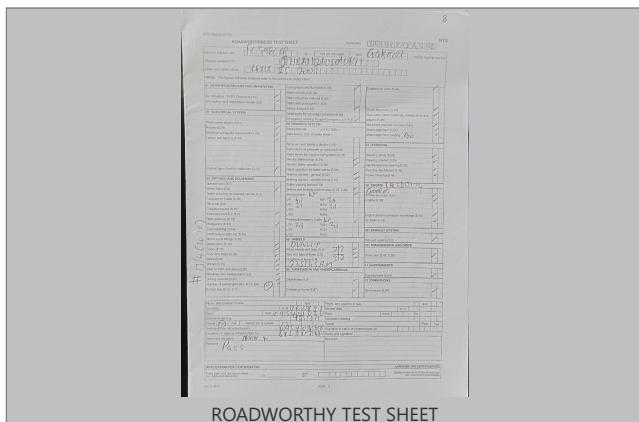
ROADWORTHY TEST SHEET

The image shows a detailed roadworthy test sheet from DEKRA. It includes sections for vehicle identification, inspection details, and a comprehensive checklist of components to be inspected. Handwritten notes and signatures are visible throughout the form, indicating a completed inspection.
