Private Client

DEKRA Boksburg  
Bentel Ave - 1459  
BOKSBURG - GT  
011 826 4386

## Assignment

## Vehicle Data

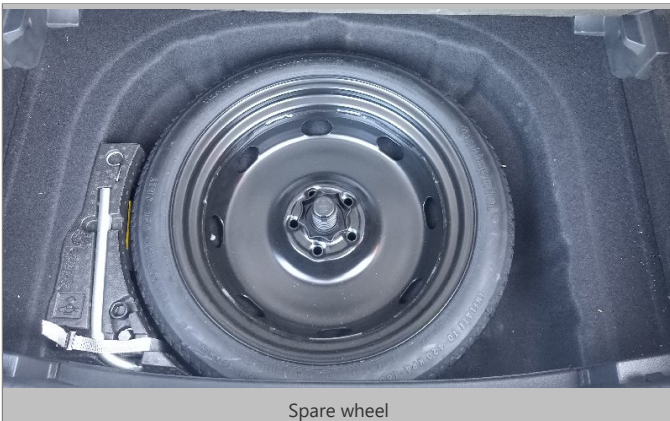
| | Size | Load/Speed Index | Manufacture | Model | Type* | Production Date | Tread Depth (mm) |
|---|---|---|---|---|---|---|---|
| Spare | T125/70R18 | 99M | Continental | Temp | V | 0000 | 4 mm |

Spare wheel

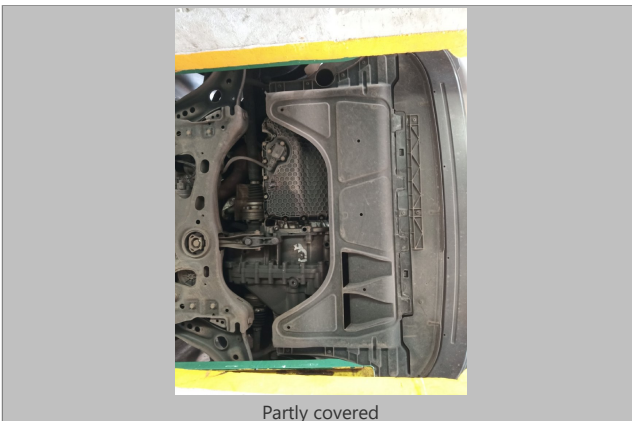
Undercarriage: Undercarriage mostly covered, limited visibility.

Partly covered

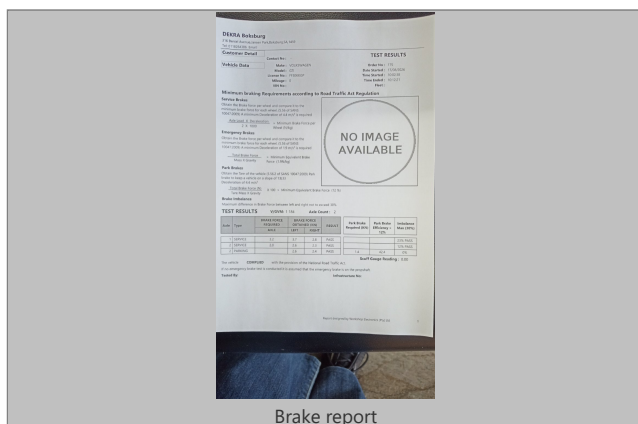
| | Left | Right | | |
|---|---|---|---|---|
| Front | 3.6 | 2.8 | - | |
| Rear | 2.6 | 2.3 | - | |
| Emergency / Parking | 2.5 | 2.3 | - | |

Brake report

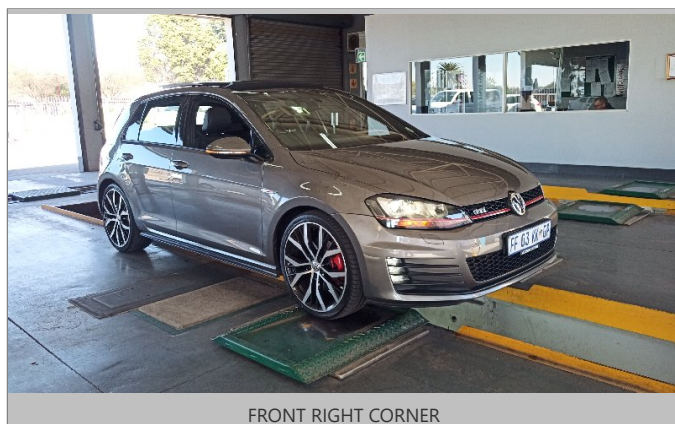
General Comments: ACCORDING TO AGE AND MILEAGE OF VEHICLE NORMAL WEAR AND TEAR ON INTERIOR, EXTERIOR, ELECTRICAL AND MECHANICAL PARTS. Body • Exterior: Minor dents stone chips and or scratches on various body panels.

FRONT RIGHT CORNER

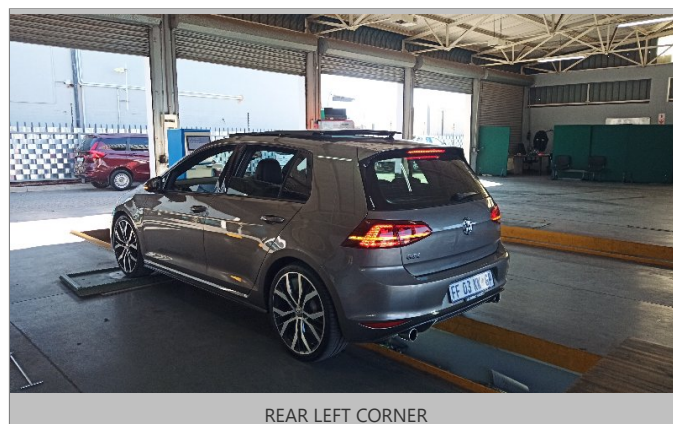
REAR LEFT CORNER

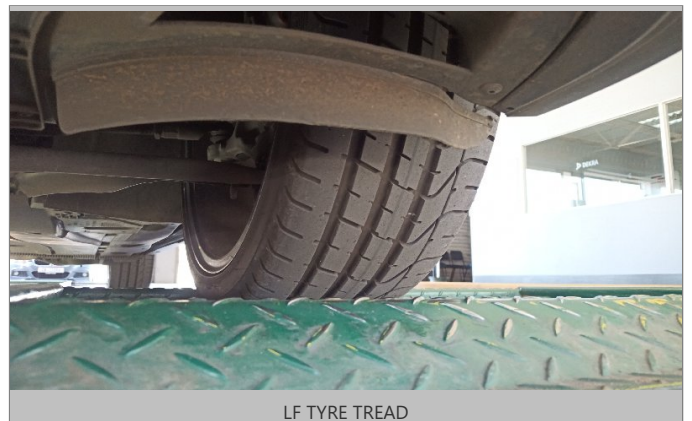
| | Size | Load/Speed Index | Manufacture | Model | Type* | Production Date | Tread Depth (mm) |
|---|---|---|---|---|---|---|---|
| Front Left | 225/35R19 | 88Y | Pirelli | Pzero | V | 4123 | 4 mm |

LF TYRE TREAD

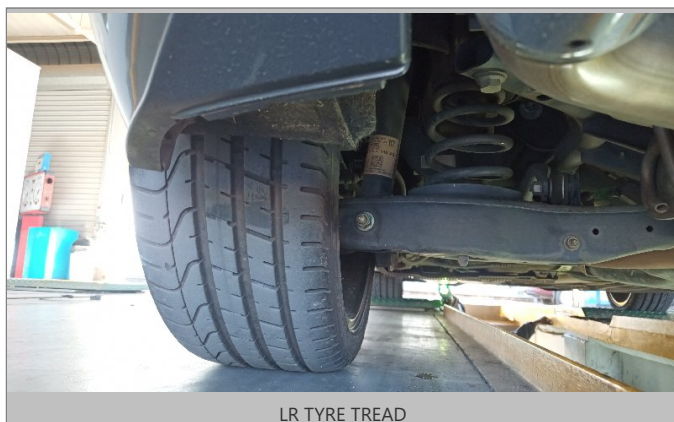
| | Size | Load/Speed Index | Manufacture | Model | Type* | Production Date | Tread Depth (mm) |
|---|---|---|---|---|---|---|---|
| Rear Left | 225/35R19 | 88Y | Pirelli | Pzero | V | 4123 | 4 mm |

LR TYRE TREAD

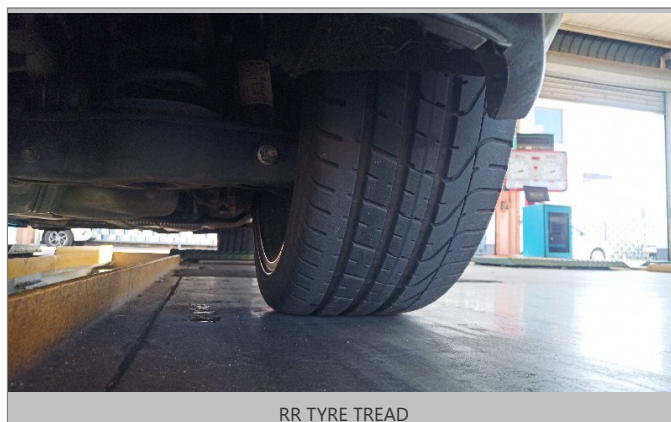
| | Size | Load/Speed Index | Manufacture | Model | Type* | Production Date | Tread Depth (mm) |
|---|---|---|---|---|---|---|---|
| Rear Right | 225/35R19 | 88Y | Pirelli | Pzero | V | 4123 | 4 mm |

RR TYRE TREAD

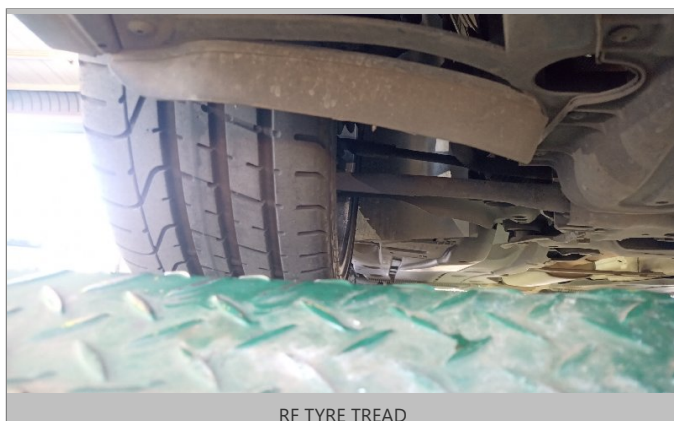
| | Size | Load/Speed Index | Manufacture | Model | Type* | Production Date | Tread Depth (mm) |
|---|---|---|---|---|---|---|---|
| Front Right | 225/35R19 | 88Y | Pirelli | Pzero | V | 4123 | 4 mm |

RF TYRE TREAD
