## CONDITION REPORT

Report No:  
2017295585  
DATE  
08/09/2026

| Manufacturer | FORD | Registration Number | DF22CLZN |
| Model | RANGER 2.2 TDCI XL D-CAB DSL PU [2017-2020] | Register Number | YKB599W |

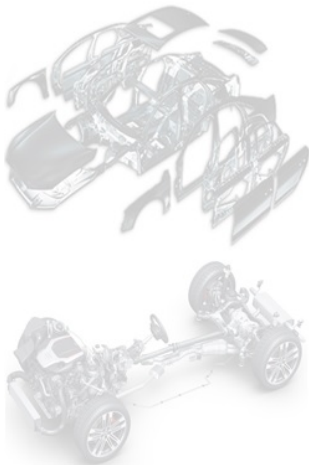
Damage

Repair Way

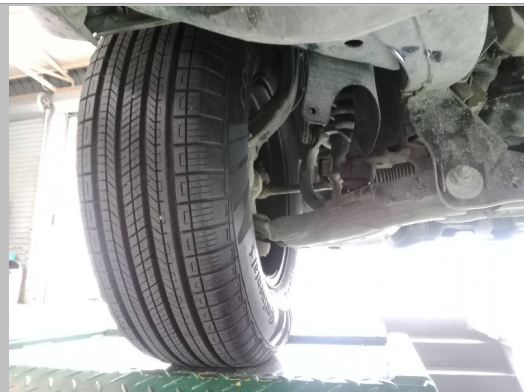
LF TYRE TREAD

| | Size | Load/Speed Index | Manufacture | Model | Type* | Production Date | Tread Depth (mm) |
|---|---|---|---|---|---|---|---|
| Front Left | 255/70R17 | 112T | Continental | Crosscontact | V | 1226 | 8 mm |

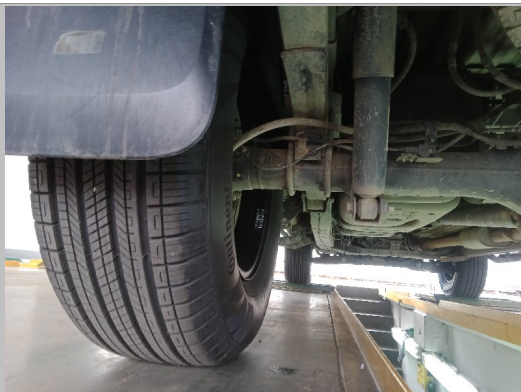
LR TYRE TREAD

| | Size | Load/Speed Index | Manufacture | Model | Type* | Production Date | Tread Depth (mm) |
|---|---|---|---|---|---|---|---|
| Rear Left | 255/70R17 | 112T | Continental | Crosscontact | V | 2026 | 8 mm |

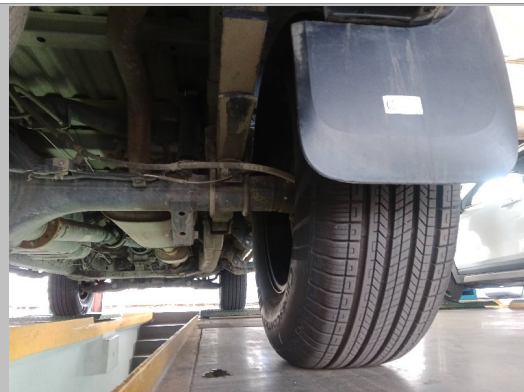
RR TYRE TREAD

| | Size | Load/Speed Index | Manufacture | Model | Type* | Production Date | Tread Depth (mm) |
|---|---|---|---|---|---|---|---|
| Rear Right | 255/70R17 | 112T | Continental | Crosscontact | V | 1226 | 8 mm |

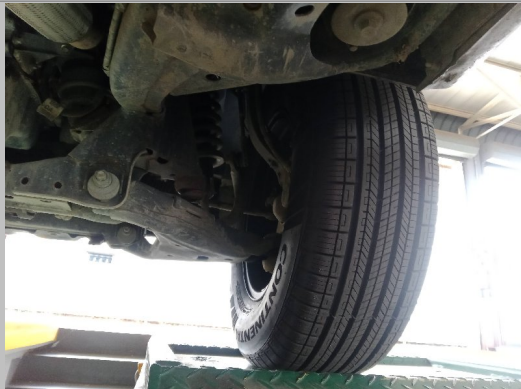
RF TYRE TREAD

| | Size | Load/Speed Index | Manufacture | Model | Type* | Production Date | Tread Depth (mm) |
|---|---|---|---|---|---|---|---|
| Front Right | 255/70R17 | 112T | Continental | Crosscontact | V | 2226 | 8 mm |

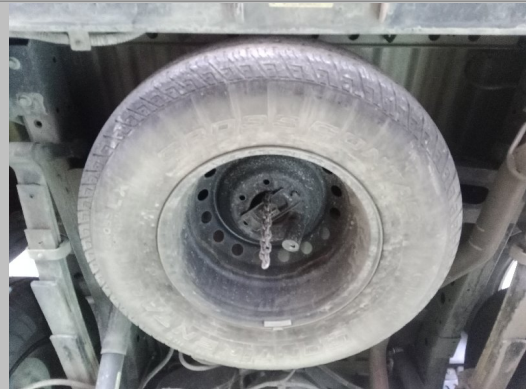
Sparewheel

| | Size | Load/Speed Index | Manufacture | Model | Type* | Production Date | Tread Depth (mm) |
|---|---|---|---|---|---|---|---|
| Spare | 265/70R16 | 111T | Continental | Crosscontact | V | 0000 | 2 mm |

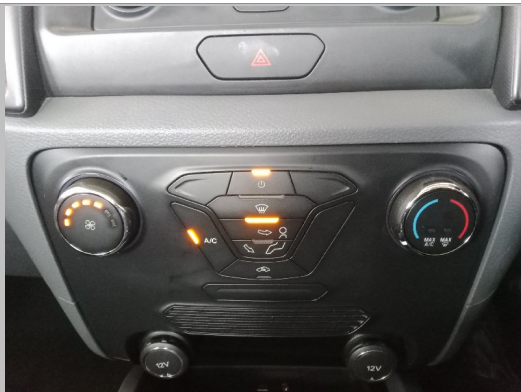
Aircon working

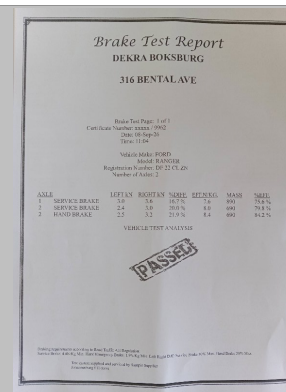
BRAKE TEST REPORT

| | Left | Right | Axle Weight [KG] | Deceleration [m/s <sup>2</sup> ] |
|---|---|---|---|---|
| Front | 3.0 | 3.6 | - | |
| Rear | 2.4 | 3.0 | - | |
| Emergency / Parking | 2.5 | 3.2 | - | |
