DEKRA Boksburg  
Bentel Ave - 1459  
BOKSBURG - GT  
011 826 4386

## Assignment

## Vehicle Data

## VEHICLE INSPECTION

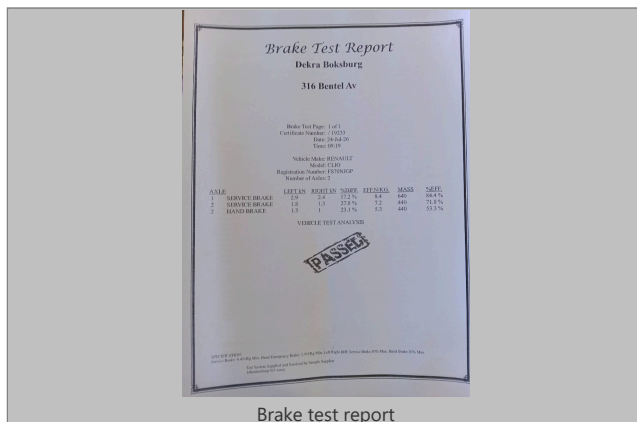
Brake test report

| | Left | Right | | |
|---|---|---|---|---|
| Front | 2.9 | 2.4 | - | |
| Rear | 1.8 | 1.3 | - | |
| Emergency / Parking | 1.3 | 1 | - | |

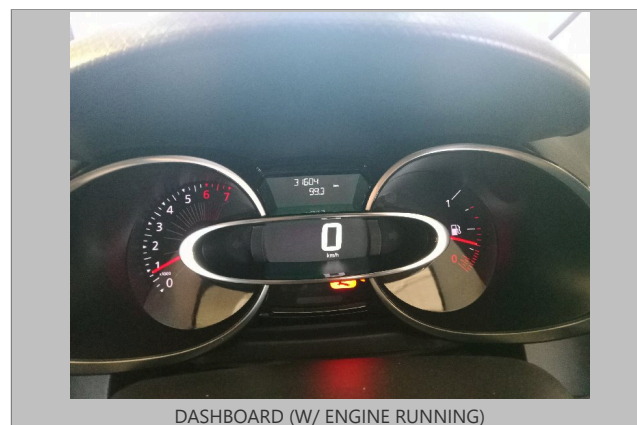
DASHBOARD (W/ ENGINE RUNNING)

General Comments: ACCORDING TO THE AGE AND MILEAGE OF THE VEHICLE, NORMAL WEAR AND TEAR MARKS ARE VISIBLE ON THE INTERIOR, EXTERIOR, ELECTRICAL AND MECHANICAL PARTS. Engine Compartment: Engine, gearbox and undercarriage mostly covered underneath.  
Electrical Components and Instruments: Service warning light illuminated at time of inspection.  
Body • Exterior: Cosmetical enhancements done to some body panels.

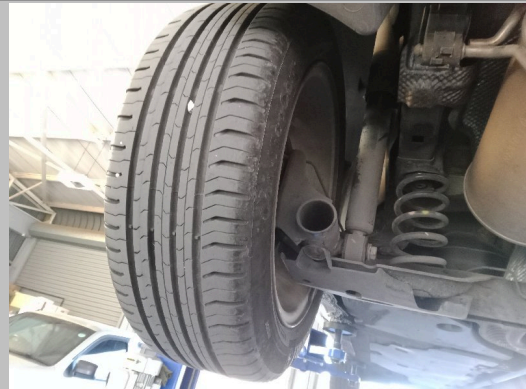
LR TYRE TREAD

| | Size | Load/Speed Index | Manufacture | Model | Type* | Production Date | Tread Depth (mm) |
|---|---|---|---|---|---|---|---|
| Rear Left | 195/55R16 | 87H | Continental | Contact 5 | V | 1216 | 5 mm |

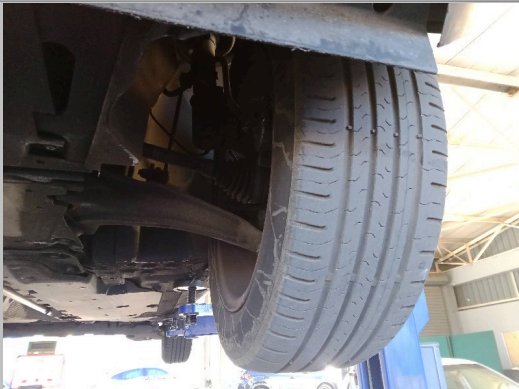
LF TYRE TREAD

| | Size | Load/Speed Index | Manufacture | Model | Type* | Production Date | Tread Depth (mm) |
|---|---|---|---|---|---|---|---|
| Front Left | 195/55R16 | 87H | Continental | Contact 5 | V | 1216 | 2 mm |

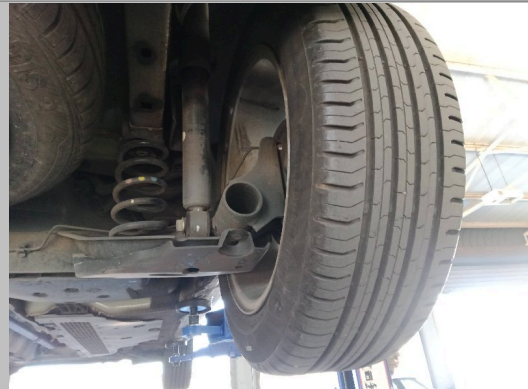
RR TYRE TREAD

| | Size | Load/Speed Index | Manufacture | Model | Type* | Production Date | Tread Depth (mm) |
|---|---|---|---|---|---|---|---|
| Rear Right | 195/55R16 | 87H | Continental | Contact 5 | V | 1116 | 5 mm |

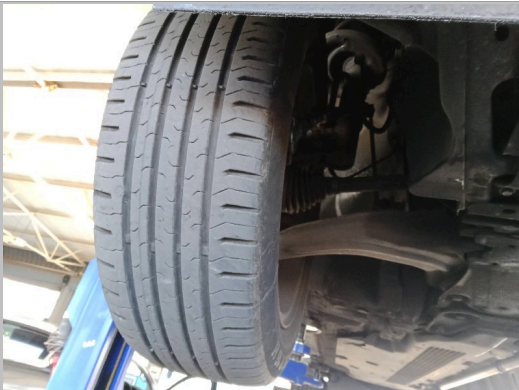
RF TYRE TREAD

| | Size | Load/Speed Index | Manufacture | Model | Type* | Production Date | Tread Depth (mm) |
|---|---|---|---|---|---|---|---|
| Front Right | 195/55R16 | 87H | Continental | Contact 5 | V | 1216 | 2 mm |

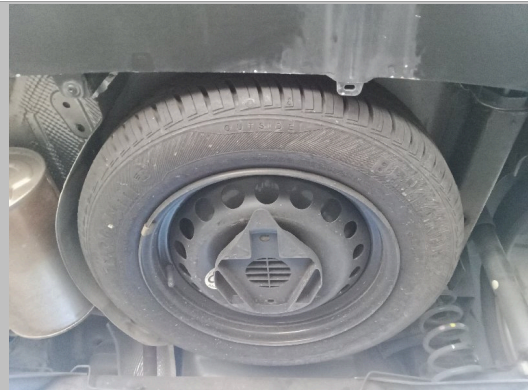
Sparewheel

| | Size | Load/Speed Index | Manufacture | Model | Type* | Production Date | Tread Depth (mm) |
|---|---|---|---|---|---|---|---|
| Spare | 185/65R15 | 88T | Barum | Brillantis | V | 1016 | 6 mm |

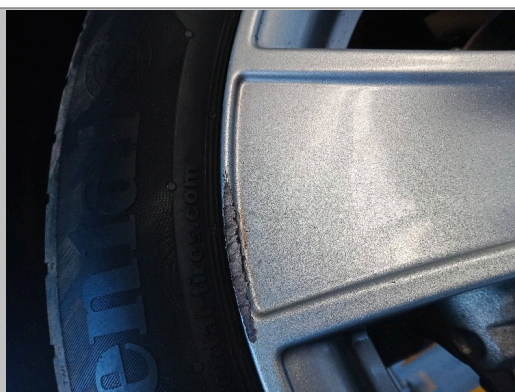
Rim Front Left Scratched  
Rim Front Right Scratched  
Rim Rear Left Scratched  
Rim Rear Right Scratched
