DEKRA Boksburg  
Bentel Ave - 1459  
BOKSBURG - GT  
011 826 4386

## Assignment

| Model | TIGUAN 2.0 TSI HIGHLINE 4MOTION 162KW DSG [2016-2019] | Register Number | HFX903K |

## VEHICLE INSPECTION

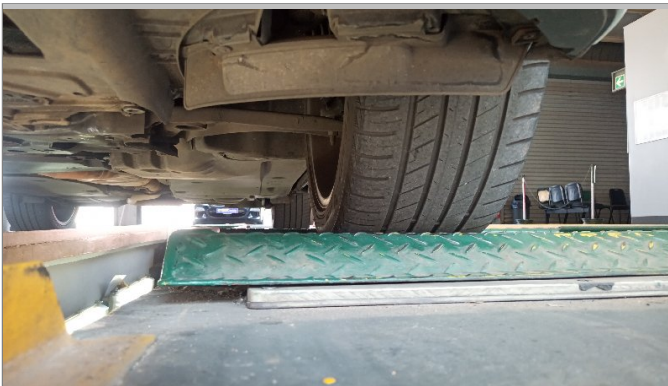
LF TYRE TREAD

| | Size | Load/Speed Index | Manufacture | Model | Type* | Production Date | Tread Depth (mm) |
|---|---|---|---|---|---|---|---|
| Front Left | 255/40R20 | 101Y | Black Hawk | Hiscend | V | 1622 | 4 mm |

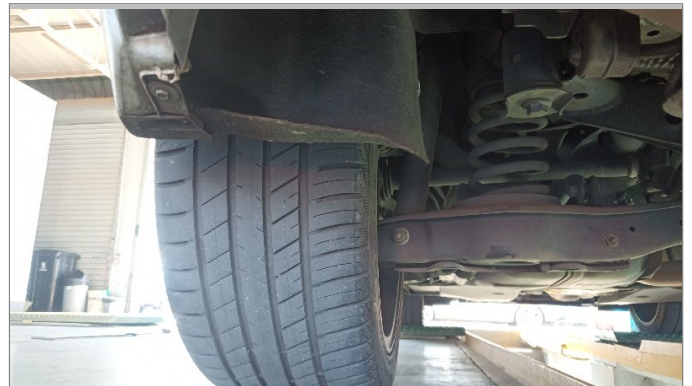
LR TYRE TREAD

| | Size | Load/Speed Index | Manufacture | Model | Type* | Production Date | Tread Depth (mm) |
|---|---|---|---|---|---|---|---|
| Rear Left | 255/40R20 | 101Y | Black Hawk | Hiscend | V | 2622 | 5 mm |

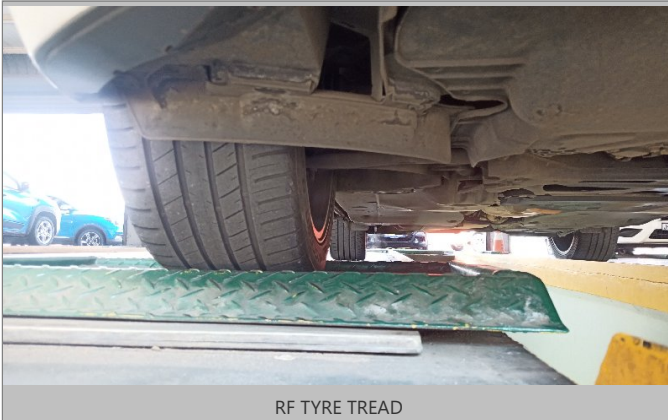
RF TYRE TREAD

| | Size | Load/Speed Index | Manufacture | Model | Type* | Production Date | Tread Depth (mm) |
|---|---|---|---|---|---|---|---|
| Front Right | 255/40R20 | 101Y | Black Hawk | Hiscend | V | 2622 | 4 mm |

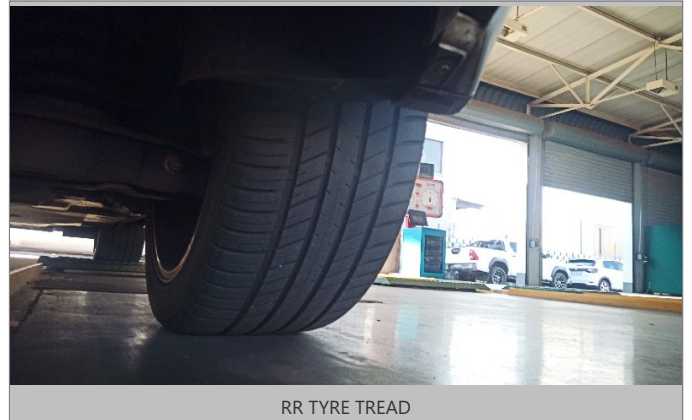
RR TYRE TREAD

| | Size | Load/Speed Index | Manufacture | Model | Type* | Production Date | Tread Depth (mm) |
|---|---|---|---|---|---|---|---|
| Rear Right | 255/40R20 | 101Y | Black Hawk | Hiscend | V | 0320 | 5 mm |

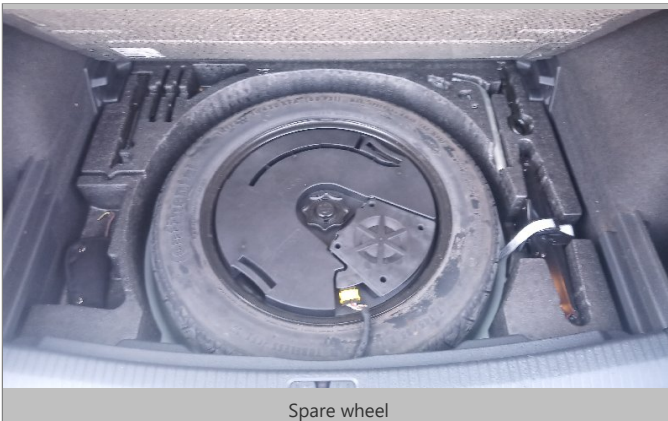
Spare wheel

| | Size | Load/Speed Index | Manufacture | Model | Type* | Production Date | Tread Depth (mm) |
|---|---|---|---|---|---|---|---|
| Spare | T145/85R18 | 103M | Continental | Temp | V | 0000 | 4 mm |

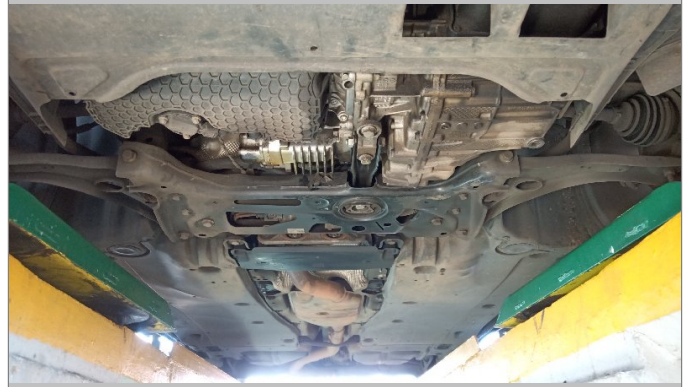
CHASSIS

Axle and Suspension: Control arm bushings on left and right front Control arms are Slightly perished.

Undercarriage: Mostly covered

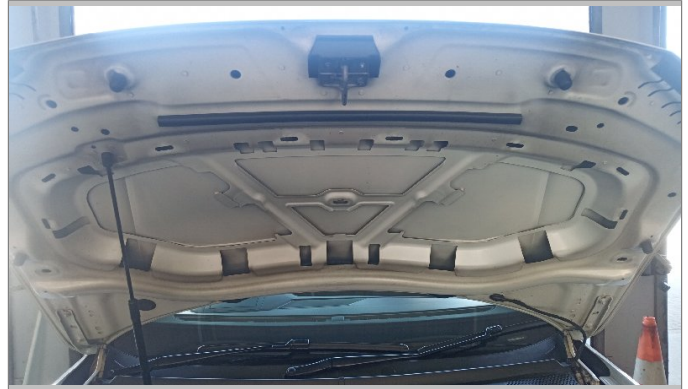
Bonnet insulation 1

Brakes: 4 Motion AWD, brakes tested on road test and incline test on park brake Bonnet insulation lose replace clips
