Private Client

Assignment

VEHICLE INSPECTION

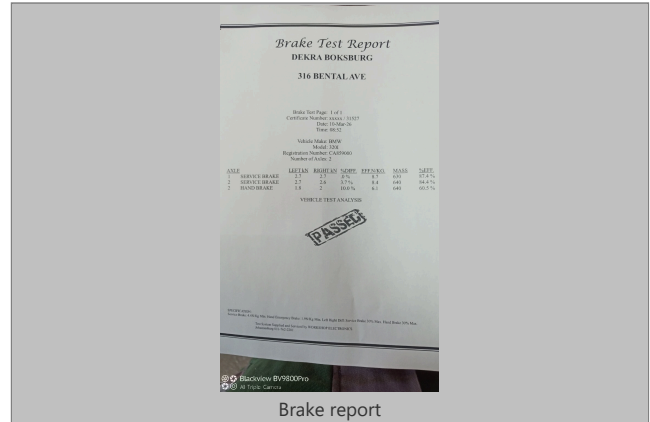
Brake report

Left	Right		
	Braking Force [KN]	Braking Force [KN]	Axle Weight [KG]	Deceleration [m/s ²]
Front	2.7	2.7	-	
Rear	2.7	2.6	-	
Emergency / Parking	1.8	2	-

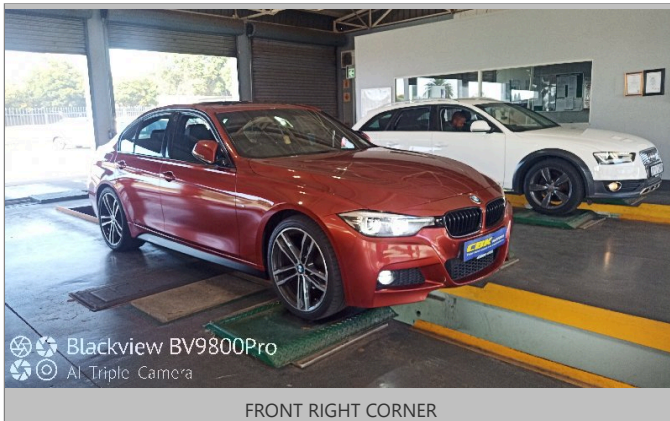
FRONT RIGHT CORNER

General Comments: ACCORDING TO AGE AND MILEAGE OF VEHICLE NORMAL WEAR AND TEAR ON INTERIOR, EXTERIOR, ELECTRICAL AND MECHANICAL PARTS. Body • Exterior: Minor dents stone chips and or scratches on various body panels

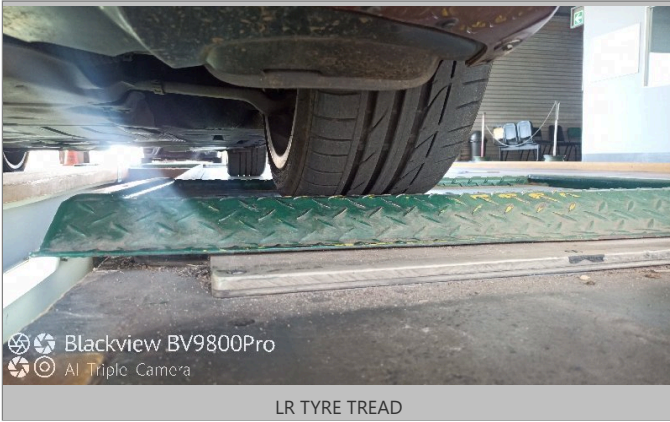
LR TYRE TREAD

Size	Load/Speed Index	Manufacture	Model	Type*	Production Date	Tread Depth (mm)
Front Left	225/40R19	89Y	Bridgestone	Potenza	V	4621	3 mm
Front Right	225/40R19	89Y	Bridgestone	Potenza	V	4821	3 mm
Rear Left	255/35R19	92Y	Bridgestone	Potenza	V	2423	3 mm
Rear Right	255/35R19	92Y	Bridgestone	Potenza	V	3425	3 mm

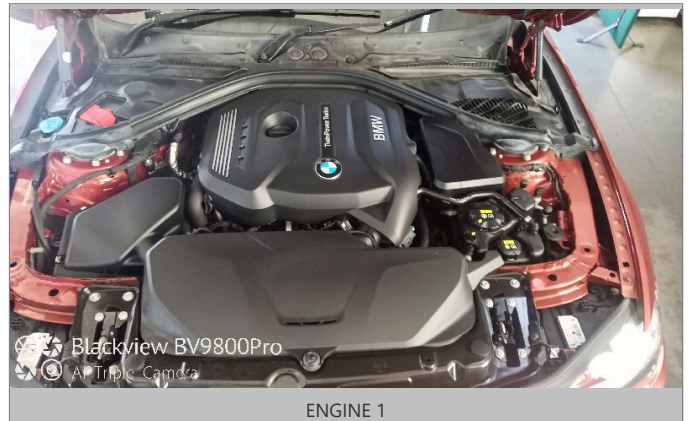
ENGINE 1

Engine number – not possible to verify engine number (not visible without dismantling)
Inspection conditions for the vehicle inspection were sufficient
