## Assignment

| Manufacturer | ISUZU | Registration Number | JK25JPGP |
| Model | MU-X 3.0 4X4 DSL AT [2018-2020] | Register Number | YWG653W |

## VEHICLE INSPECTION

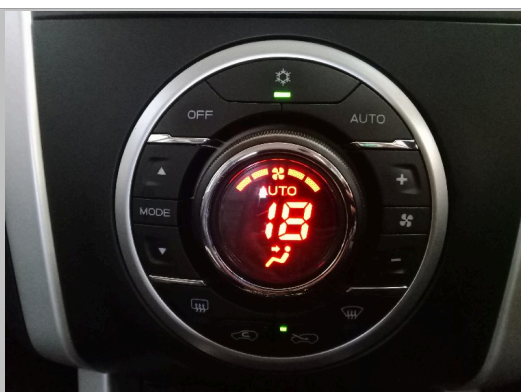
Aircon working

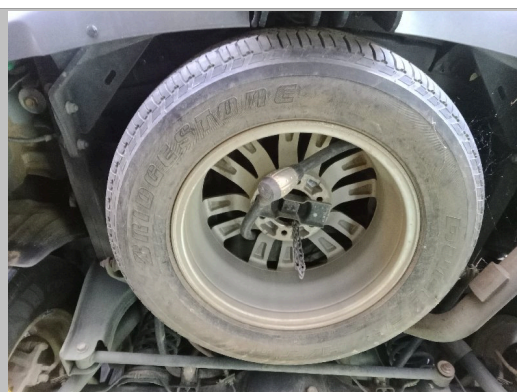
Sparewheel

| | Size | Load/Speed Index | Manufacture | Model | Type* | Production Date | Tread Depth (mm) |
|---|---|---|---|---|---|---|---|
| Spare | 255/60R18 | 108S | Bridgestone | Dueler | V | 0000 | 7 mm |

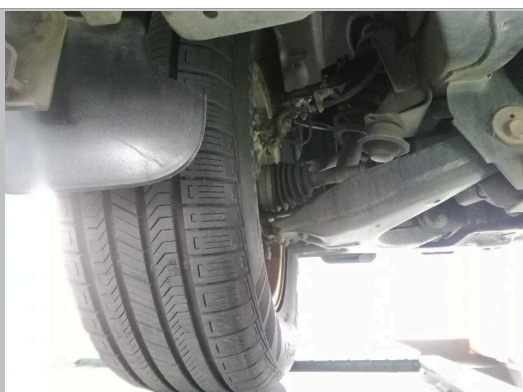
LF TYRE TREAD

| | Size | Load/Speed Index | Manufacture | Model | Type* | Production Date | Tread Depth (mm) |
|---|---|---|---|---|---|---|---|
| Front Left | 265/65R18 | 114T | Continental | Crosscontact | V | 2025 | 5 mm |

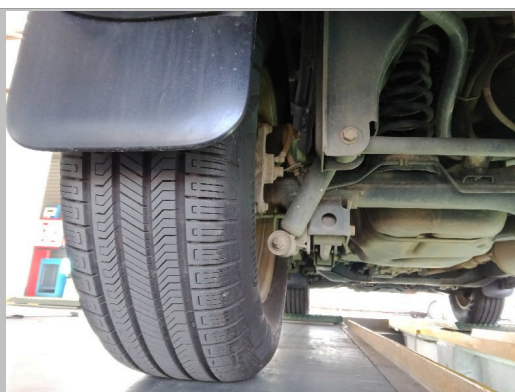
LR TYRE TREAD

| | Size | Load/Speed Index | Manufacture | Model | Type* | Production Date | Tread Depth (mm) |
|---|---|---|---|---|---|---|---|
| Rear Left | 265/65R18 | 114T | Continental | Crosscontact | V | 1825 | 6 mm |

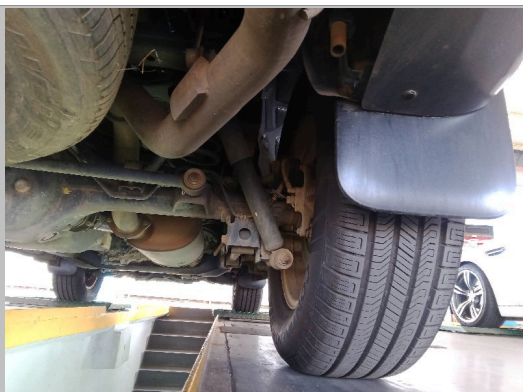
RR TYRE TREAD

| | Size | Load/Speed Index | Manufacture | Model | Type* | Production Date | Tread Depth (mm) |
|---|---|---|---|---|---|---|---|
| Rear Right | 265/65R18 | 114T | Continental | Crosscontact | V | 2025 | 6 mm |

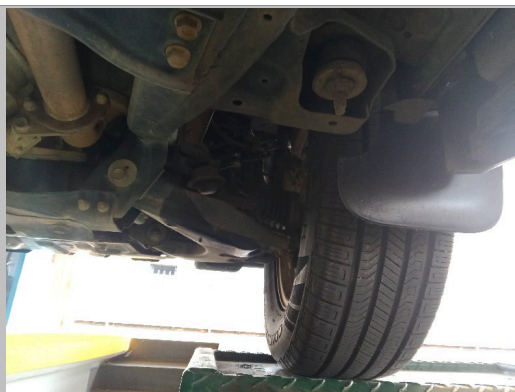
RF TYRE TREAD

| | Size | Load/Speed Index | Manufacture | Model | Type* | Production Date | Tread Depth (mm) |
|---|---|---|---|---|---|---|---|
| Front Right | 265/65R18 | 114T | Continental | Crosscontact | V | 1825 | 5 mm |

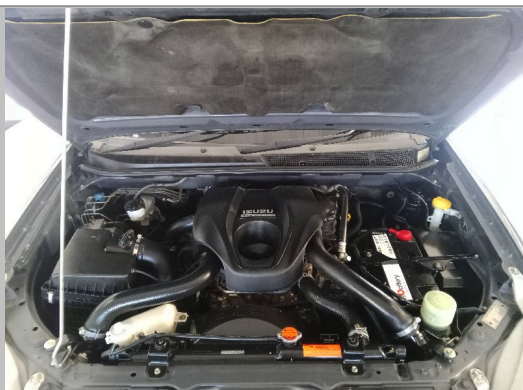
ENGINE 1

General Comments: ACCORDING TO THE AGE AND MILEAGE OF THE VEHICLE, NORMAL WEAR AND TEAR MARKS ARE VISIBLE ON THE INTERIOR, EXTERIOR, ELECTRICAL AND MECHANICAL PARTS. Engine Compartment: Engine mostly covered underneath.

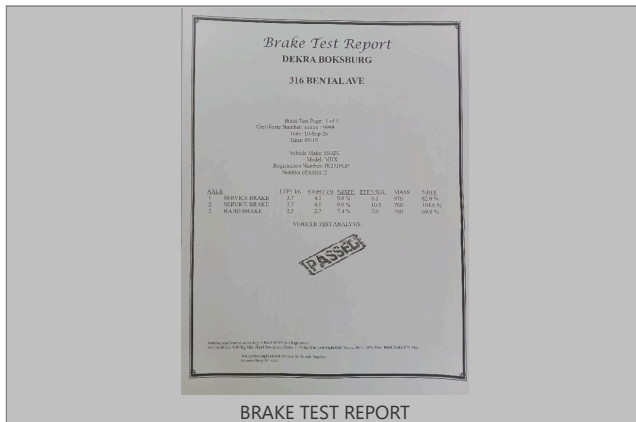
BRAKE TEST REPORT

| | Left | Right | | |
|---|---|---|---|---|
| Front | 3.7 | 4.1 | - | |
| Rear | 3.7 | 4.1 | - | |
| Emergency / Parking | 2.5 | 2.7 | - | |
