Private Client

DEKRA Boksburg  
Bentel Ave - 1459  
BOKSBURG - GT  
011 826 4386

## Assignment

| Model | BT-50 DBL 2.2 DSL HR SLX D-CAB W/LRD PU [2017-2021] | Register Number | YLF510W |

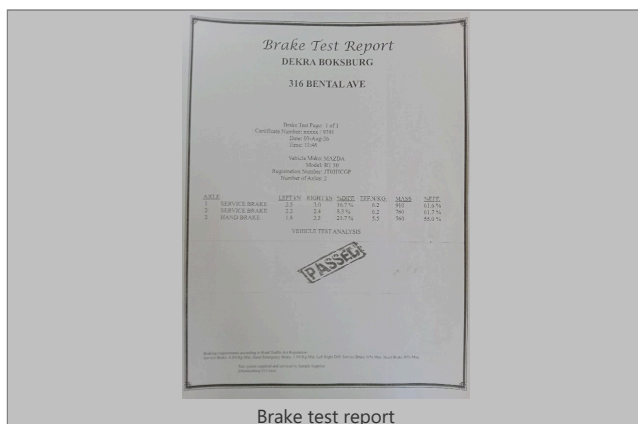
Brake test report

## Brakes

### Brake Test Results

| | Left | Right | | |
| | Braking Force [KN] | Braking Force [KN] | Axle Weight [KG] | Deceleration [m/s <sup>2</sup> ] |
| Front | 2.5 | 3.0 | - | |
| Rear | 2.2 | 2.4 | - | |
| Emergency / Parking | 1.8 | 2.3 | - | |

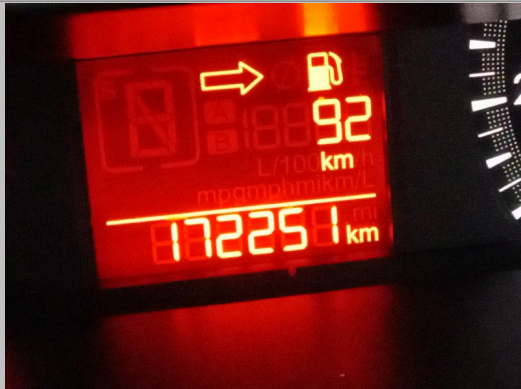
ODOMETER

| Km Reading | 172,251 KM | Transmission | MANUAL |

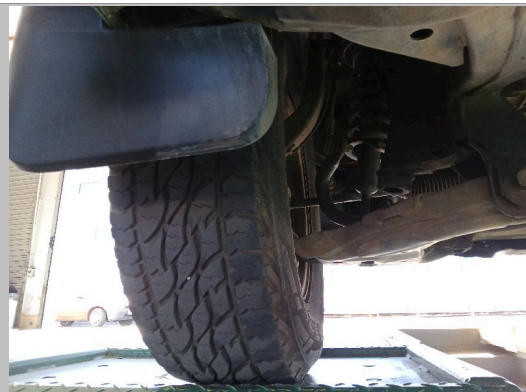
LF TYRE TREAD

| | Size | Load/Speed Index | Manufacture | Model | Type* | Production Date | Tread Depth (mm) |
|---|---|---|---|---|---|---|---|
| Front Left | 255/70R16 | 111S | Bridgestone | Dueler | V | 3922 | 5 mm |

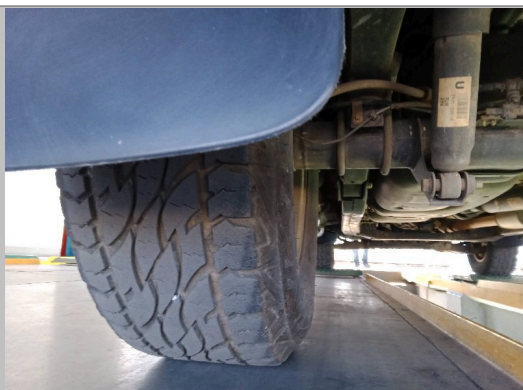
LR TYRE TREAD

| | Size | Load/Speed Index | Manufacture | Model | Type* | Production Date | Tread Depth (mm) |
|---|---|---|---|---|---|---|---|
| Rear Left | 255/70R16 | 111S | Bridgestone | Dueler | V | 4622 | 4 mm |

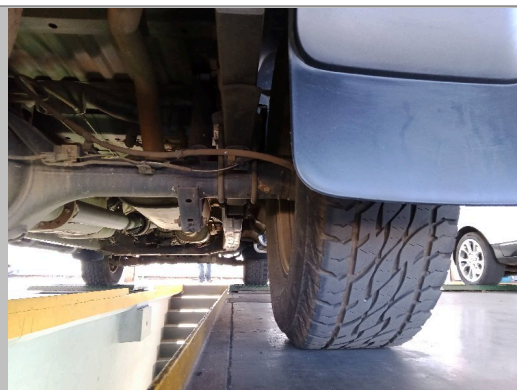
RR TYRE TREAD

| | Size | Load/Speed Index | Manufacture | Model | Type* | Production Date | Tread Depth (mm) |
|---|---|---|---|---|---|---|---|
| Rear Right | 255/70R16 | 111S | Bridgestone | Dueler | V | 4722 | 4 mm |

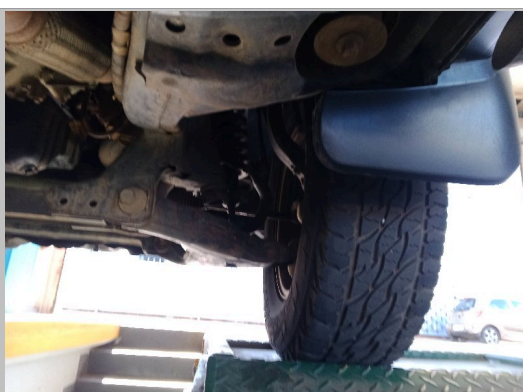
RF TYRE TREAD

| | Size | Load/Speed Index | Manufacture | Model | Type* | Production Date | Tread Depth (mm) |
|---|---|---|---|---|---|---|---|
| Front Right | 255/70R16 | 111S | Bridgestone | Dueler | V | 3822 | 5 mm |

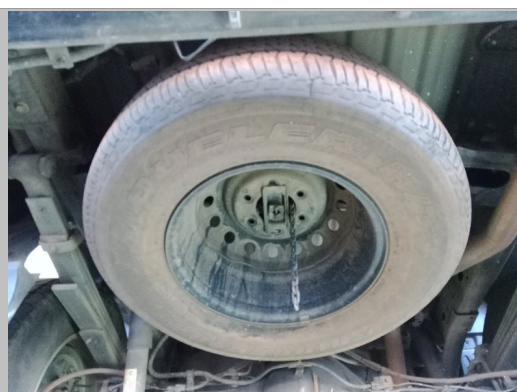
Sparewheel

| | Size | Load/Speed Index | Manufacture | Model | Type* | Production Date | Tread Depth (mm) |
|---|---|---|---|---|---|---|---|
| Spare | 255/70R16 | 111T | Bridgestone | Dueler | V | 0000 | 5 mm |

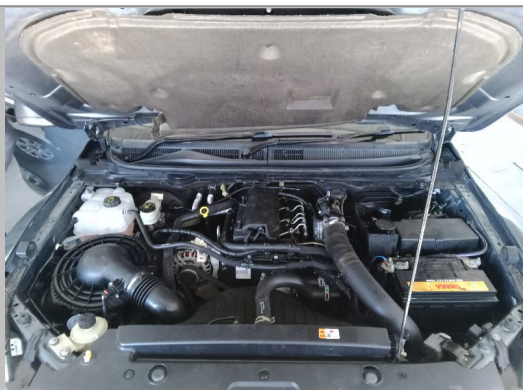
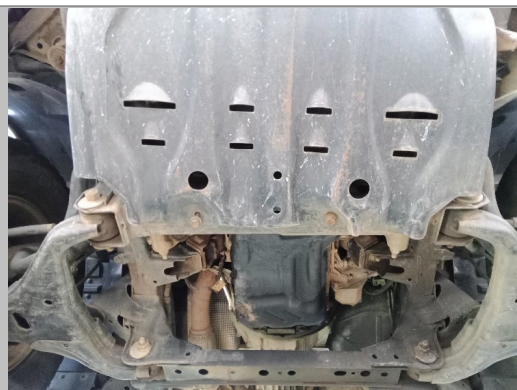
ENGINE 1

General Comments: ACCORDING TO THE AGE AND MILEAGE OF THE VEHICLE, NORMAL WEAR AND TEAR MARKS ARE VISIBLE ON THE INTERIOR, EXTERIOR, ELECTRICAL AND MECHANICAL PARTS. Engine Compartment: Engine partly covered underneath.  
Body • Exterior: Minor dents, scratches and stone chips on some body panels. Cosmetical enhancements done to some body panels.

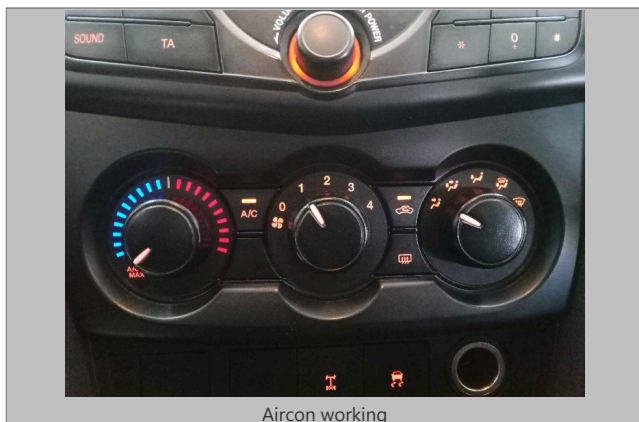
Aircon working
