## Assignment

## Vehicle Data

| Manufacturer | MERCEDES BENZ | Registration Number | LF29KNGP |
| Model | W205 | Register Number | YRY338W |

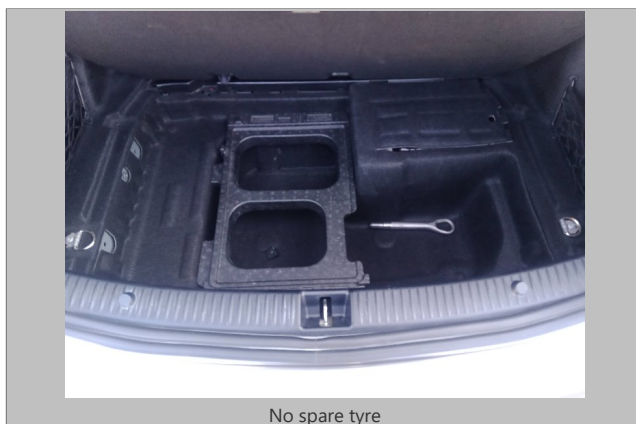
No spare tyre

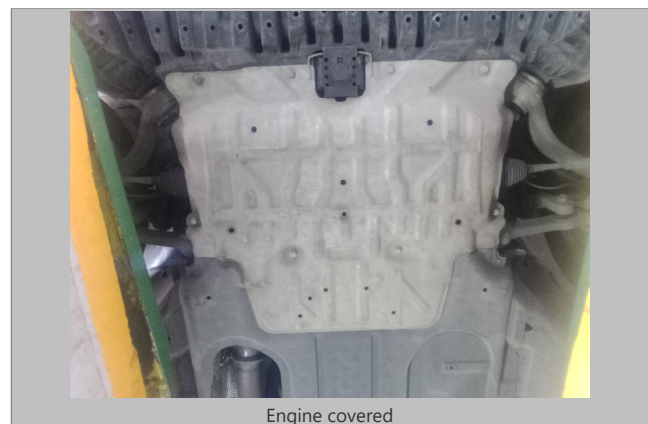
Engine covered

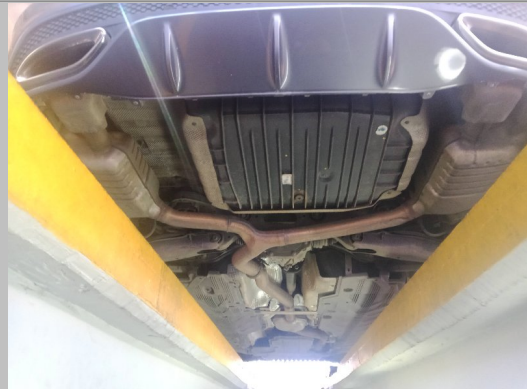
Chassis 2

General Comments: ACCORDING TO THE AGE AND MILEAGE OF THE VEHICLE: NORMAL WEAR AND TEAR MARKS ON THE BODY, INTERIOR, AND MECHANICAL. COSMETIC SPRAY WORK ON VARIOUS PANELS. Undercarriage: Undercarriage mostly covered.

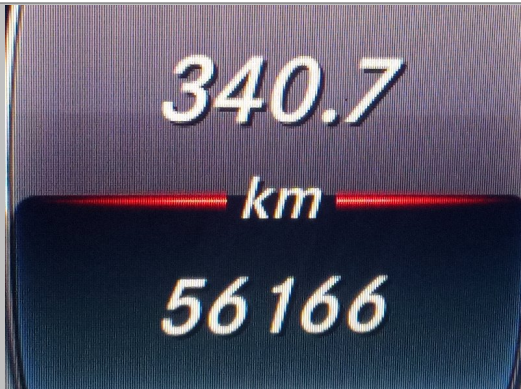
ODOMETER

| Km Reading | 56,166 KM | Fuel | PETROL |

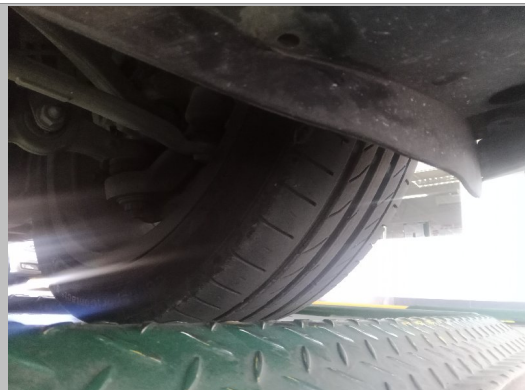
LF TYRE TREAD

| | Size | Load/Speed Index | Manufacture | Model | Type* | Production Date | Tread Depth (mm) |
|---|---|---|---|---|---|---|---|
| Front Left | 225/45R18 | 95Y | Continental | Contact 5 | V | 0719 | 3 mm |

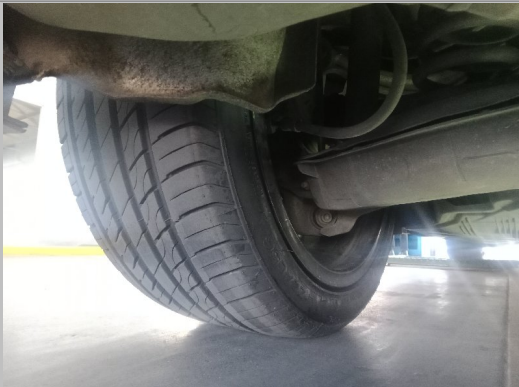
LR TYRE TREAD

| | Size | Load/Speed Index | Manufacture | Model | Type* | Production Date | Tread Depth (mm) |
|---|---|---|---|---|---|---|---|
| Rear Left | 245/40ZR18 | 97W | I link | Lzeal 56 | V | 1726 | 6 mm |

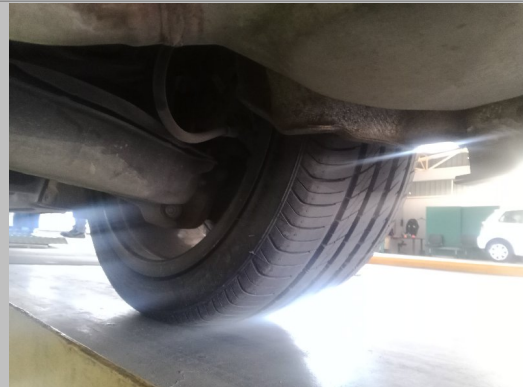
RR TYRE TREAD

| | Size | Load/Speed Index | Manufacture | Model | Type* | Production Date | Tread Depth (mm) |
|---|---|---|---|---|---|---|---|
| Rear Right | 245/40ZR18 | 97W | I link | Lzeal 56 | V | 1726 | 6 mm |

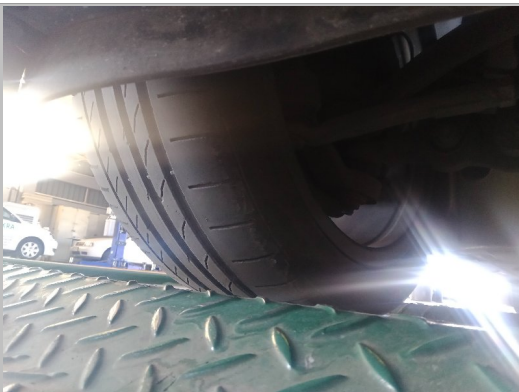
RF TYRE TREAD

| | Size | Load/Speed Index | Manufacture | Model | Type* | Production Date | Tread Depth (mm) |
|---|---|---|---|---|---|---|---|
| Front Right | 225/45R18 | 95Y | Continental | Contact 5 | V | 0719 | 2 mm |
