Private Client

DEKRA Boksburg  
Bentel Ave - 1459  
BOKSBURG - GT  
011 826 4386

| Manufacturer | MERCEDES BENZ | Registration Number | MY46JRGF |

## VEHICLE INSPECTION

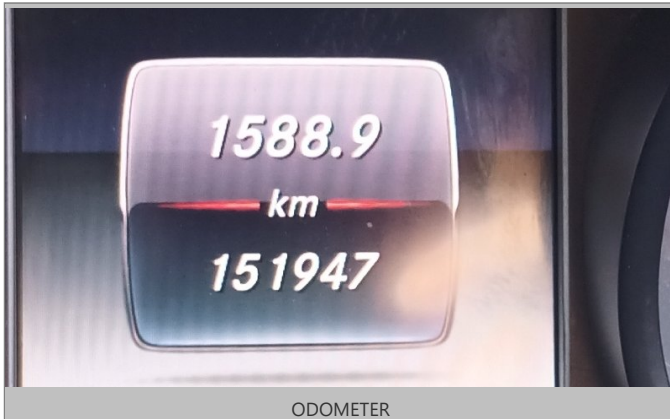
ODOMETER

| Km Reading | 151,947 KM | Fuel | DIESEL |

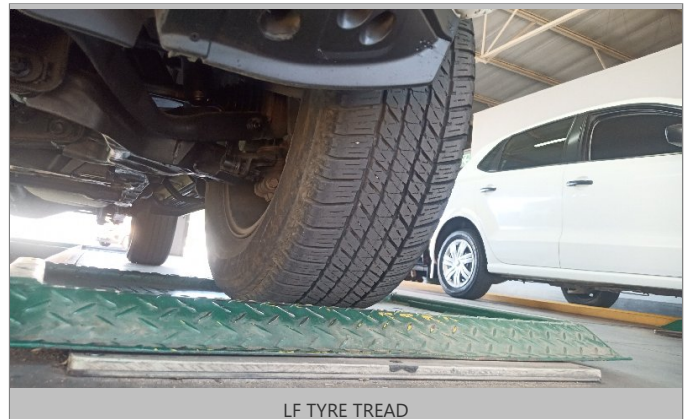
LF TYRE TREAD

| | Size | Load/Speed Index | Manufacture | Model | Type* | Production Date | Tread Depth (mm) |
|---|---|---|---|---|---|---|---|
| Front Left | 265/60R18 | 110H | Bridgestone | Dueler | V | 4513 | 5 mm |

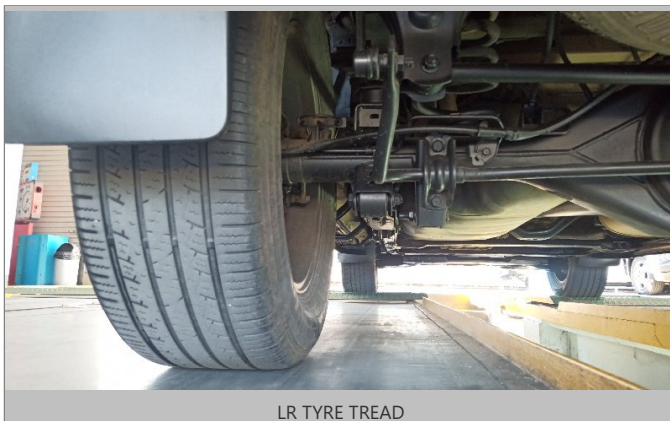
LR TYRE TREAD

| | Size | Load/Speed Index | Manufacture | Model | Type* | Production Date | Tread Depth (mm) |
|---|---|---|---|---|---|---|---|
| Rear Left | 265/60R18 | 110H | Hilo | Sport XV1 | V | 1121 | 4 mm |

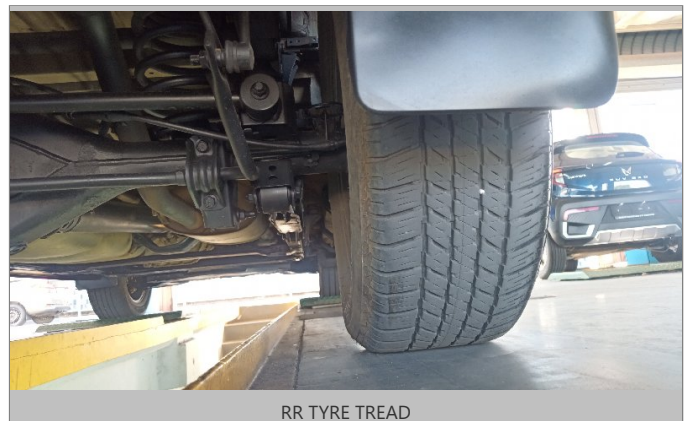
RR TYRE TREAD

| | Size | Load/Speed Index | Manufacture | Model | Type* | Production Date | Tread Depth (mm) |
|---|---|---|---|---|---|---|---|
| Rear Right | 265/60R18 | 110H | Bridgestone | Dueler | V | 2319 | 6 mm |

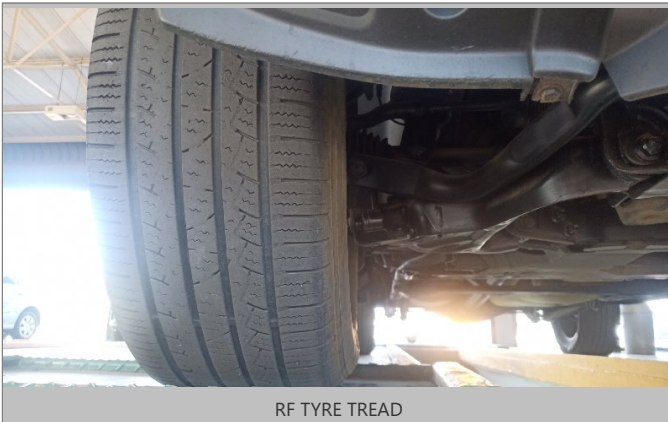
RF TYRE TREAD

| | Size | Load/Speed Index | Manufacture | Model | Type* | Production Date | Tread Depth (mm) |
|---|---|---|---|---|---|---|---|
| Front Right | 265/65R18 | 110H | Hilo | Sport XV1 | V | 1121 | 4 mm |

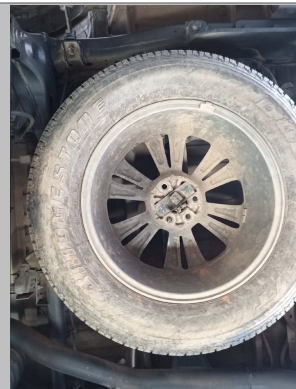
Spare wheel

| | Size | Load/Speed Index | Manufacture | Model | Type* | Production Date | Tread Depth (mm) |
|---|---|---|---|---|---|---|---|
| Spare | 265/60R18 | 110H | Bridgestone | Dueler | V | //// | 9 mm |

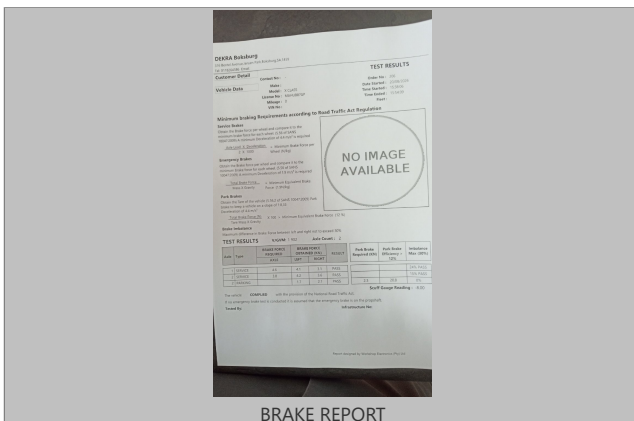
BRAKE REPORT

| | Left | Right | | |
|---|---|---|---|---|
| Front | 4.1 | 3.1 | - | |
| Rear | 4.2 | 3.6 | - | |
| Emergency / Parking | 1.7 | 2.1 | - | |
