Private Client

DEKRA Boksburg  
Bentel Ave - 1459  
BOKSBURG - GT  
011 826 4386

| Manufacturer | BMW | Registration Number | JF52TNGP |

## VEHICLE INSPECTION

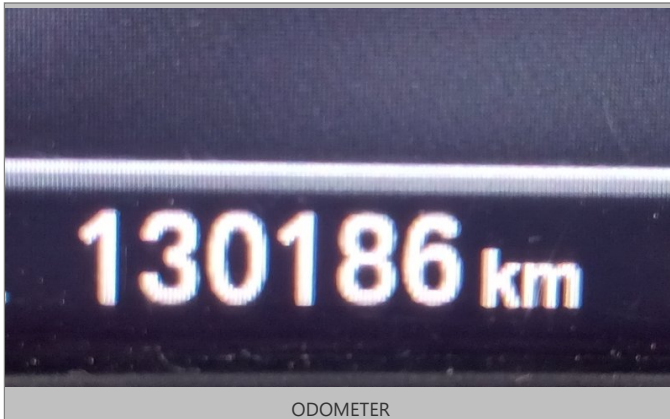
ODOMETER

| Km Reading | 130,186 KM | Fuel | DIESEL |

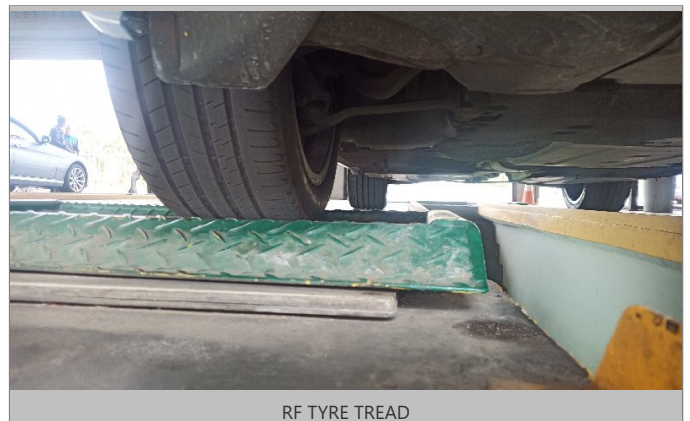
RF TYRE TREAD

| | Size | Load/Speed Index | Manufacture | Model | Type* | Production Date | Tread Depth (mm) |
|---|---|---|---|---|---|---|---|
| Front Right | 245/45R20 | 103W | Bridgestone | Alenza | V | 1024 | 4 mm |

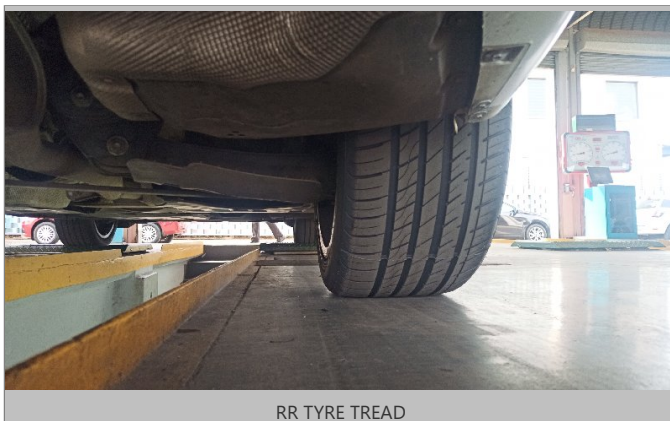
RR TYRE TREAD

| | Size | Load/Speed Index | Manufacture | Model | Type* | Production Date | Tread Depth (mm) |
|---|---|---|---|---|---|---|---|
| Rear Right | 275/40ZR20 | 102W | Ilank | L-ZEAL56 | V | 2226 | 6 mm |

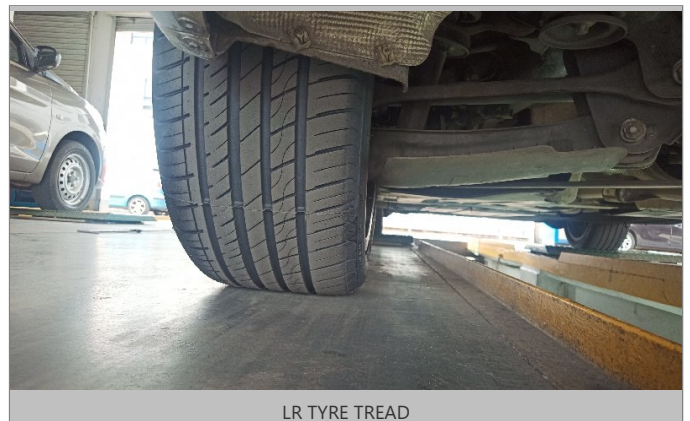
LR TYRE TREAD

| | Size | Load/Speed Index | Manufacture | Model | Type* | Production Date | Tread Depth (mm) |
|---|---|---|---|---|---|---|---|
| Rear Left | 275/40ZR20 | 102W | Ilank | L-zeal 56 | V | 2226 | 6 mm |

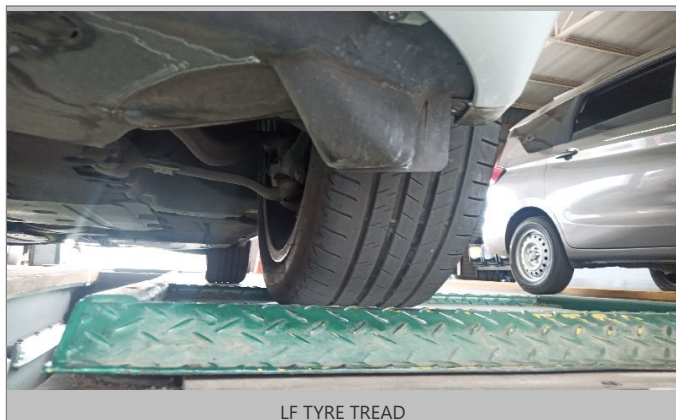
LF TYRE TREAD

| | Size | Load/Speed Index | Manufacture | Model | Type* | Production Date | Tread Depth (mm) |
|---|---|---|---|---|---|---|---|
| Front Left | 245/45R20 | 103W | Bridgestone | Alenza | V | 0824 | 4 mm |

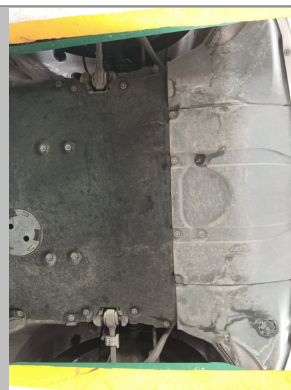
Covered

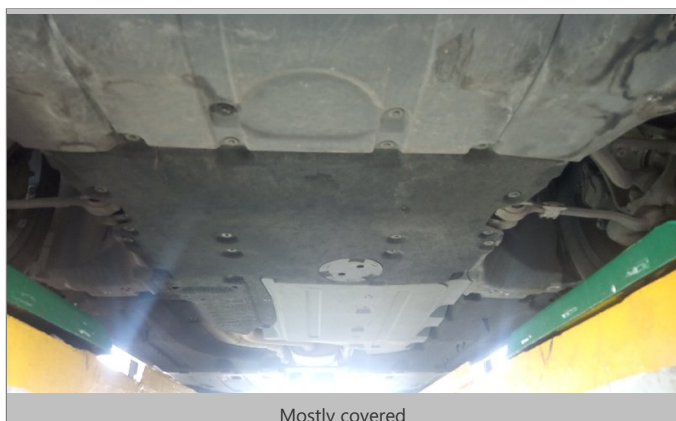
Undercarriage: Undercarriage mostly covered limited visibility.

Mostly covered

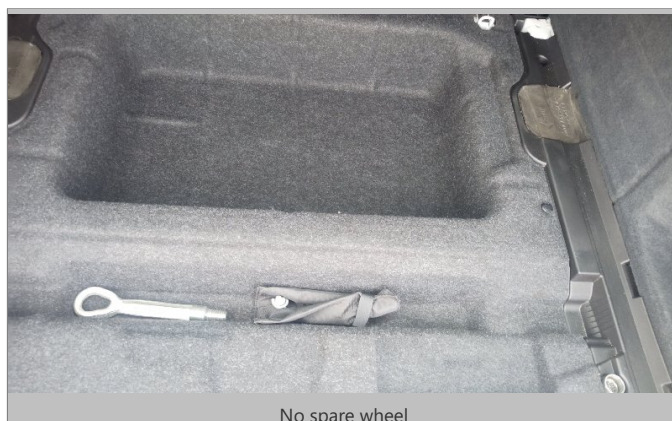
No spare wheel

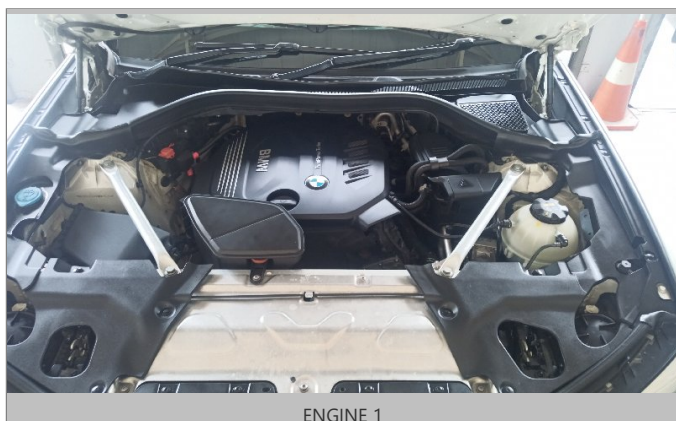
ENGINE 1

Engine number – not possible to verify engine number (not visible without dismantling)  
Inspection conditions for the vehicle inspection were sufficient

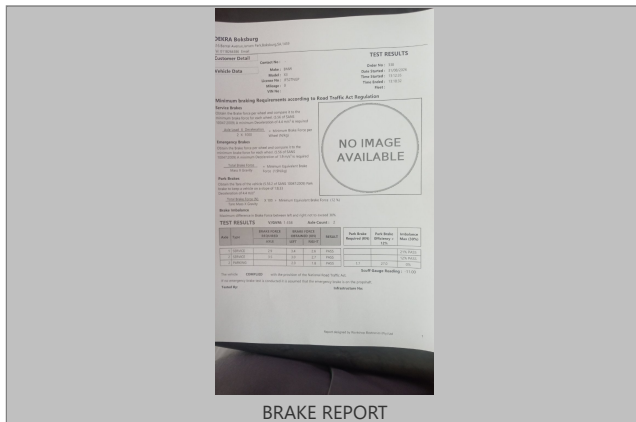
BRAKE REPORT

| | Left | Right | | |
|---|---|---|---|---|
| Front | 3.4 | 2.6 | - | |
| Rear | 3.0 | 2.7 | - | |
| Emergency / Parking | 2 | 1.8 | - | |
