DEKRA Boksburg
Bentel Ave - 1459
BOKSBURG - GT
011 826 4386

Client	Private Client	Inspection Location	BOKSBURG DEKRA
Requested Date	24/06/2026		316 BENTELL AVE BOKSBURG - 1459
Inspection Date	24/06/2026		BOKSBURG - GT

VEHICLE INSPECTION

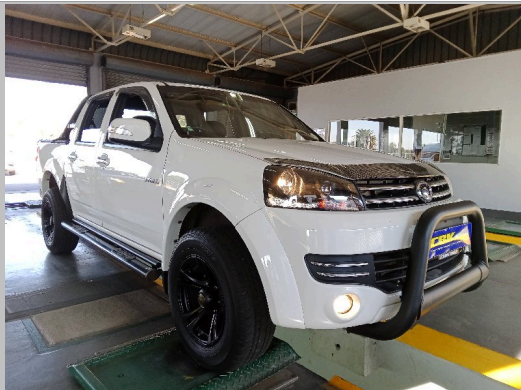
FRONT RIGHT CORNER

General Comments: ACCORDING TO THE AGE AND MILEAGE OF THE VEHICLE, NORMAL WEAR AND TEAR MARKS ARE VISIBLE ON THE INTERIOR, EXTERIOR, ELECTRICAL AND MECHANICAL PARTS. Body • Exterior: Minor dents, scratches and stonechips on some body panels. Cosmetic enhancements done to some body panels.

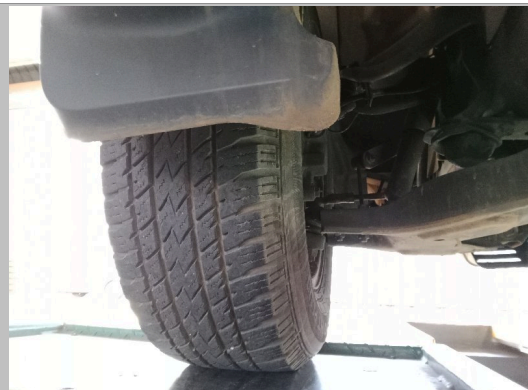
LF TYRE TREAD

Size	Load/Speed Index	Manufacture	Model	Type*	Production Date	Tread Depth (mm)
Front Left	235/70R16	106T	Giti	Savero	V	3119	8 mm
Front Right	235/70R16	106T	Giti	Savero	V	3119	8 mm
Rear Left	235/70R16	106T	Giti	Savero	V	3119	9 mm
Rear Right	235/70R16	106T	Giti SI	Savero	V	3119	9 mm
Spare	235/70R16	106T	Giti	Savero	V	0000	10 mm
